Date : 12/30/2024  
Project No : 2022C227  
Client Company : Artisan  
Arrival Time : 12/30/2024  
Onsite Hours :

ASEC Report ID : 74977  
Name of the Project : Riverwalk Manor (CMT) Unit 2, PH 4E  
and 4F  
Project Location : Dallas  
Weather : sunny  
Departure Time : 12/30/2024  
ASEC Technician Name : Russell Hendrix

A request was made for a visual inspection of the retaining wall drainage improvement between Lots #984 and #985 in the Naturewalk Development. The purpose of the inspection was to assess the adequacy of the recently installed drainage system and address an erosion issue reported by the homeowner of Lot #984. A meeting was held with Josh Anderson, an Artisan representative, to discuss the retaining wall addition completed approximately a year ago along with the recent drain and sod placement.

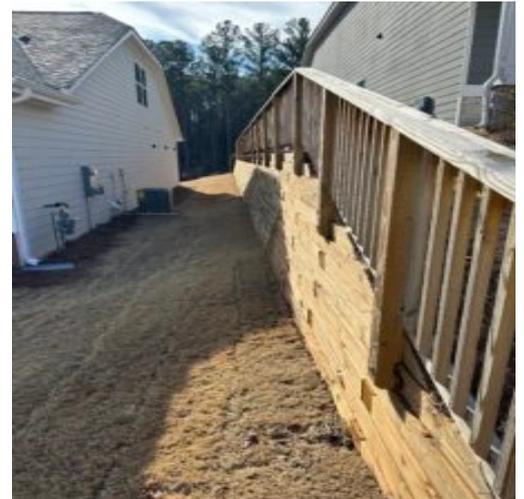
Retaining wall between lots 984 & 985

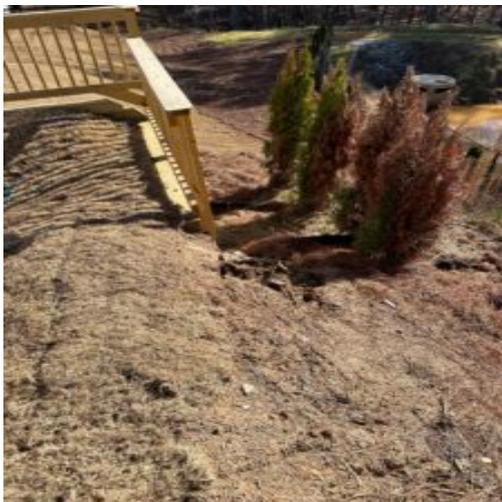
Drain exit at bottom of wall (black 8 inch corrugated pipe).
