Date : 04/27/2026
Project No : 2023C159
Client Company : CW Matthews
Arrival Time : 04/27/2026
Onsite Hours : N/A

ASEC Report ID : 93765
Name of the Project : Airfield Repairs 2021-23
Project Location : HJAIA, Atlanta, GA
Weather : overcast
Departure Time : 04/27/2026
ASEC Technician Name : Russell Hendrix

As requested, the site was visited by our AS Engineering and Consulting (ASEC) representative for the purpose of providing quality control inspection and testing services. Visual observation techniques were employed to verify compliance with project drawing/specifications, applicable codes, and materials submittals. The following observations were observed on site this day:

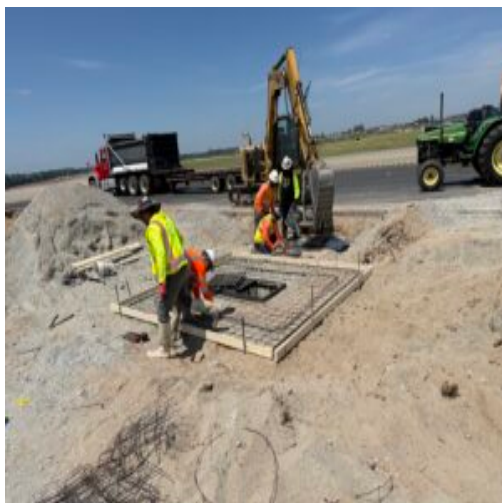
form/rebar collar area 1 observed by 2MNext and AtlNext before concrete placement.

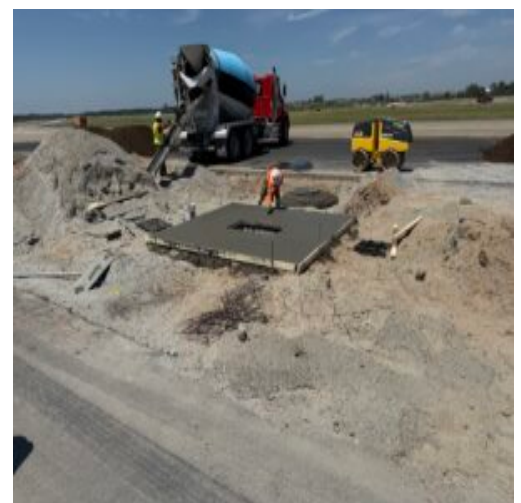
Placed concrete Collar area 1

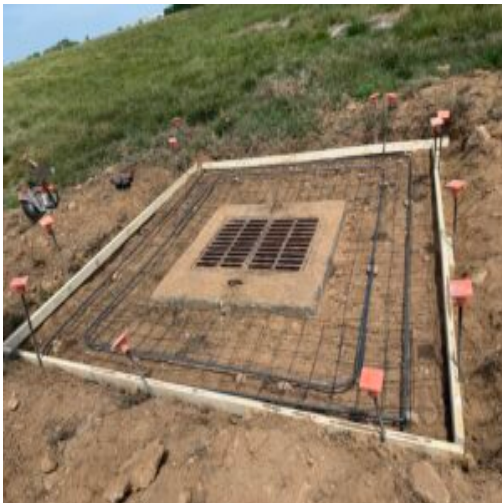
Formed/rebar Collar next to flume observed by 2MNext and AtlNext before concrete placement.

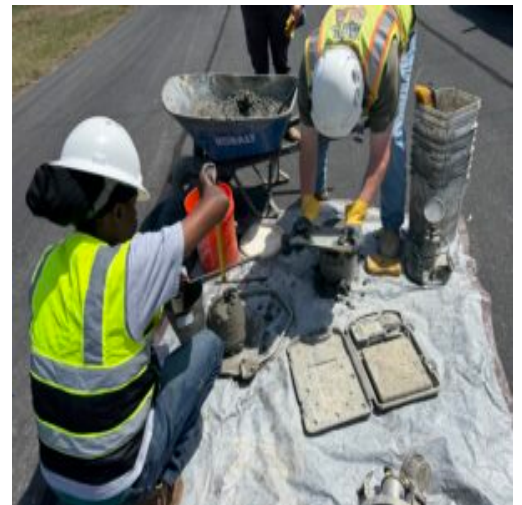
Concrete testing

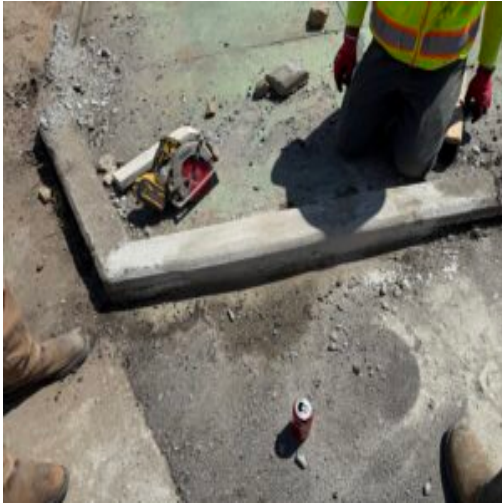
Curb repair area 1

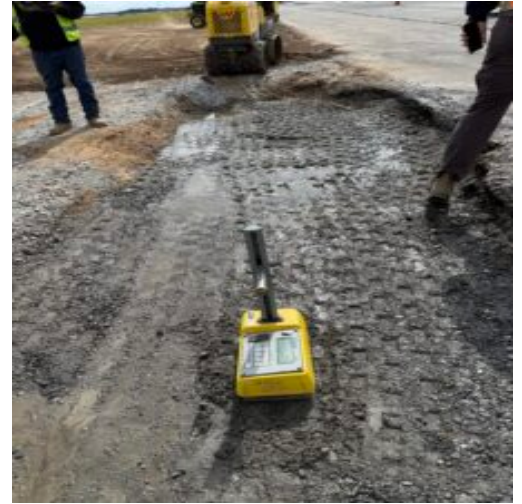
Testing

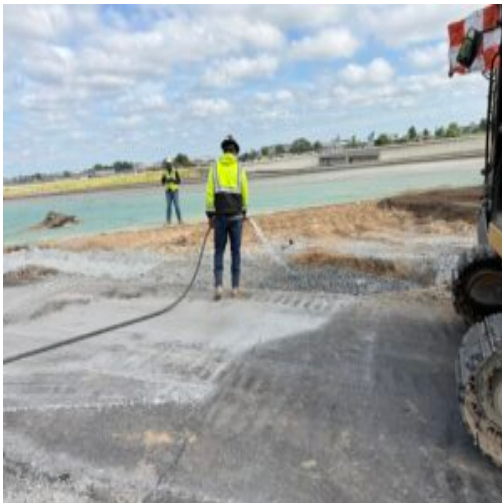
Adding water to GAB

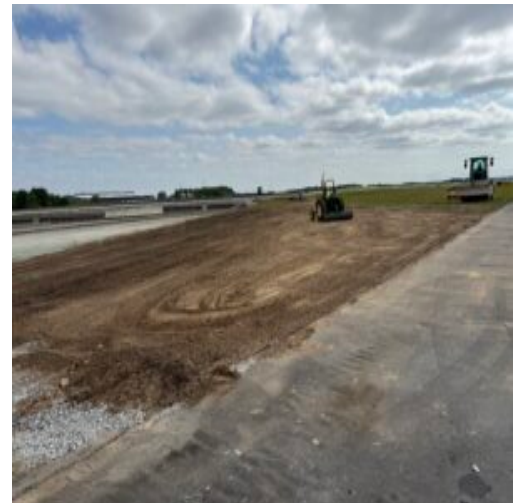
Preparing area

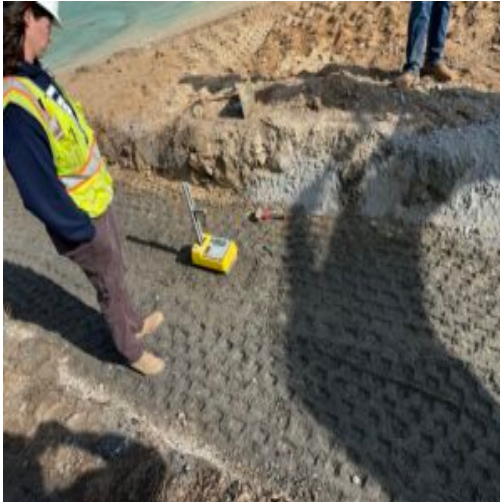
Testing

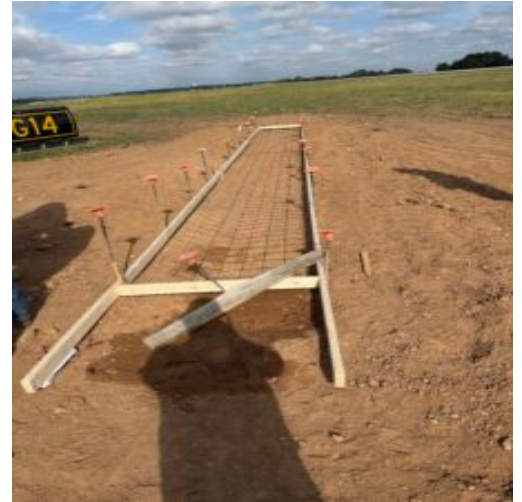
Formed Flume

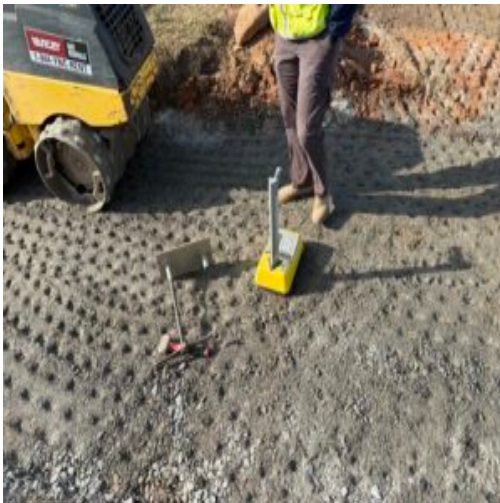
Testing

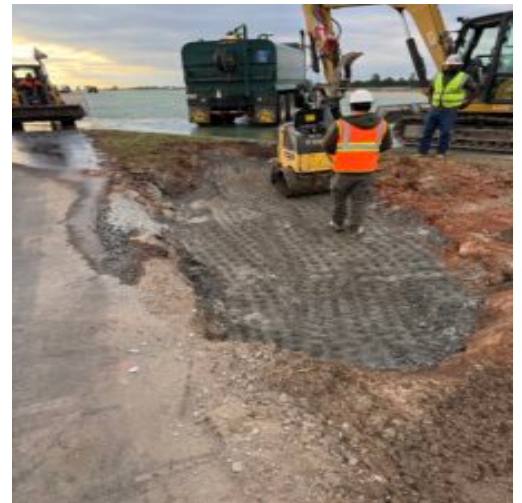
Compacting
