Date : 10/10/2024
Project No : 2023C180
Client Company : Artisan Communities
Arrival Time : 10/10/2024
Onsite Hours :

ASEC Report ID : 72306
Name of the Project : Lakeside Sub. - Lovers Lane, Calhoun
Project Location : Calhoun
Weather : sunny
Departure Time : 10/10/2024
ASEC Technician Name : Russell Hendrix

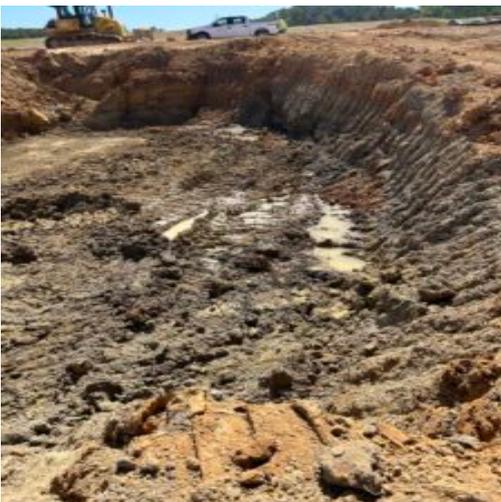
During excavation, water intrusion was observed in the newly cleared area. A call was placed to the ASEC engineer, who recommended the use of on-site rock less than 24 inches material and geotextile fabric on the western side of the area to address the water intrusion.

Water intrusion designated tennis court location

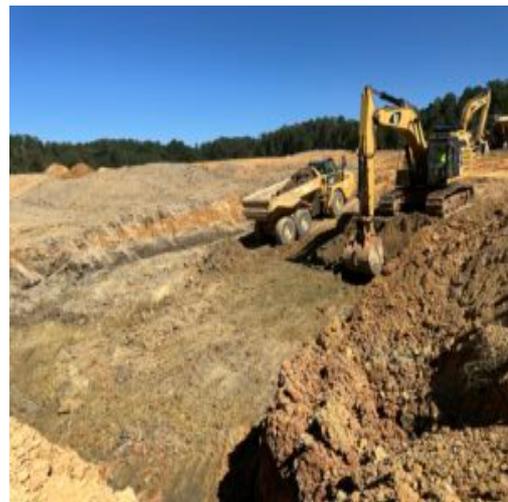
Upon arrival at the site, it was discussed with the foreman that a burn pit had been previously located at the future tennis court area, measuring approximately 70 feet by 70 feet and 8 feet deep (see attached photos). The buried organic and burned material from this pit was excavated and relocated to a non-structural slope area.

excavating tennis court area

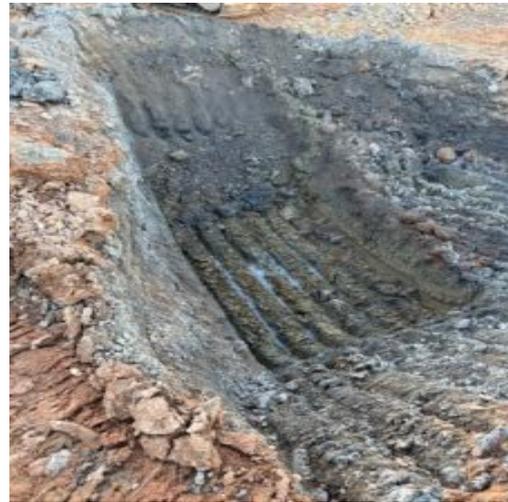
While implementing the recommendation, it was noted that some of the rock placed exceeded 24 inches in size, contrary to the specified recommendation. A meeting was held with the operator to address concerns about potential air voids due to the oversized rock.

Tennis court area with water intrusion first lift of rock placed
