Date : 08/09/2025
Project No : 2023C180
Client Company : Artisan Communities
Arrival Time : 08/09/2025 07:00
Onsite Hours : 00:30

ASEC Report ID : 84115
Name of the Project : Lakeside Sub., Lovers Lane > Retaining
Wall
Project Location : Calhoun
Weather : overcast
Departure Time : 08/09/2025 07:30
ASEC Technician Name : Sean Willett

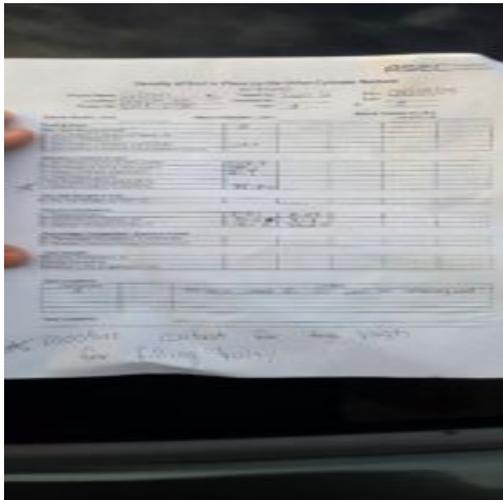
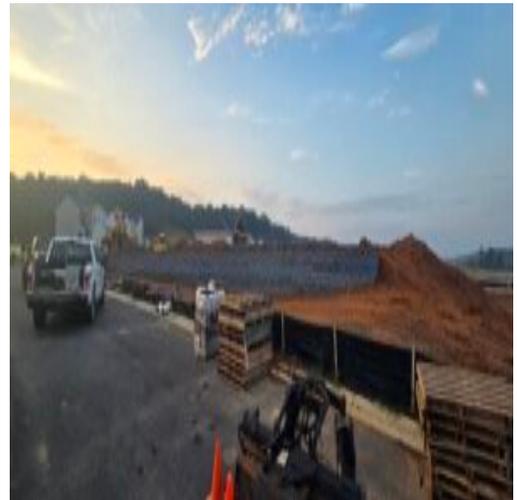
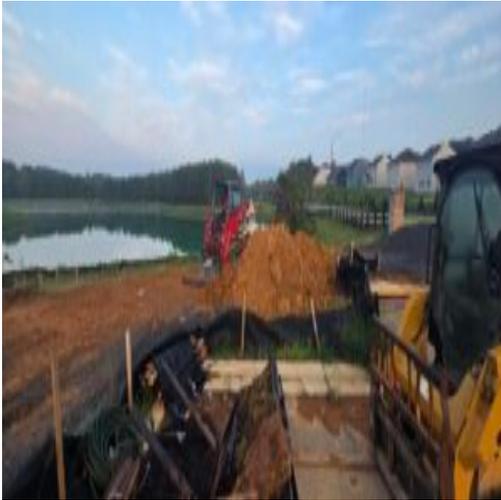
Upon arrival to the site, it appeared the site was over saturated from previous rainfall. The contractor requested a moisture check. Moisture checks were found to be well above optimum moisture contents. The technician provided a copy of test results to the contractor.

The retaining wall appears to have approximate 2 feet of fill left to be at finished grade.
