Date : 10/17/2024
Project No : 2024C161
Client Company : Artisan
Arrival Time : 10/17/2024
Onsite Hours :

ASEC Report ID : 71473
Name of the Project : The Georgian - Heritage Pointe - DCP's
and Geo Drilling
Project Location : Villa Rica
Weather : sunny
Departure Time : 10/17/2024
ASEC Technician Name : Russell Hendrix

A request was made to evaluate the footing at Lot #53 located at Heritage Pointe, The Georgian, in Paulding County, following concerns raised by a previous engineer/technician regarding the adequacy of the existing footing.

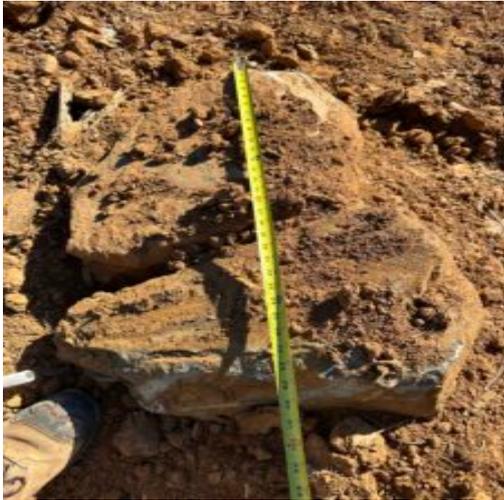
The site was found to contain numerous boulders, some exceeding 24 inches in size (refer to attached photos). Solid rock was also encountered within the footing itself (refer to attached photos), further contributing to the auger refusal.

- **Boulder Fill:** Based on field observations, there is reason to suspect that the lot may have been used as boulder fill. This raises concerns about the suitability of the material and its potential impact on the foundation's stability.

Boulders on the lot

- Conduct a more detailed geotechnical analysis, potentially through excavation or core drilling, to verify the fill material and its suitability for support.
- Assess the need for additional remediation, particularly in areas where the footing is underlaid by boulders or solid rock.
- Monitor the stability of the existing piers to ensure they are providing adequate support over time.

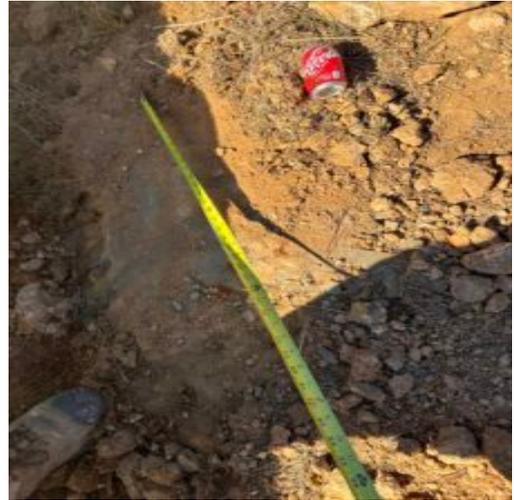
Boulders on the lot

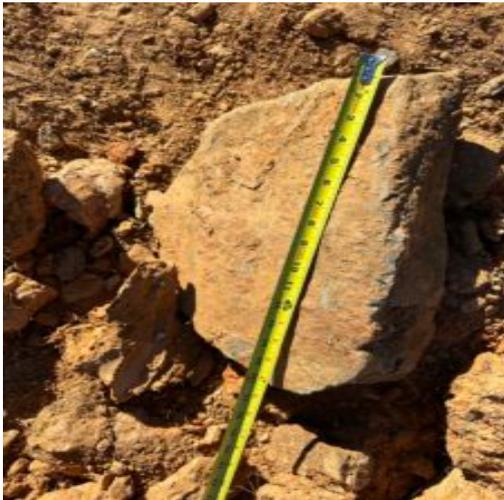
Boulders on the lot

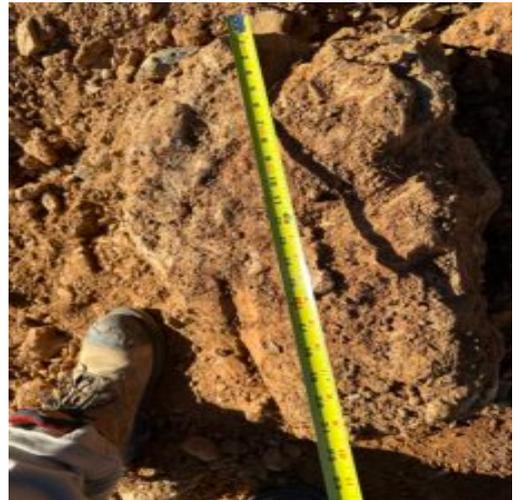
Boulders on the lot

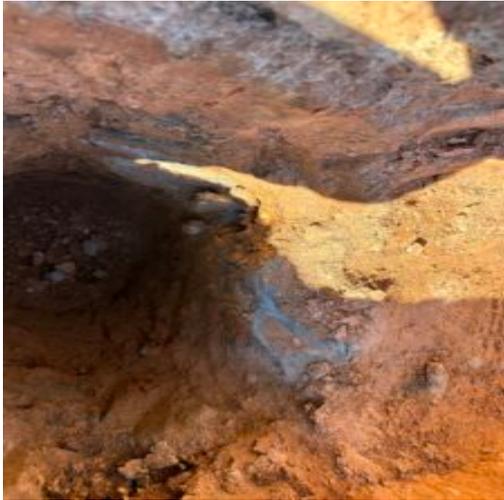
Rock in the footing

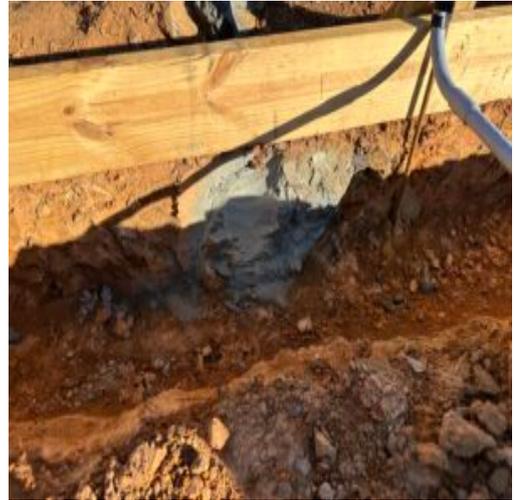
Rock in the footing

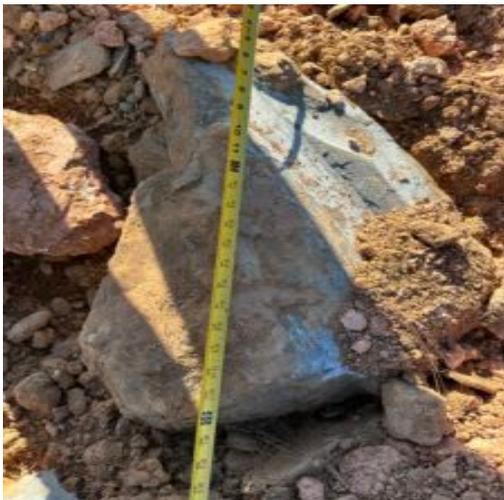
Boulder on the lot

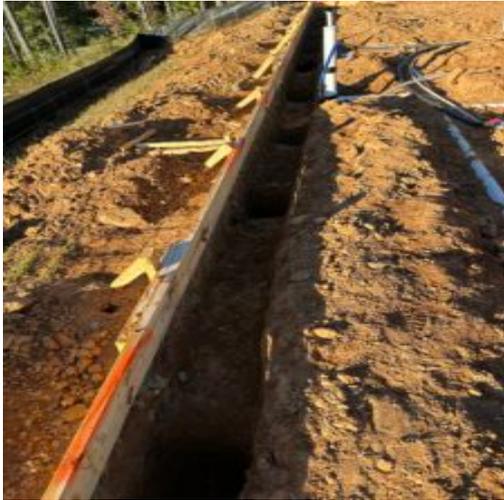
Footing with exposed rock

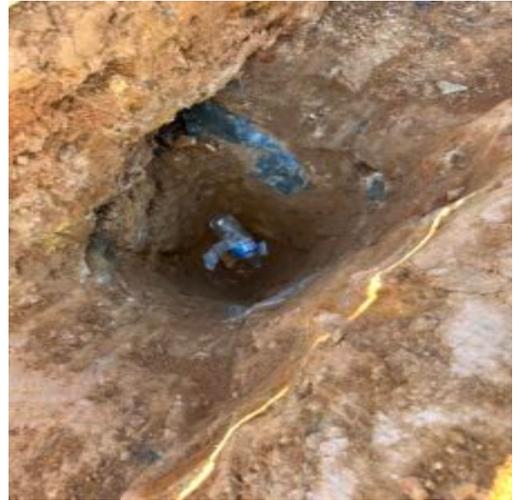
exposed rock in pier
