Date : 12/24/2024
Project No : 2024C168
Client Company : Century Communities
Arrival Time : 12/24/2024 08:00
Onsite Hours : 06:00

ASEC Report ID : 78908
Name of the Project : Reserve @ Gum Springs
Project Location : Jefferson, Jackson County, Georgia
Weather : cold
Departure Time : 12/24/2024 14:00
ASEC Technician Name : Mahendra Mylabathula

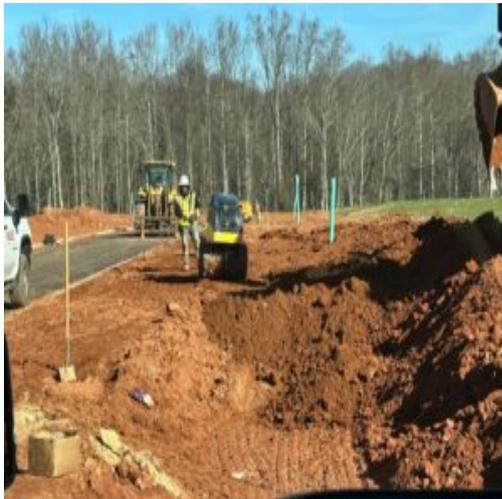
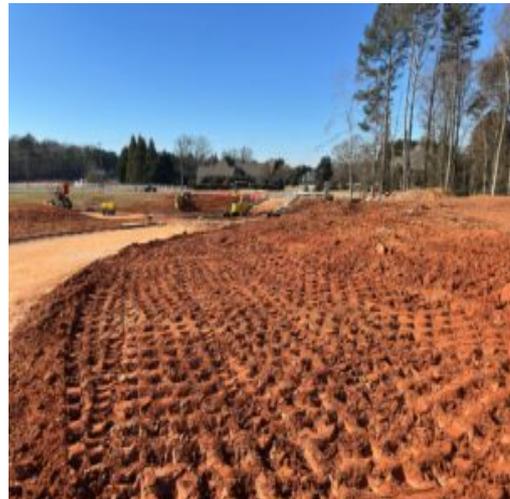
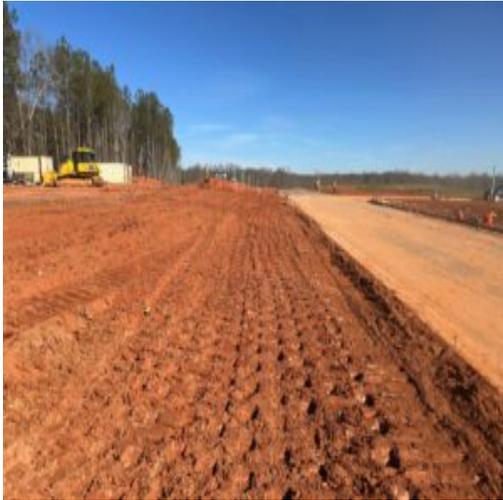
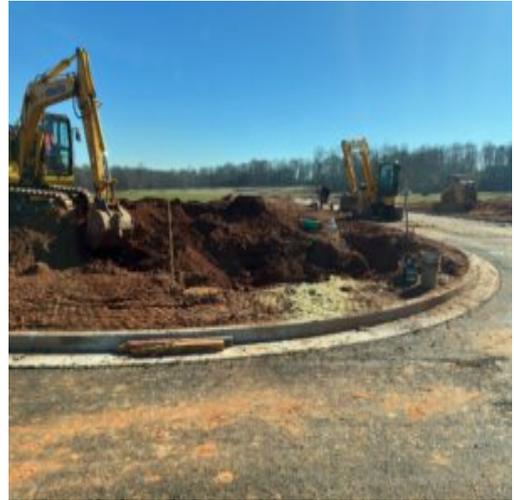
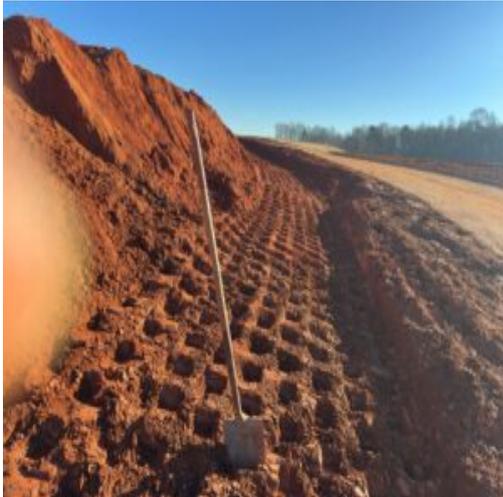
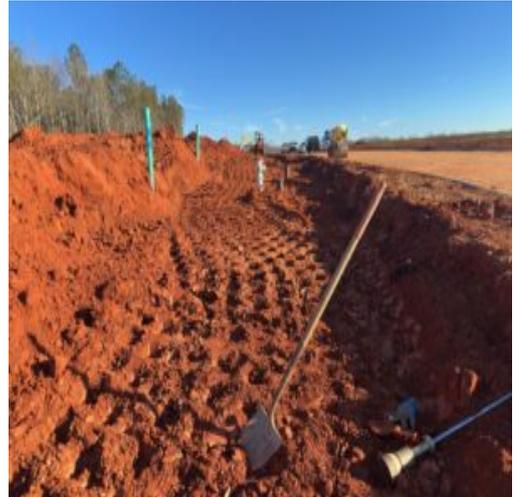
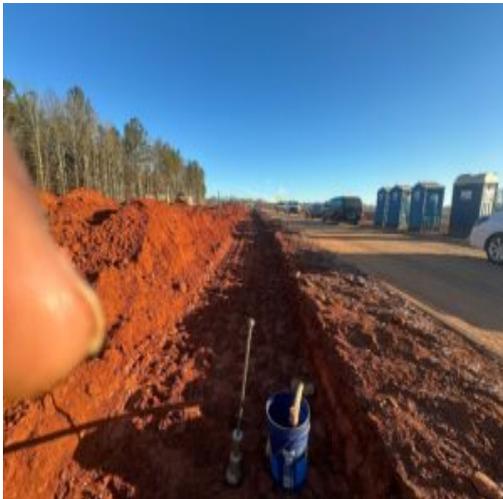
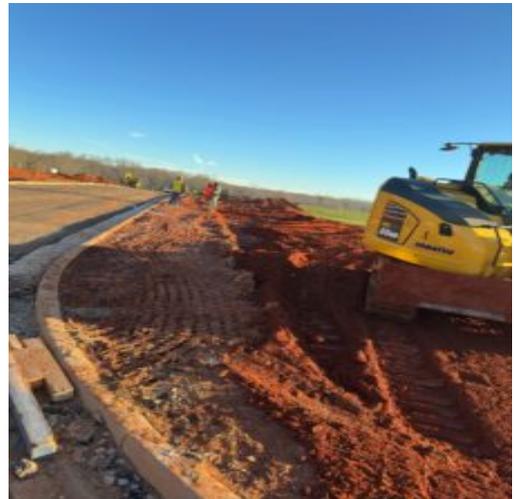
- The placement and compaction of backfill soils for the water line from Lot #1 to Lot #5 continued this day.
- At the time of arrival, our representative observed that work was in progress with 1-foot lifts being placed and compacted with a 6-ton pad feet and trench compactors. Compaction testing was performed using the Standard Test Method for Density of Soil in Place by Drive-Cylinder (ASTM D 2937), along with general probing using a 3/8" diameter probe rod.
- Density test results indicate that most of the compacted materials met the project requirement of 95% of the maximum dry density obtained by a Standard Proctor ASTM 698.
