Date : 11/06/2025  
Project No : 2024C202  
Client Company : CCG  
Arrival Time : 11/06/2025 08:00  
Onsite Hours : 03:00

ASEC Report ID : 87540  
Name of the Project : Old Griffin Rd - Hawthorne Reserve  
Project Location : Dallas  
Weather : Sunny  
Departure Time : 11/06/2025 11:00  
ASEC Technician Name : Clyde Smith

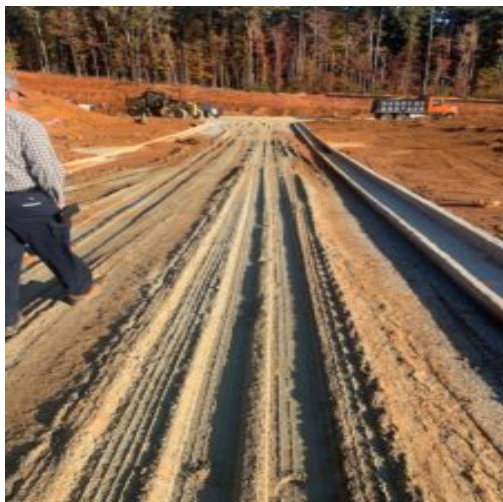
Previous areas damaged by rain event

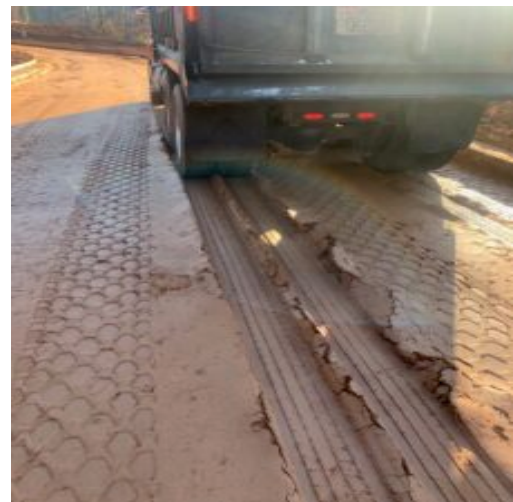
Proof roll failed area

Recommended repair areas: 1.14' x 28' x 6", 2.20' x 50' x 4", 3. 10' x 20' x 6", 4. 12' x 13' x 6", and 5. 17' x 13' x 4".

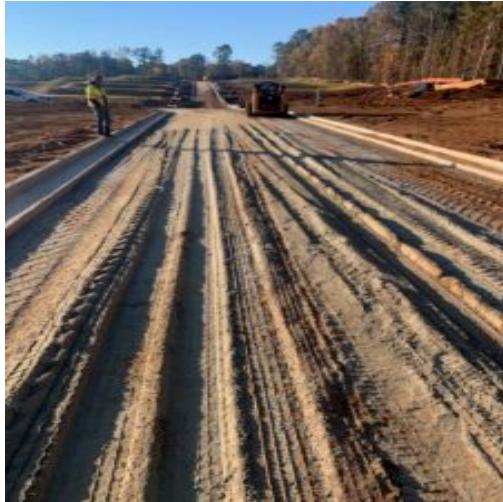
Previous area damaged by rain event

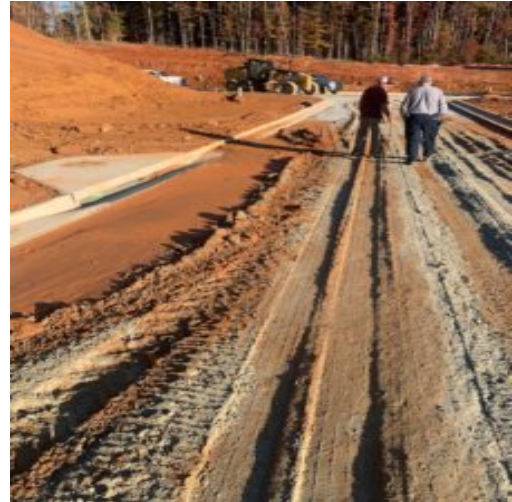
Previous area damaged contamination

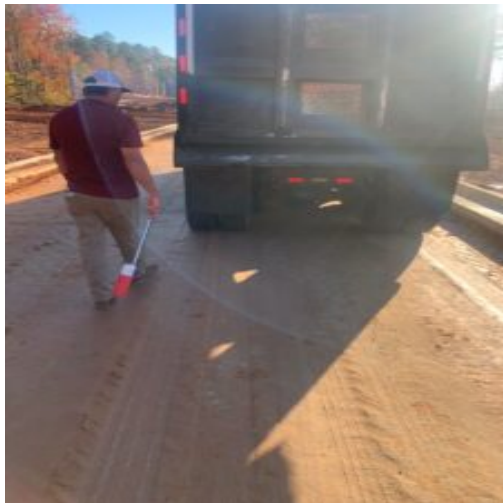
Proof roll

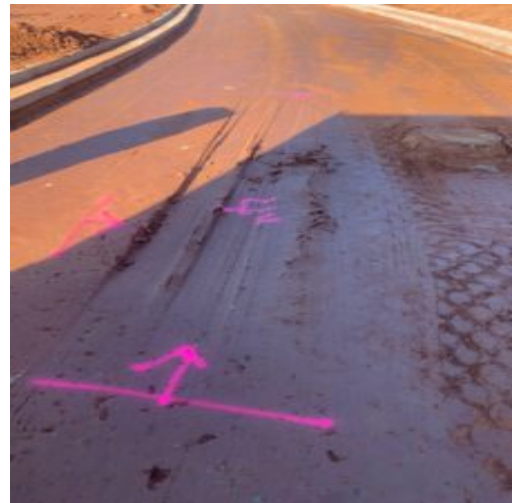
Proof roll failed area

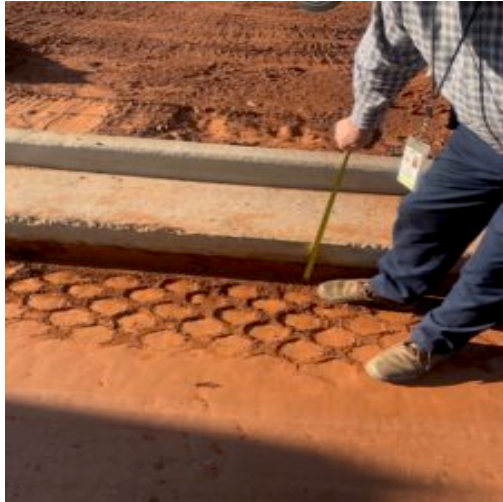
Depth check

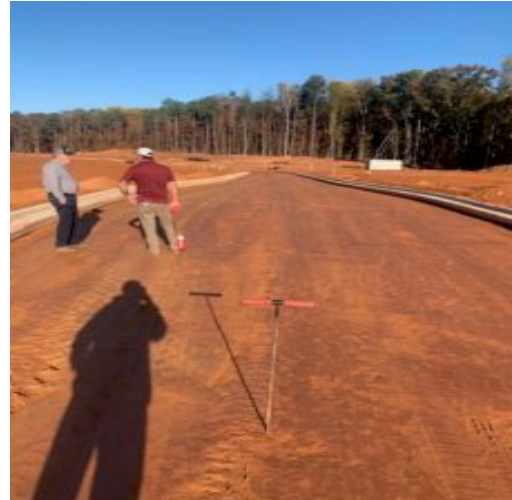
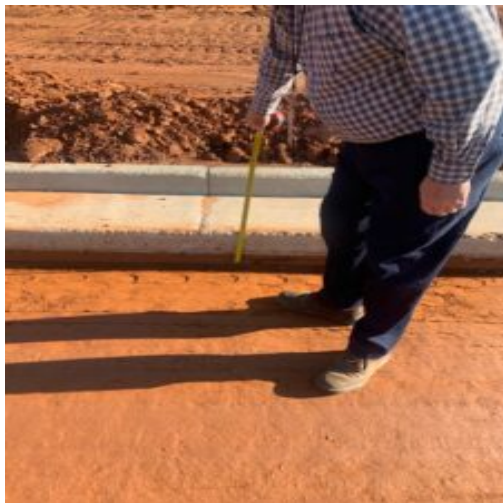
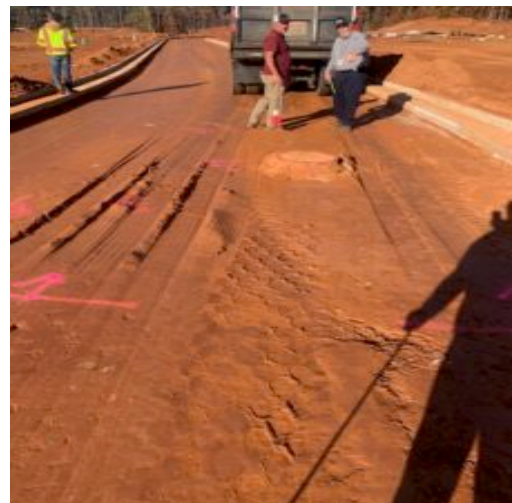
Failed area

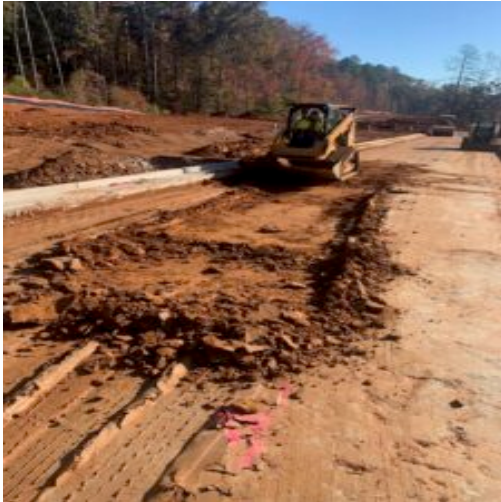
Recommended repair area
