Date : 11/13/2025
Project No : 2024C202
Client Company : CCG
Arrival Time : 11/13/2025 08:00
Onsite Hours : 07:30

ASEC Report ID : 87755
Name of the Project : Old Griffin Rd - Hawthorne Reserve
Project Location : Dallas
Weather : Sunny
Departure Time : 11/13/2025 15:30
ASEC Technician Name : Clyde Smith

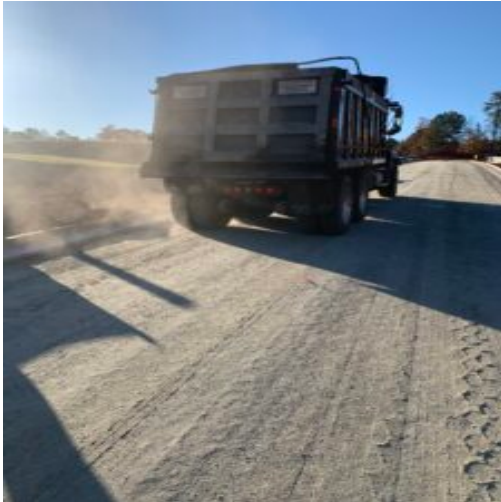
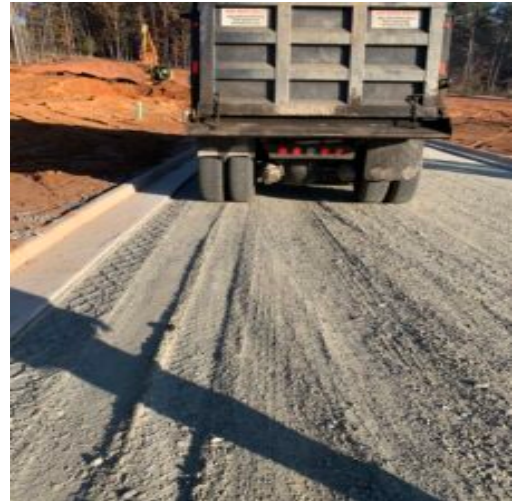
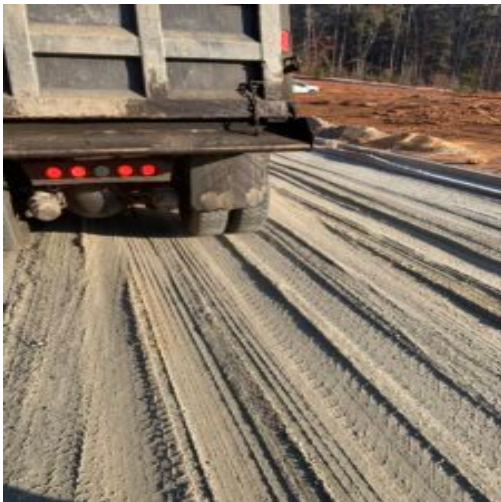
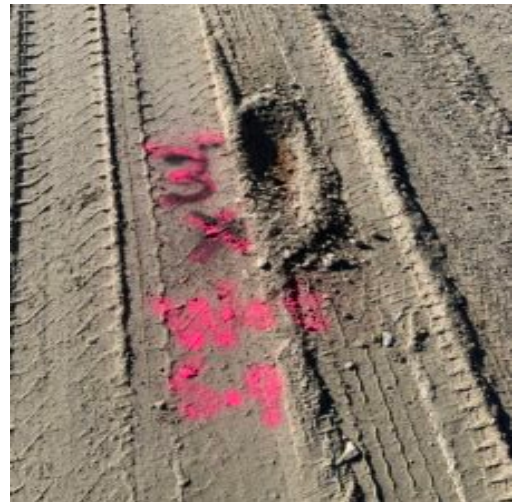
During the initial visit, proofrolling of the in-place sub-base stone was observed. Moderate to severe movement was noted under traffic. Depth checks of in-place base stone were performed, with measured thicknesses ranging from approximately 3 inches to 6 inches. All areas observed exhibited wet underlying subgrade soils.

Proof rolling of sub base on Hawthorne having slight to severe movement under traffic. Also in place base stone depths ranging from 3" to six".

Recommendations were provided to the contractor to clip and remove the in-place sub-base stone where soil contamination was present and to undercut wet subgrade soils to a suitable, stable bearing condition. The contractor was advised to replace removed materials with suitable base stone free of soil contamination. The contractor indicated that he believed the removed base stone could be reused without contamination concerns; the writer advised against reusing contaminated stone.

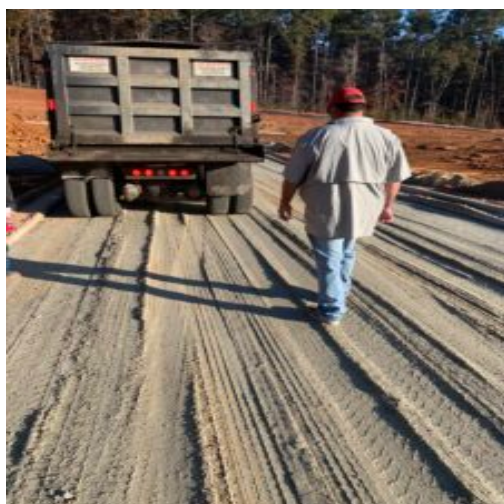
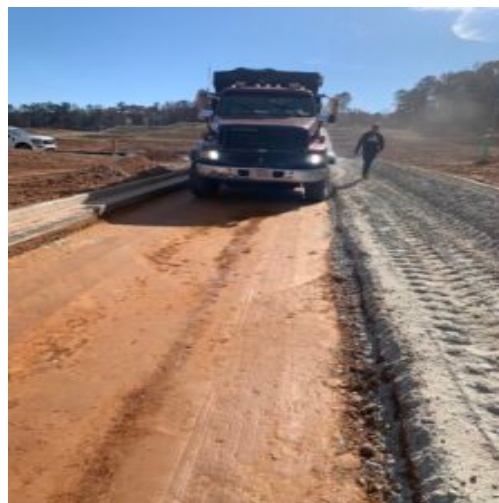
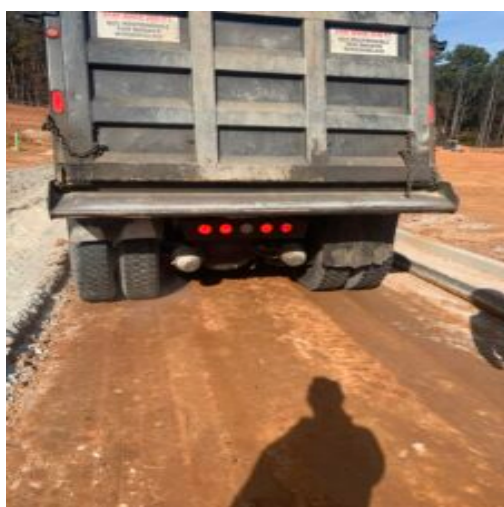
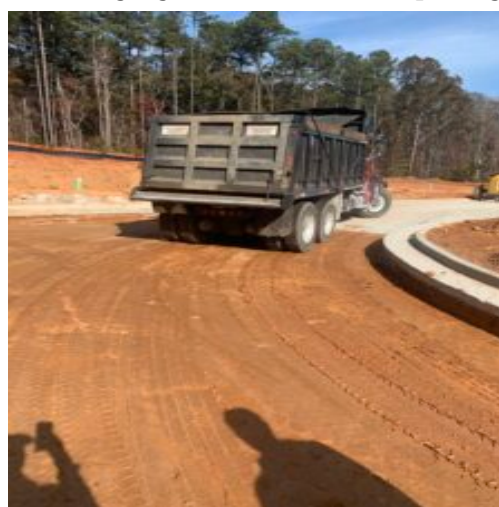
A second trip was made later in the day to observe the exposed subgrade soils following removal of the base stone and clipping of wet areas. Subgrade conditions were evaluated by probing with a rounded-end steel rod and by observing proofrolling with a loaded tandem-axle dump truck carrying approximately 18 tons of stone. The subgrade soils appeared stable with no apparent movement. Depth checks into the subgrade ranged from approximately 9 inches to 14 inches. Based on these observations, the subgrade was approved for placement of new base stone, with a reminder not to reuse contaminated stone as such material may move once moisture is introduced during base stone placement and compaction.

Re observe sub grade after removal of base stone and clip wet sub grades on Hawthorne with depth checks ranging from 9" to 14" requiring 9".
