Date : 11/14/2025
Project No : 2024C202
Client Company : CCG
Arrival Time : 11/14/2025 08:30
Onsite Hours : 01:30

ASEC Report ID : 87861
Name of the Project : Old Griffin Rd - Hawthorne Reserve
Project Location : Dallas
Weather : Sunny
Departure Time : 11/14/2025 10:00
ASEC Technician Name : Clyde Smith

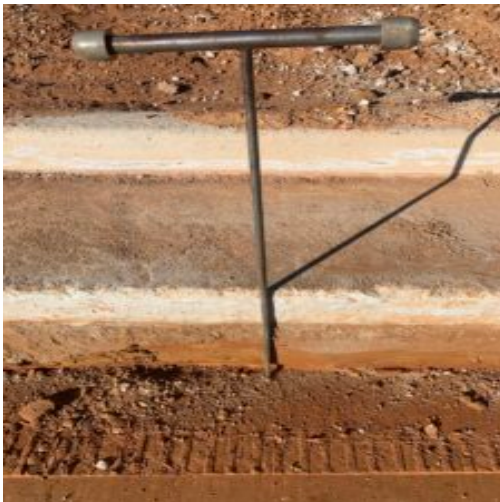
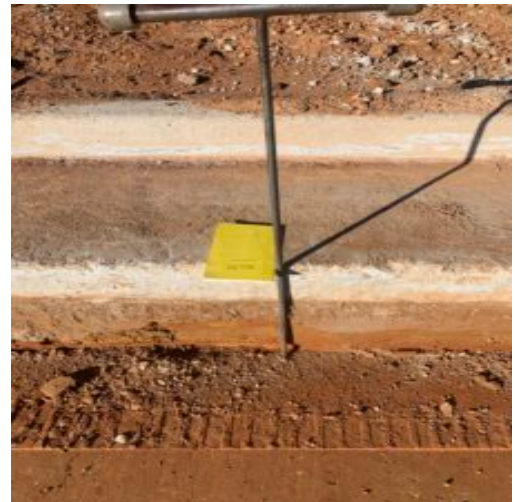
Depth checks ranging from 9" to 14"

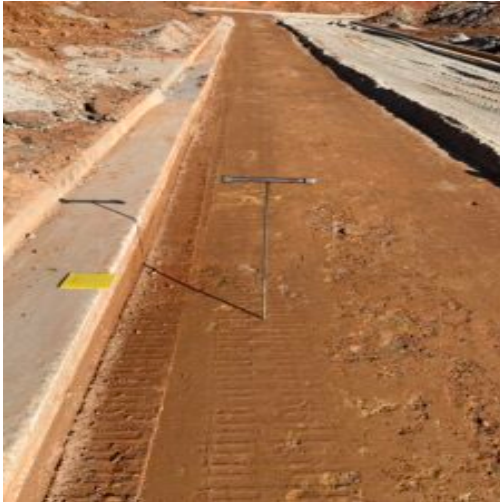
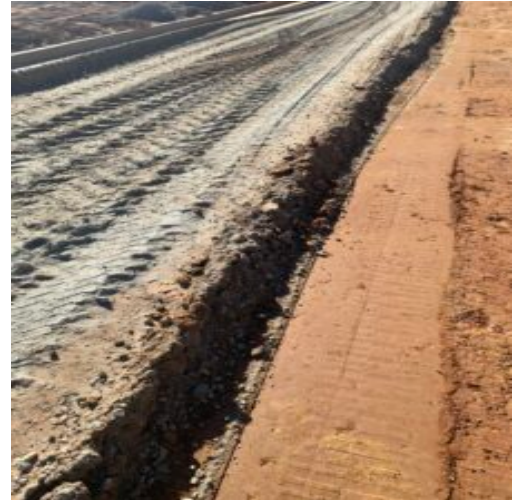
Repaired sub grade observed by probing

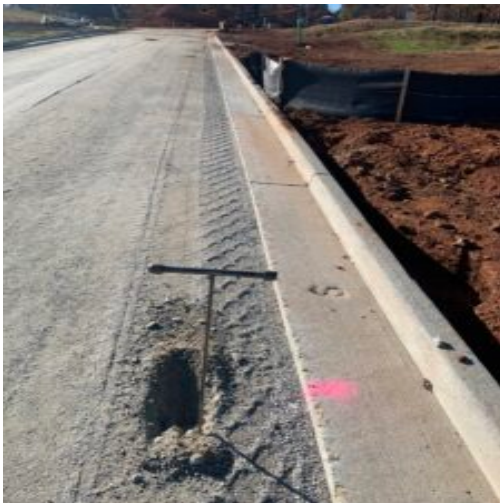
Remaining areas at south end for repair
