Date : 06/04/2025  
Project No : 2024C213  
Client Company : WDG  
Arrival Time : 06/04/2025 08:30  
Onsite Hours : 01:45

ASEC Report ID : 81962  
Name of the Project : Covington Town Center PH II  
Project Location : Covington, GA  
Weather : Overcast  
Departure Time : 06/04/2025 10:15  
ASEC Technician Name : Sean Willett

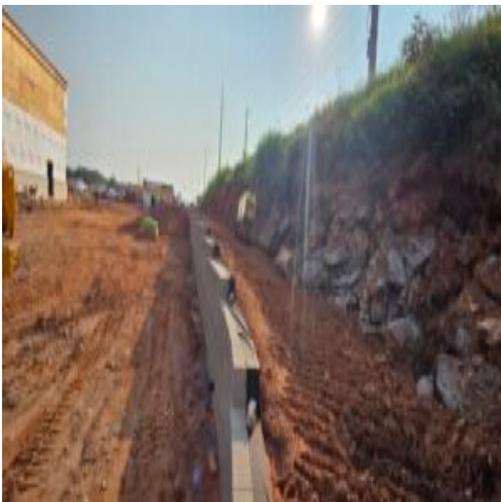
back wall long main road

The technician density tested backfill for the retaining wall located on the back side of the site along the main road and also a retaining wall located on the right side of main building.

All tests showed to be low compaction and too high moisture contents. The technician provided test results to the foreman (Buck) and recommended to allow for aeration before recompacting.
