ASEC Report ID : 70588
Name of the Project : Naturewalk - 7 Hills Amenities
Project Location : Dallas
Weather : overcast
Departure Time : 09/24/2024
ASEC Technician Name : Russell Hendrix

*This report is for Nature Walk Unit 3 Phase 6B Lots (split Lots #1035 and #1036).

A request was made to perform four test pits (two for each lot) to evaluate subsurface conditions. These pits were intended to aid in determining the soils suitability of the lots for future home construction.

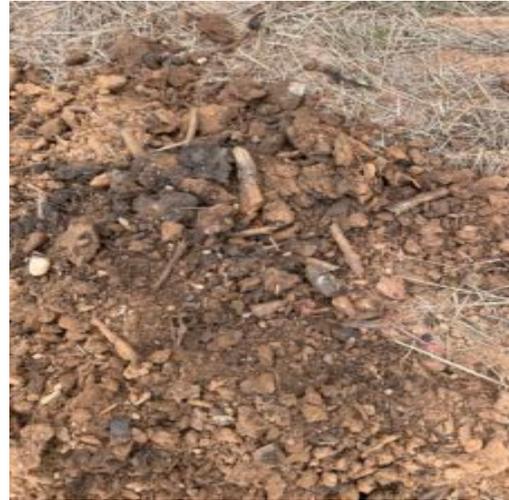
A meeting was held with the onsite builder, where it was communicated that the two lots are suspected of having been used as a burn pit in the past. Given the presence of burned organic material and potential large obstructions in the subsurface, it was advised that these lots should not be used for building until further investigation or remediation is performed.

burned organic material

Further geotechnical investigation or testing should be conducted to determine the full extent of the subsurface conditions before any construction is initiated.

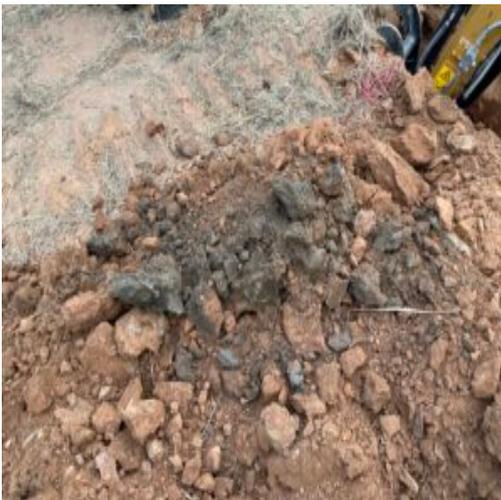
Burned organic material

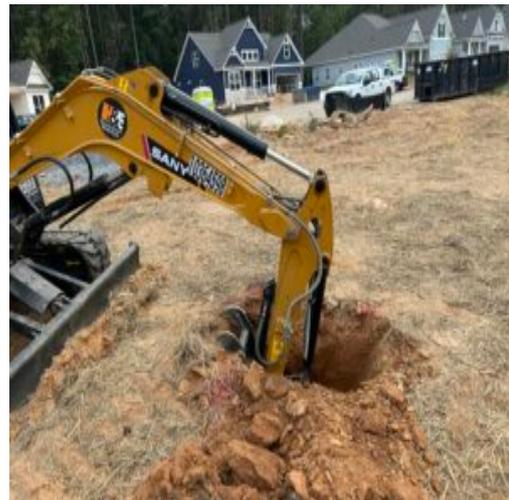
excavating

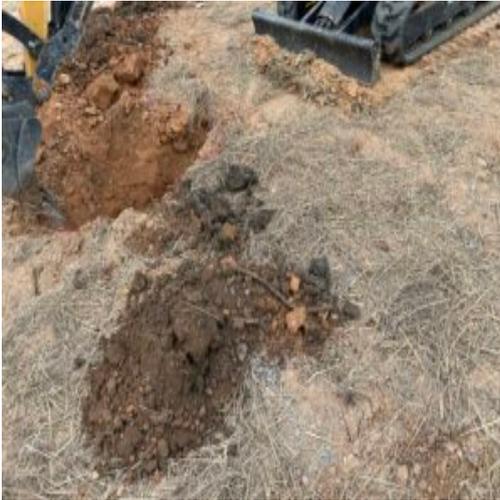
burned organic material

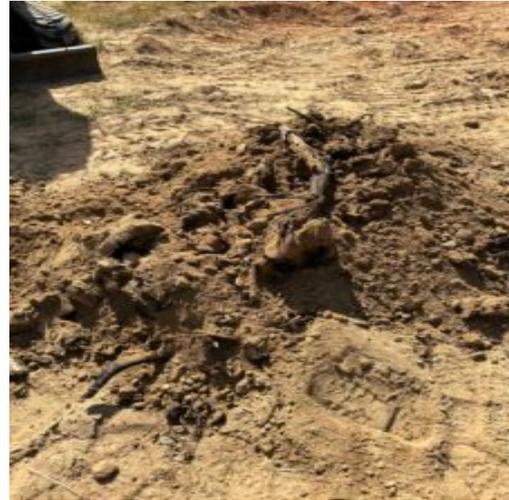
burned organic material

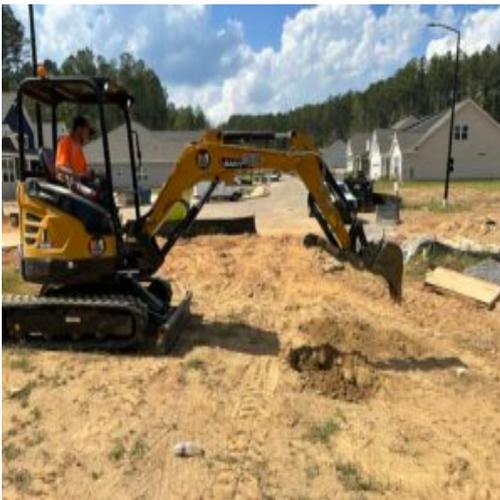
excavating

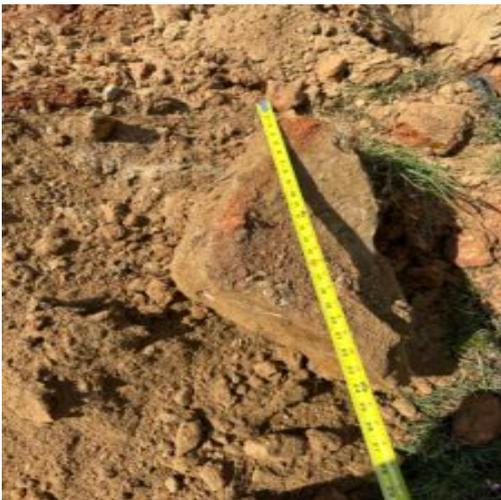
- **Lot #1035B (Back):**
 - **Surface conditions:**
 - Two 24-inch boulders were encountered within the first 2-4 feet from the surface.
 - **Material:**
 - Brown silty sand encountered to a depth of 6 feet.
 - **Depth:**
 - Six (6) feet was the maximum depth achievable using the mini-excavator on-site.
 - **Material below 6 feet:**
 - Unknown, as the excavation was not able to proceed beyond 6 feet.
- **Lot #1035F (Front):**

24 inch rock placed in first 2 feet of fill

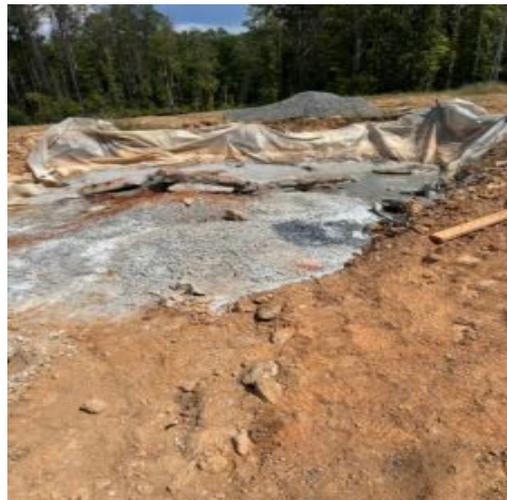
Upon arrival, it was observed that both lots were being used as a location for concrete washout and gravel storage. The exact location of the future building pads for the homes was unknown at the time of the site visit.

concrete washout/gravel pile placed on both lots
