ASEC Report ID : 79167
Name of the Project : Naturewalk - 7 Hills Amenities
Project Location : Dallas
Weather :
Departure Time : 03/28/2025 10:30
ASEC Technician Name : Solomon Cherie

Seven Hills: Amenities

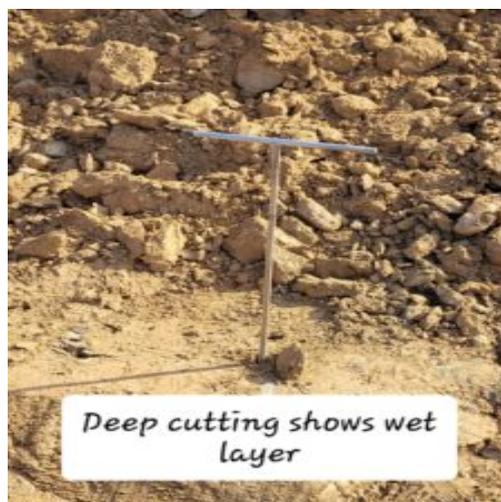
- Upon arrival, the contractor was engaged in attempting to recompact the Pickle ball court parking using a Komatsu PC 360LC and cut from the west of the job site. It was observed that the sheeps-foot compactor displayed pumping of the surficial soils.
- Mr. Clyde Smith of AS Engineering & Consulting suggested cutting down 6 inches with the dozer to examine the underlying wet soils. It was determined that the wet soils went down 1 foot. It was recommended that this top foot be cut out, scarified, aerated and replaced in 6 to 8 inch lifts and recompactd.

Prob rod showing a foot deep wet layer.
