Date : 07/09/2025
Project No : 2024C217
Client Company : Artisan
Arrival Time : 07/09/2025 08:00
Onsite Hours : 08:00

ASEC Report ID : 82888
Name of the Project : Naturewalk - 7 Hills Amenities
Project Location : Dallas
Weather : Sunny
Departure Time : 07/09/2025 16:00
ASEC Technician Name : Safiullah Momand

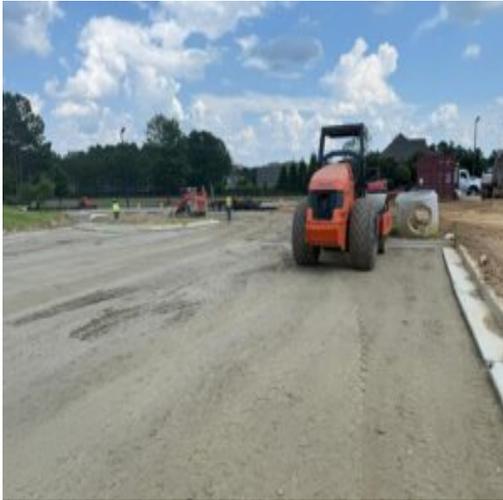
Furthermore, our representative visually inspected the parking lot area where the placement of a 6-inch GAB layer was in progress. It was noted that the GAB material appeared to contain an excessive amount of silt. In accordance with ASEC representative Clyde Smith's recommendation, a full bucket sample of the GAB material was collected for laboratory testing to perform a moisture-density relationship.

Compaction of Parking Lot GAB

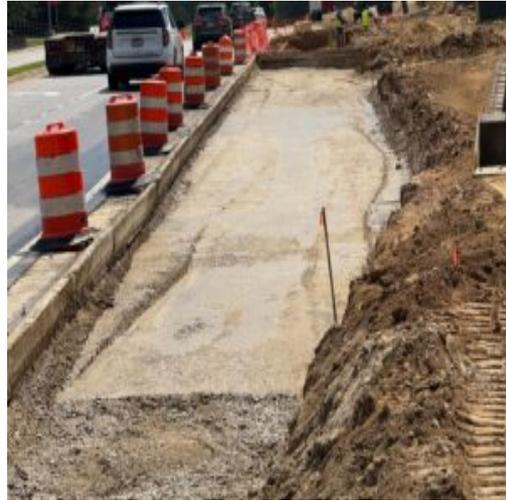
1. The contractor trimmed approximately 2 to 3 inches from the upper side and 6 inches from the lower side of the deceleration lane.
2. A layer of Tensar fabric was placed over the subgrade (142 feet long and 12.5 feet wide).
3. A 12-inch-thick initial layer of Graded Aggregate Base (GAB) was placed in a single lift over the fabric and compacted.

Compaction of Declaration lane GAB

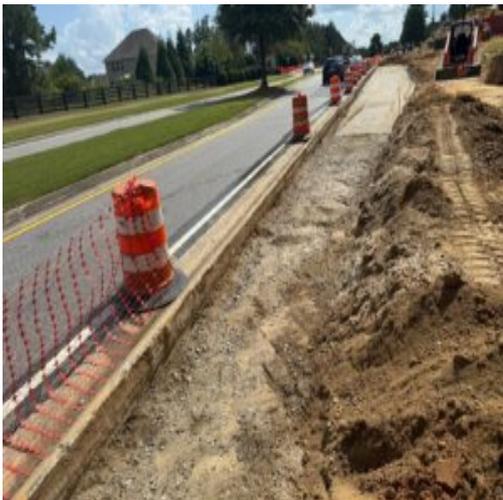
During the inspection, the writer observed that a narrow section at the beginning of the deceleration lane (approximately 30-40 feet) had not been properly compacted—neither the subgrade soils nor the GAB layer—due to limited access for large vibratory rollers. The contractor was advised to use alternative compaction equipment such as a small-width rollers or a jumping jack compactor. However, the contractor indicated that these tools were not available on-site and stated that they intended to place a 6-inch-thick concrete layer over the affected area as an alternative solution. Recommendation was given to compact this part on any method they prefer to achieve the required compaction and stability.

Non compacted part of Declaration Lane

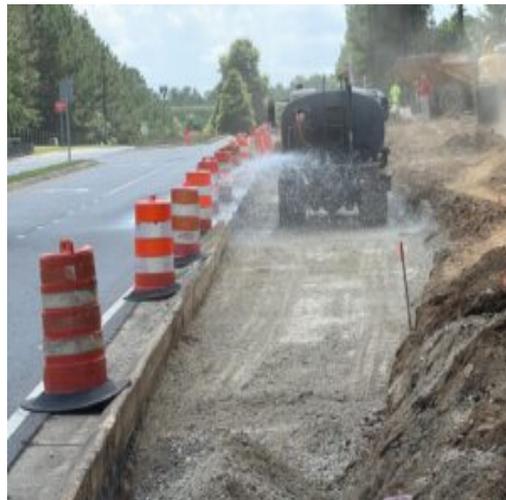
process of Declaration Lane moisturization

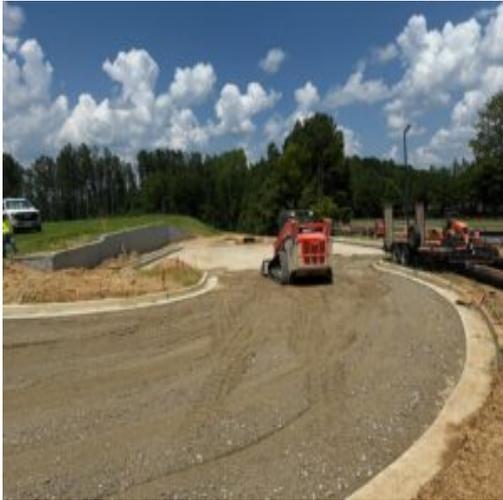
Parking Lot spreading of the GAB

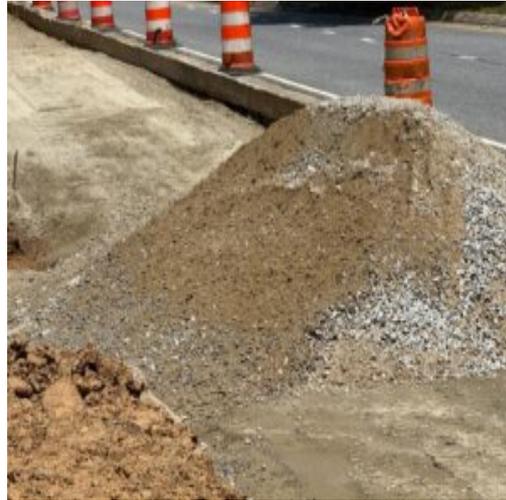
GAB material which shows Clay in it used for declaration lane

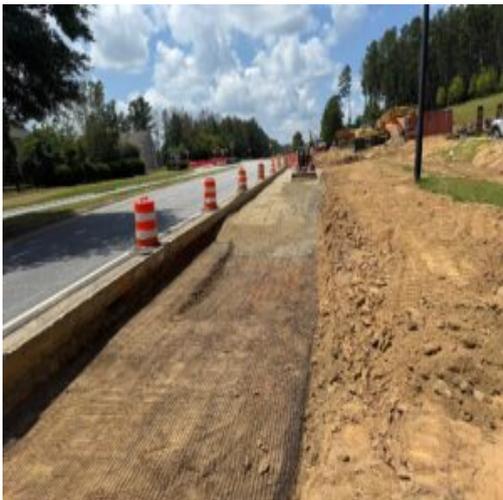
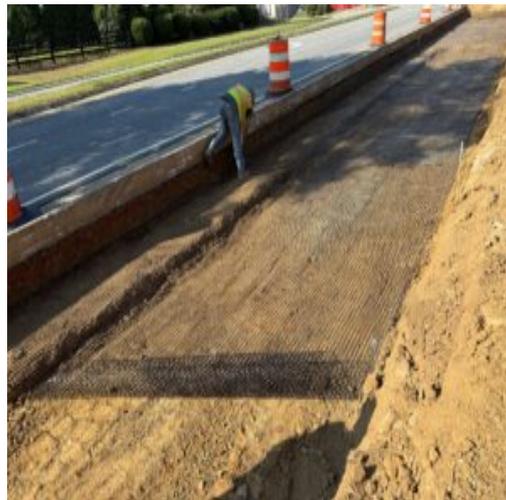
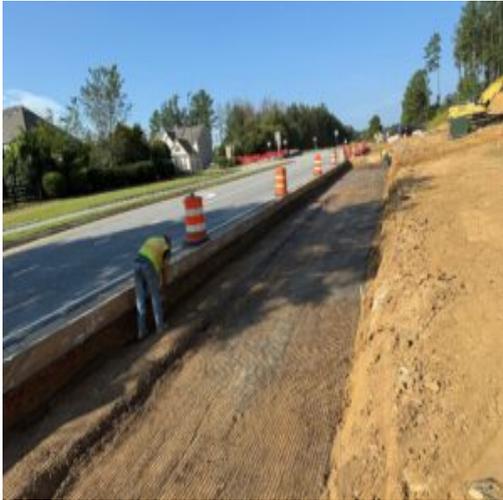
Geosynthetic Fabric work
