Date : 07/18/2025
Project No : 2024C217
Client Company : Artisan
Arrival Time : 07/18/2025 08:00
Onsite Hours : 03:00

ASEC Report ID : 83179
Name of the Project : Naturewalk - 7 Hills Amenities
Project Location : Dallas
Weather : Mostly sunny
Departure Time : 07/18/2025 11:00
ASEC Technician Name : Safiullah Momand

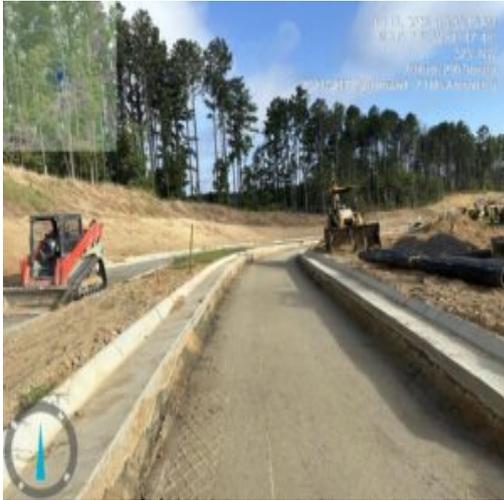
4 inches pitches repair of Subgrade

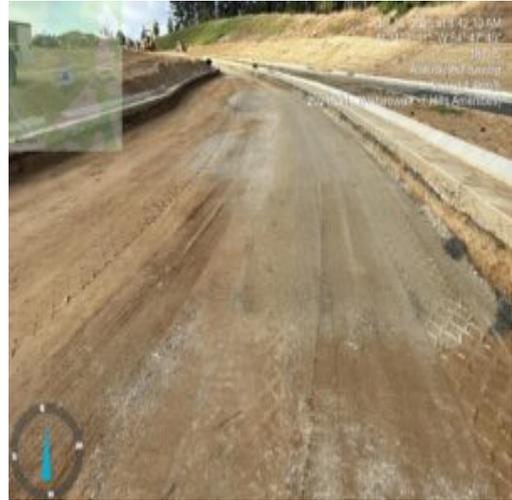
4 inches pitches repair of Subgrade

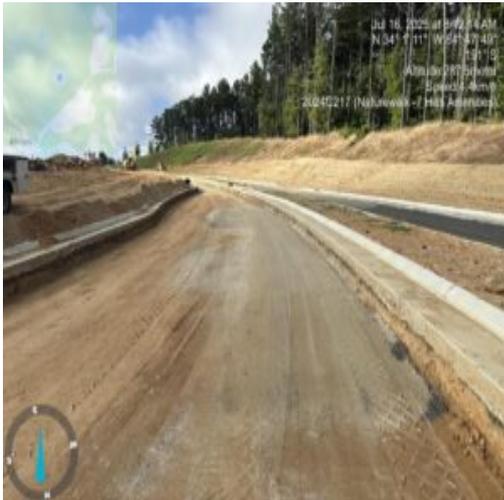
4 inches pitches repair of Subgrade

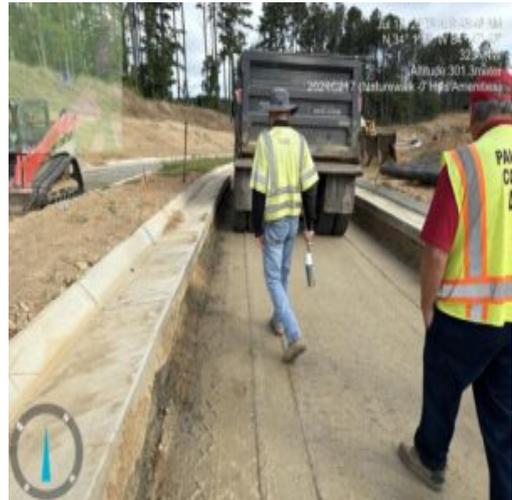
The proof-rolling was observed jointly with Paulding County representative, GAB contractor and ASEC personnel. Proof-roll results show no visible pumping and/or rutting.

Proof rolling

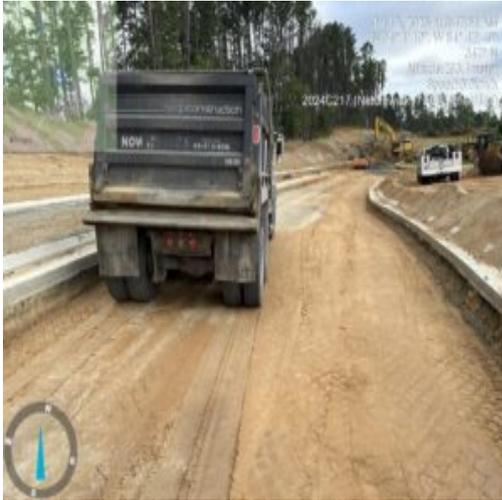
Proof rolling

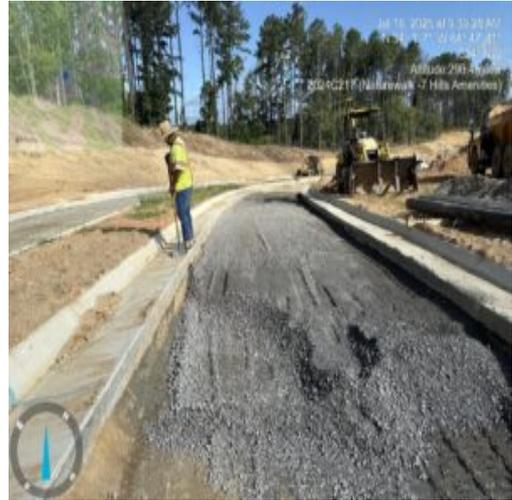
GAB work in progress

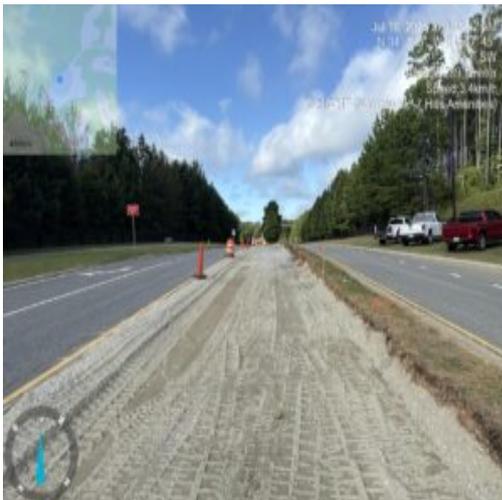
West Deceleration Lane GAB work

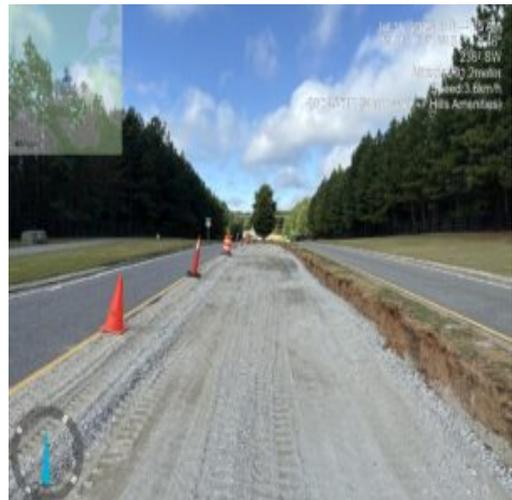
West Deceleration Lane GAB work
