Date : 07/21/2025
Project No : 2024C217
Client Company : Artisan
Arrival Time : 07/21/2025 09:00
Onsite Hours : 06:30

ASEC Report ID : 83226
Name of the Project : Naturewalk - 7 Hills Amenities
Project Location : Dallas
Weather : Mostly Cloudy
Departure Time : 07/21/2025 15:30
ASEC Technician Name : Safiullah Momand

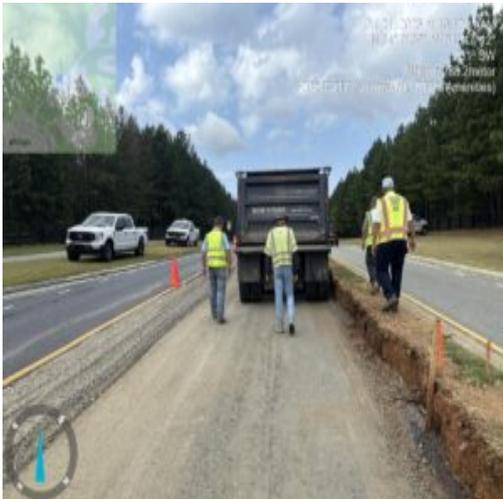
Proof-rolling was performed on the deceleration lane/turning lane in preparation for concrete curb installation. The activity was jointly observed by the Paulding County representative, Mr. Mike Keneer, the GAB contractor, and the ASEC technician. The area beneath the proposed concrete curb displayed mostly stable soils but exhibited slight deflection under truck load. Based on this observation, both the Paulding County representative and the ASEC technician recommended a minimum of three additional compaction passes to improve compaction before commencing any concrete curb-related activities.

Proof rolling on deceleration Lane

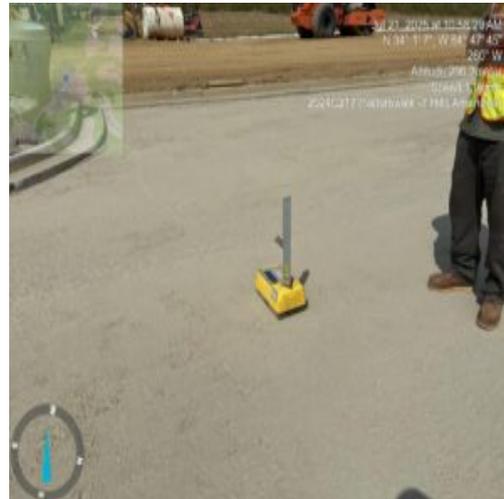
A total of six (6) compaction tests were performed using a nuclear gauge on the parking lots and the approach road located on the right side of the entrance road (Shalley Road). Density test results met job specifications for compaction.

Compaction test using the Nuclear gauge in parking lot

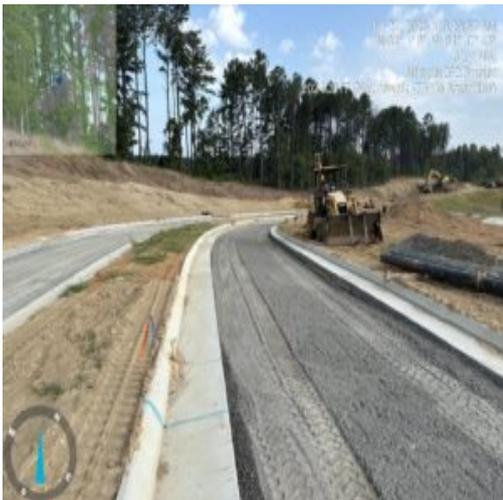
GAB work on the main entrance road

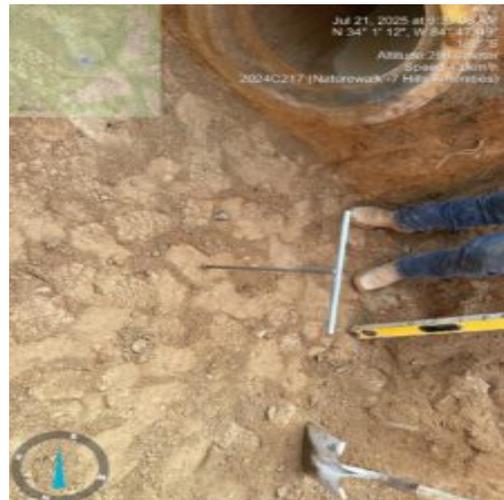
Re-installation work for a storm water inlet was observed at the center median of the entrance road (Shalley Road). The writer noted that the foundation below the inlet structure was not adequately compacted. As a corrective measure, re-compaction using a jumping jack was applied. Additionally, the backfill material surrounding the inlet was found to be insufficiently compacted. On-site recommendations were provided to the workers to properly compact the backfill in accordance with the project specifications.

Storm water inlet foundation

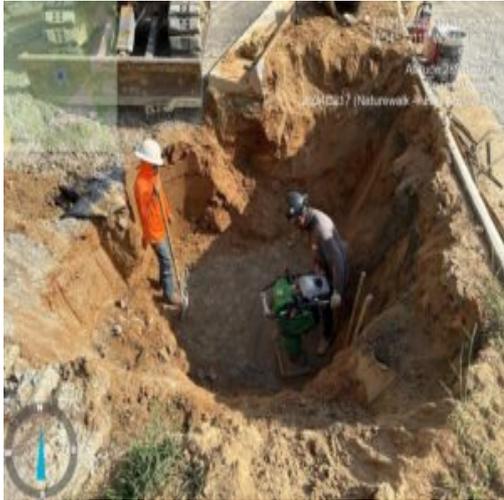
Storm water inlet foundation compaction

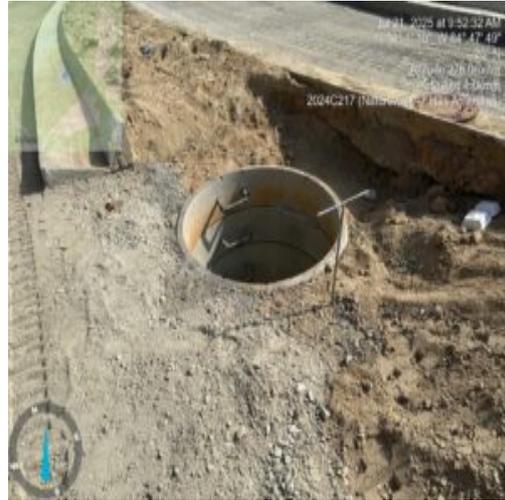
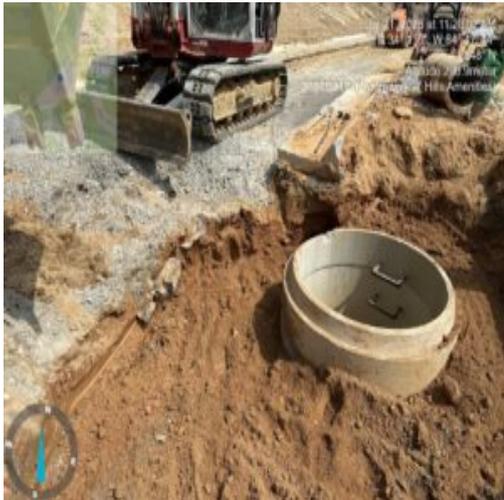
Storm water inlet poor compaction
