Date : 12/10/2025
Project No : 2024C217
Client Company : Artisan
Arrival Time : 12/10/2025 14:00
Onsite Hours : 02:30

ASEC Report ID : 88455
Name of the Project : Naturewalk - 7 Hills Amenities
Project Location : Dallas
Weather : Sunny
Departure Time : 12/10/2025 16:30
ASEC Technician Name : Clyde Smith

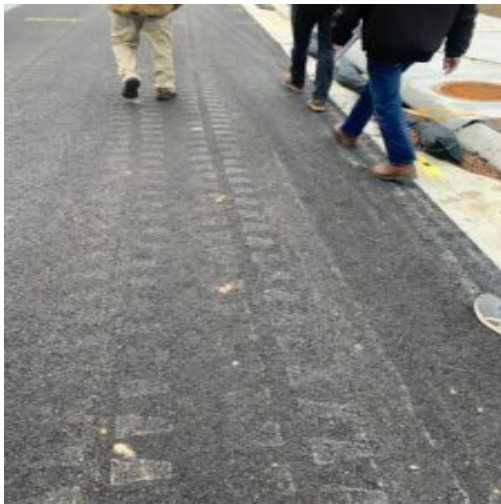
On the above date the writer was on site as requested and attended a meeting with Paulding co. members and NWGP to discuss asphalt deficiencies and repairs at east and west sides deceleration lanes. Paulding Co. made issues with in place topping mix stating that a traffic roller wasn't used during 12.5 topping mix and also stated that it appeared that a binder mix was placed instead of the required topping mix based on a gradation report and appearance showing minor surface cracking. Paulding Co. recommended to remove all 12.5 topping mix and replace. Also one section on Seven Hills Blvd. near exit lane from site was recommended to be milled 9.5" and replaced with 8.0" of class B concrete and capped with 1.5" of 12.5 topping mix. The paving contractor was informed to notify ASEC for repair placement.

East side decel lane showing topping mix

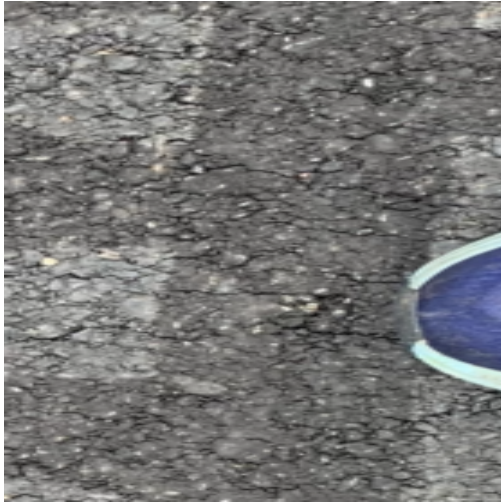
Showing surface cracking at decel lane east side

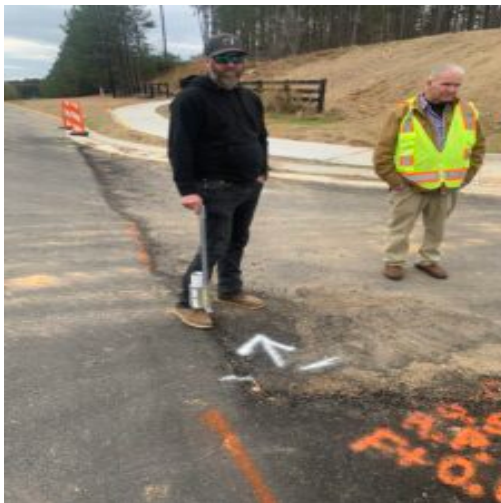
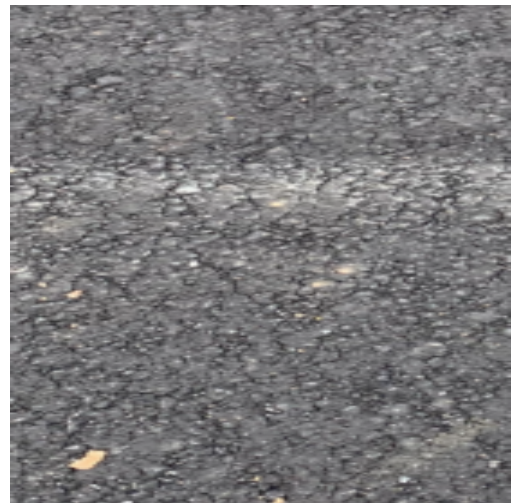
showing surface cracking at east side decel lane
