Date : 11/25/2024  
Project No : 2024C288  
Client Company : DRH  
Arrival Time : 11/25/2024  
Onsite Hours :

ASEC Report ID : 76158  
Name of the Project : Brookland Commons - Site Development  
Project Location : Monroe  
Weather : sunny  
Departure Time : 11/25/2024  
ASEC Technician Name : Russell Hendrix

As requested, the site was visited by our AS Engineering and Consulting (ASEC) representative for the purpose of providing quality control inspection and testing services. Visual observation techniques were employed to verify compliance with project drawing/specifications, applicable codes, and materials submittals. The following observations were observed on site this day:

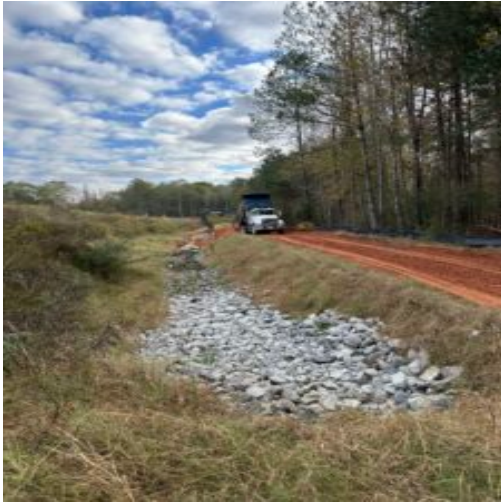
Dam construction

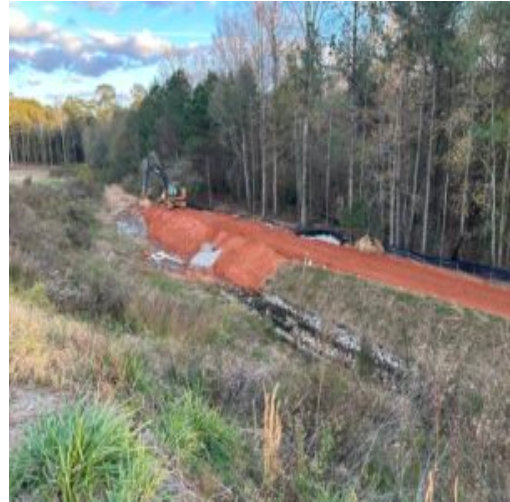
Dam construction

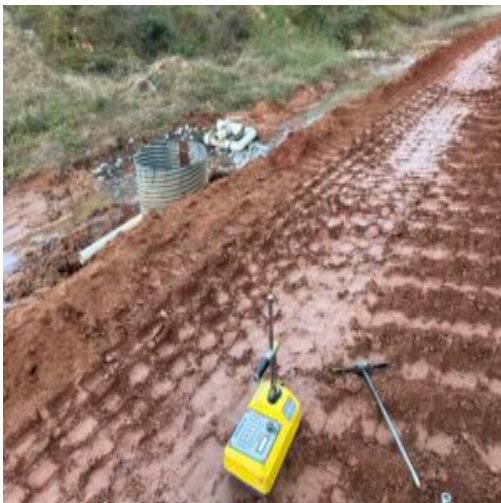
Nuclear testing

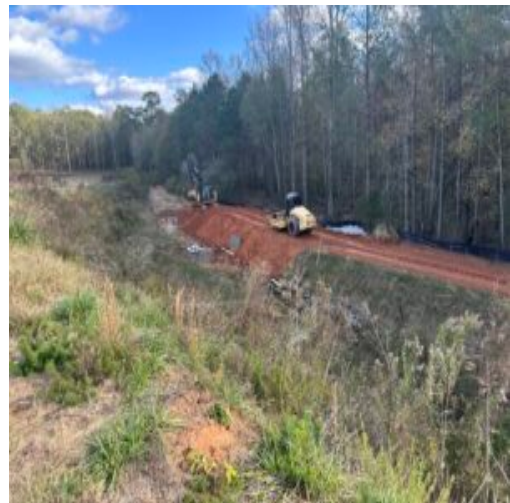
Dam compaction

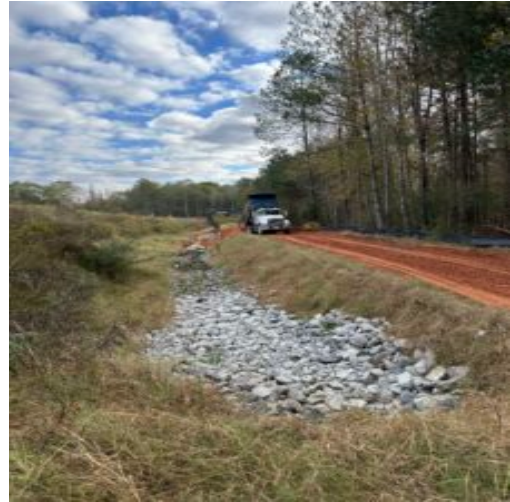
Dam construction
