ASEC Report ID : 77815
Name of the Project : Heritage Pointe - Footing Inspections
Project Location : Villa Rica
Weather : sunny
Departure Time : 02/21/2025 16:00
ASEC Technician Name : Vamsi Polisetty

Heritage Pointe Villa Rica: Footings Inspection (Lot #66)

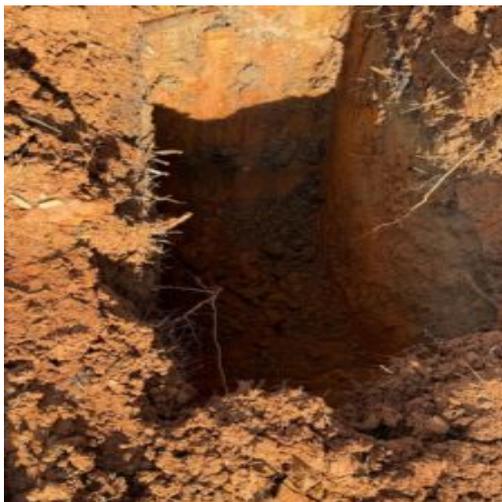
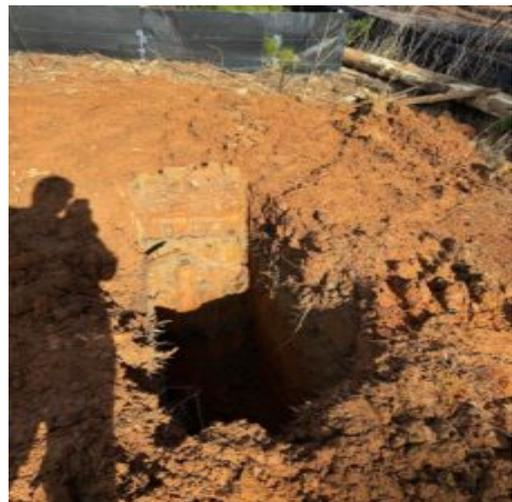
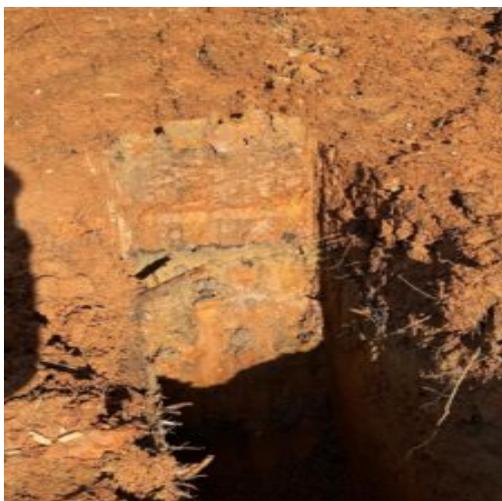
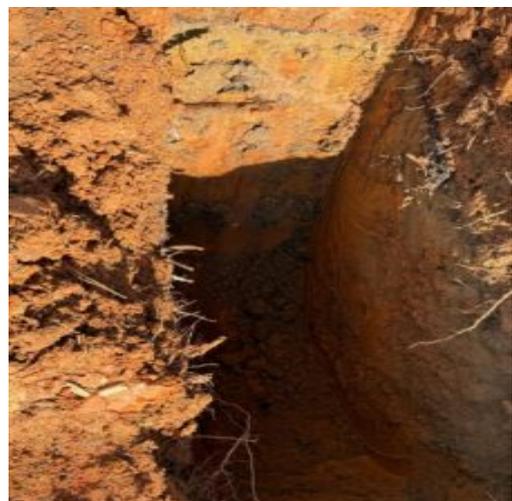
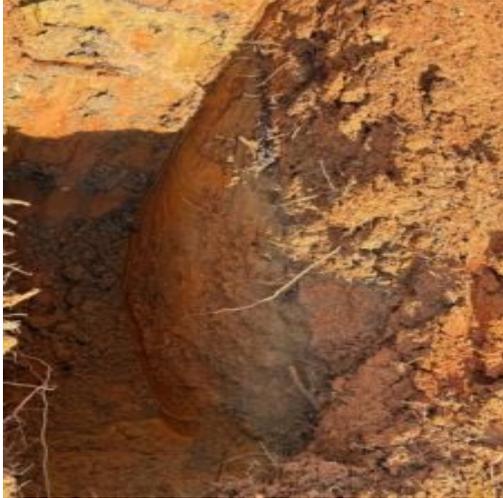
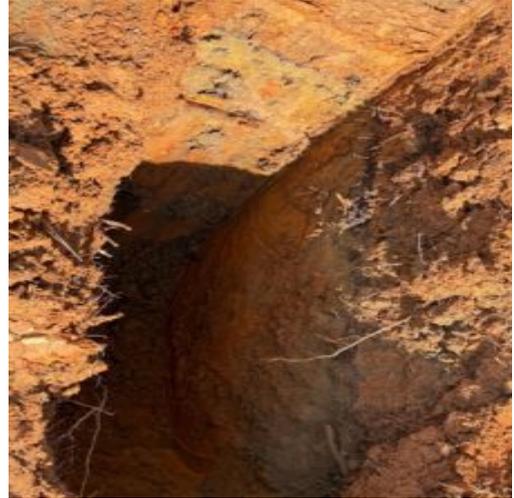
After conducting the Dynamic Cone Penetrometer (DCP) test on both sides of Lot #66, small stones and rocks were found in the soil. A 4-foot trench excavation was performed, and during the inspection, traces of organic material were discovered below a depth of 2 feet.
