Date : 03/27/2026
Project No : 2024C296
Client Company : Artisan
Arrival Time : 03/27/2026 10:00
Onsite Hours : 02:30

ASEC Report ID : 91841
Name of the Project : Heritage Pointe - Footing Inspections
Project Location : Villa Rica
Weather : sunny
Departure Time : 03/27/2026 12:30
ASEC Technician Name : Clyde Smith

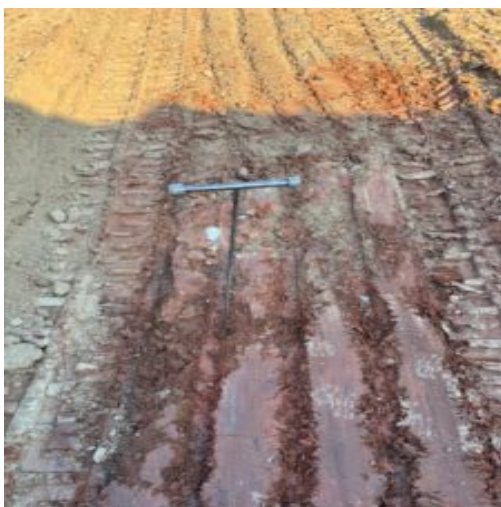
Verified suitable residual soils at excavation

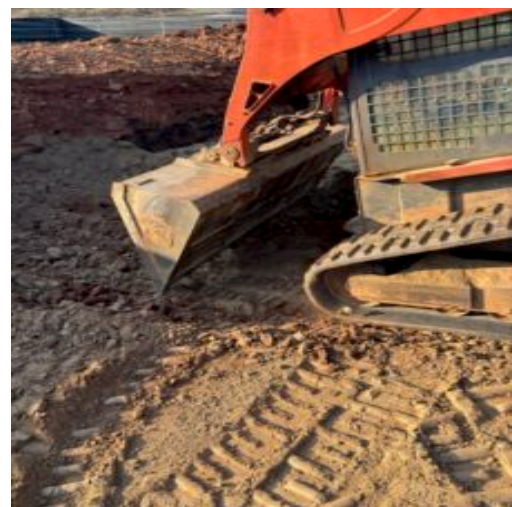
Spreading mixed soil materials

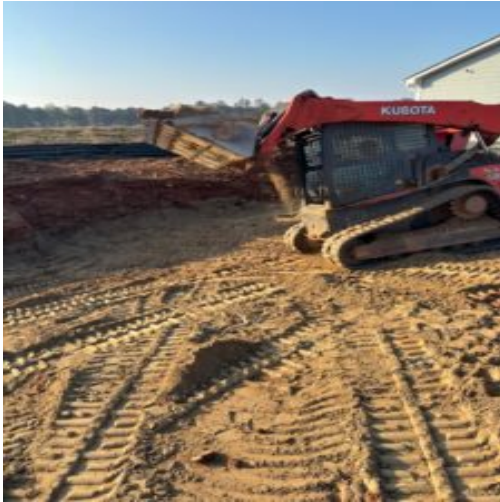
Compacting in place mixed materials using skid loader

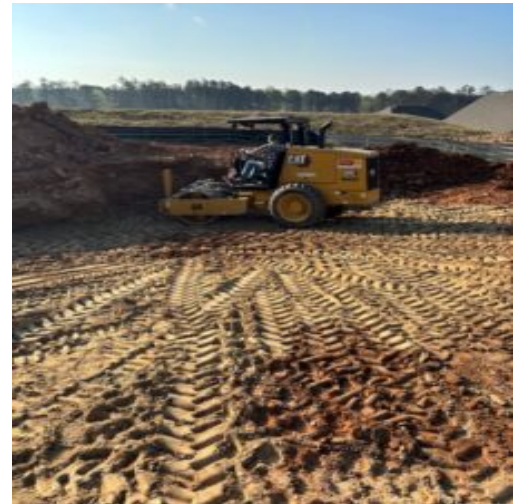
Compacting in place mixed materials using small vibratory sheet foot roller

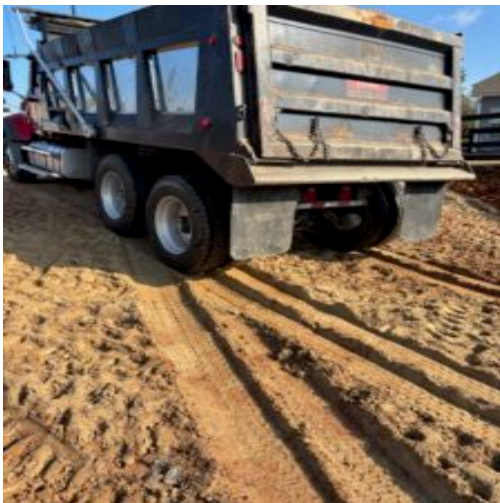
Additional compacting efforts using a tandem dump truck
