Date : 01/29/2025  
Project No : 2024C297  
Client Company : Artisan  
Arrival Time : 01/29/2025 06:00  
Onsite Hours : 01:00

ASEC Report ID : 76648  
Name of the Project : Nature Walk - Footing Inspections  
Project Location : Dallas  
Weather : sunny  
Departure Time : 01/29/2025 07:00  
ASEC Technician Name : Vamsi Polisetty

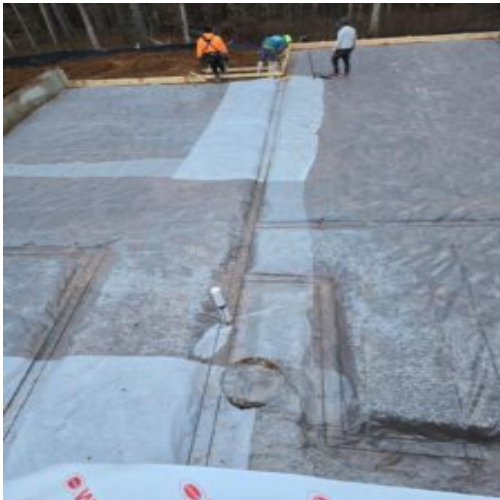
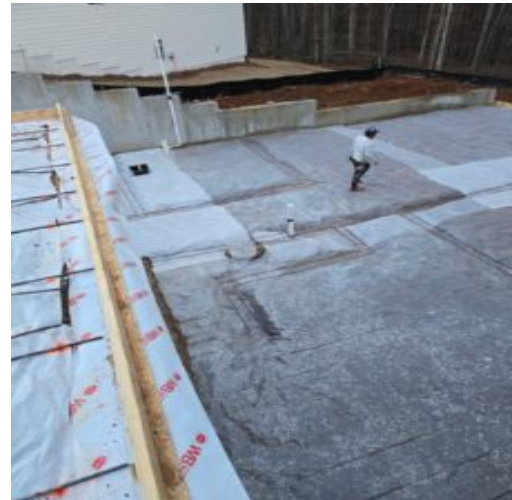
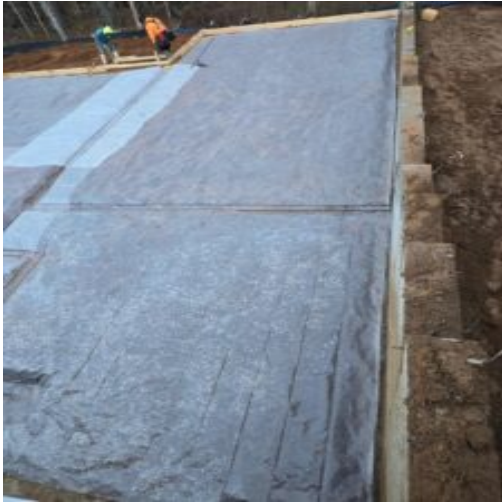
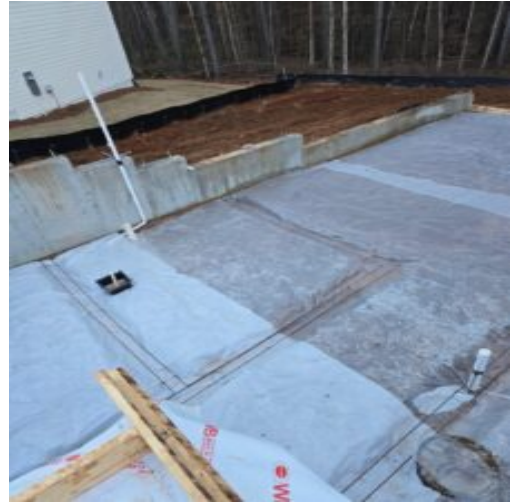
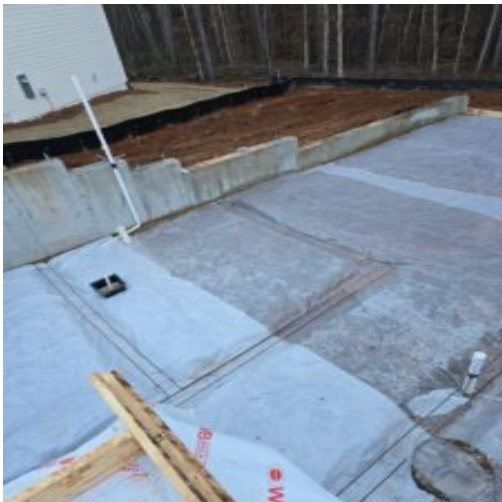
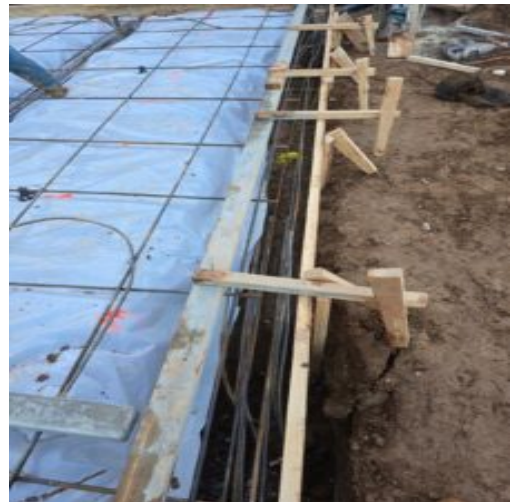
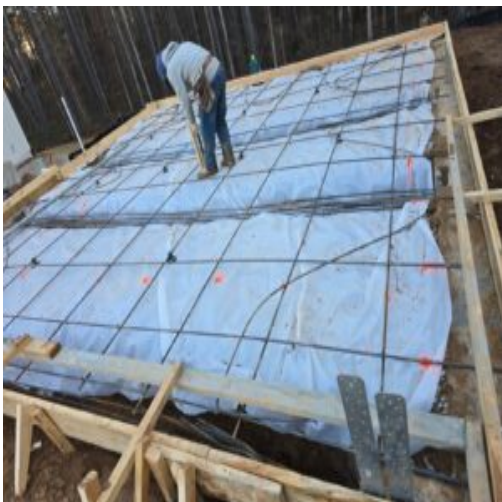
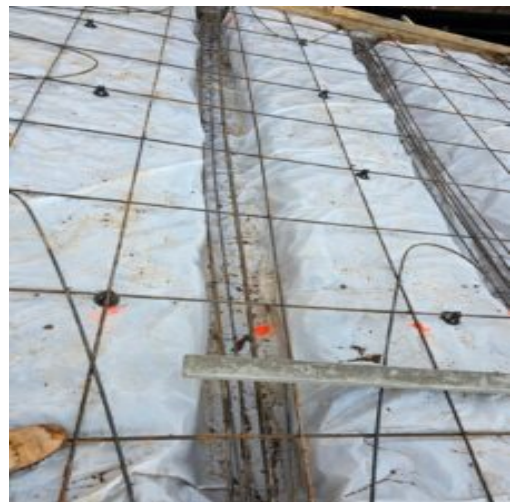
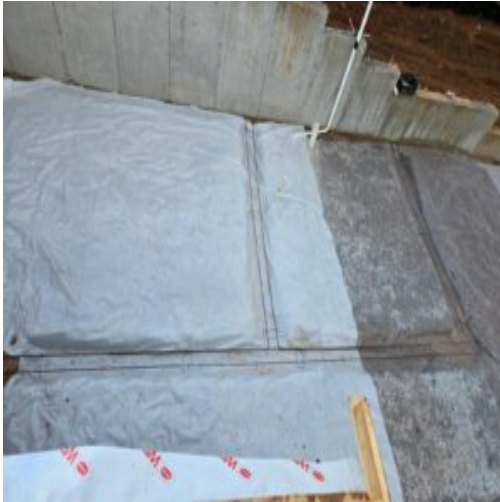
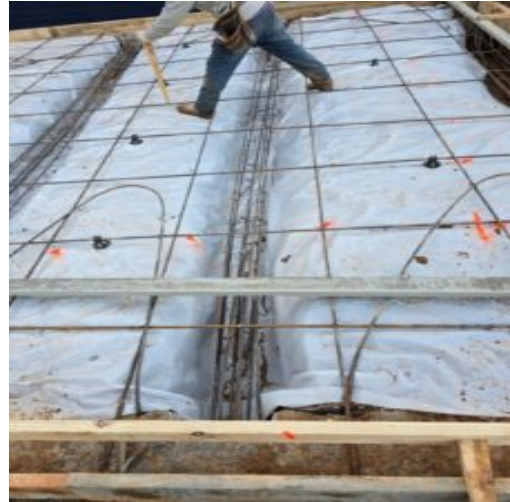
Lot #1005:

- The basement slab subgrade inspection has been completed, and the reinforcement has been confirmed to meet job specifications for size, spacing and quantity. Plastic sheeting has been laid over the basement floor. During the inspection of the tie beams, ice and mud were observed. Our representative recommended the removal of these deleterious materials prior to the placement of concrete.
