Date : 01/31/2025
Project No : 2024C315
Client Company : J. Chapman Const.
Arrival Time : 01/31/2025 08:30
Onsite Hours : 06:30

ASEC Report ID : 76845
Name of the Project : Cottages at Villa Rica - Rock Blasting
Project Location : Villa Rica
Weather : Rainy
Departure Time : 01/31/2025 15:00
ASEC Technician Name : Micah Aycock

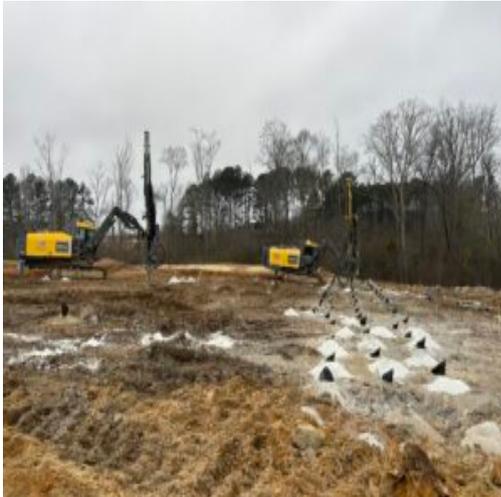
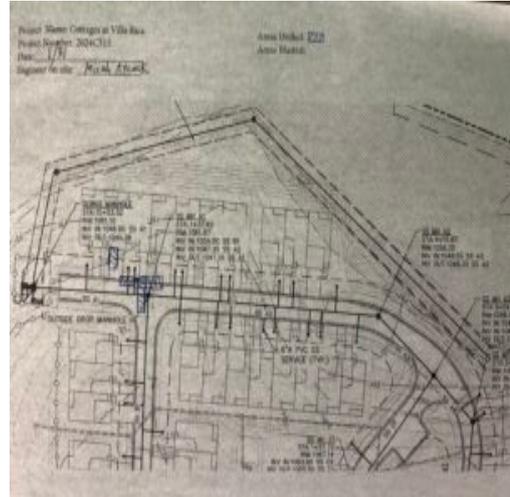
There were two drillers on site today, so the contractor drilled in two separate locations. The first area had drilling on lateral (41) south of Lot #42 and northwest of manhole A1. Rock was encountered at an average depth of 7 feet. Hole spacing was 7 feet apart and approximately 8 feet between each drilling location.

The other drilling location started north of manhole A1 and continued down south of manhole A1. The drill made contact with rock around 14 to 16 feet on average but had two locations that encountered rock at just 3 feet. The spacing was 6 feet apart and 8 feet between each drilling location. There was also drilling east and west of manhole A1, following where the main sewer line would run. These locations encountered rock around the 12-to-15-foot range.
