Date : 02/20/2025
Project No : 2024C315
Client Company : J. Chapman Const.
Arrival Time : 02/20/2025 11:00
Onsite Hours : 06:00

ASEC Report ID : 77798
Name of the Project : Cottages at Villa Rica - Rock Blasting
Project Location : Villa Rica
Weather : Sunny/cold
Departure Time : 02/20/2025 17:00
ASEC Technician Name : Micah Aycock

The aforementioned AS Engineering and Consulting (ASEC) representative visited the Cottages at Villa Rica site to monitor drilling and rock removal operations. The contractor performing the work was Precision Blasting. The following observations were made on-site:

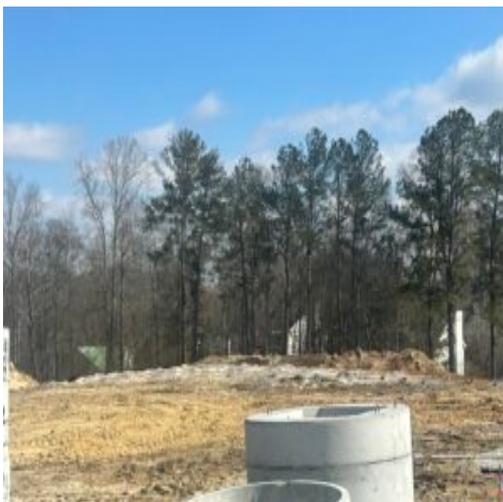
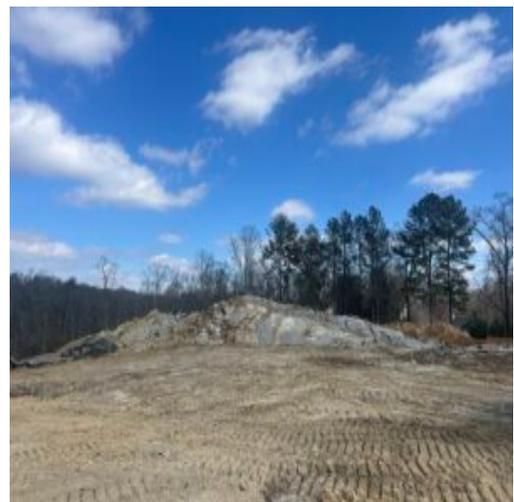
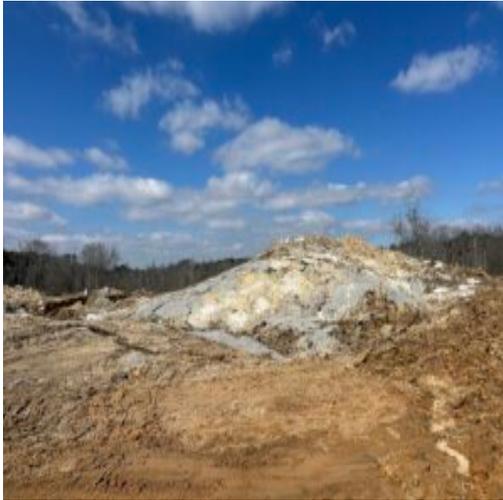
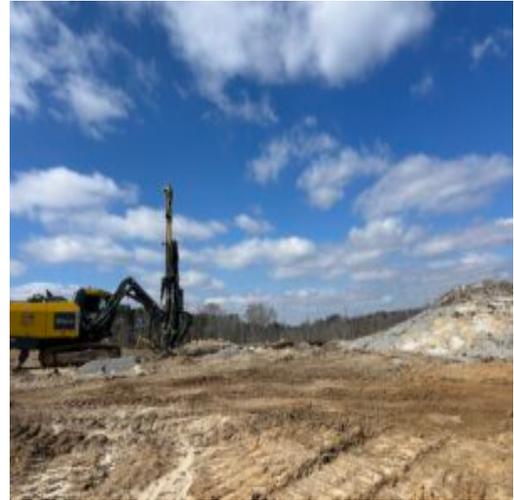
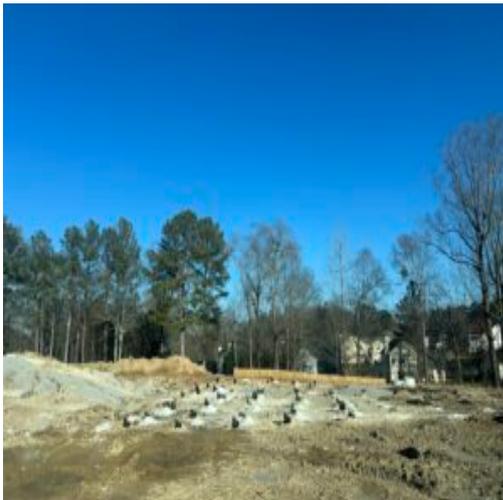
The holes that were blasted today consisted of a small trench pattern in the middle, with two mass rock patterns on either side. The location of this blasting was in-between lot #187 and lot #59, running down the main sewer line towards lots #186 and #61. A total mass rock area blasted was 5,688 square feet with an average pay thickness of 7.99 feet. The calculated volume of the mass rock blasted was 1,684.00 cubic yards. The total trench area blasted was 816 square feet with an average pay thickness of 11.68 feet. The calculated volume of trench rock blasted was 352.89 cubic yards.

Once the blast was complete the team continued drilling mass rock patterns on both sides of the existing trench. One driller on the side closest to lot #61/62 and the other closest to lot #185/186. This completed today's drilling operations in preparation for the next blast.
