Date : 03/04/2025  
Project No : 2024C315  
Client Company : J. Chapman Const.  
Arrival Time : 03/04/2025 13:30  
Onsite Hours : 05:00

ASEC Report ID : 78434  
Name of the Project : Cottages at Villa Rica - Rock Blasting  
Project Location : Villa Rica  
Weather : Cloudy  
Departure Time : 03/04/2025 18:30  
ASEC Technician Name : Micah Aycock

### Site Visit Report - Cottages at Villa Rica

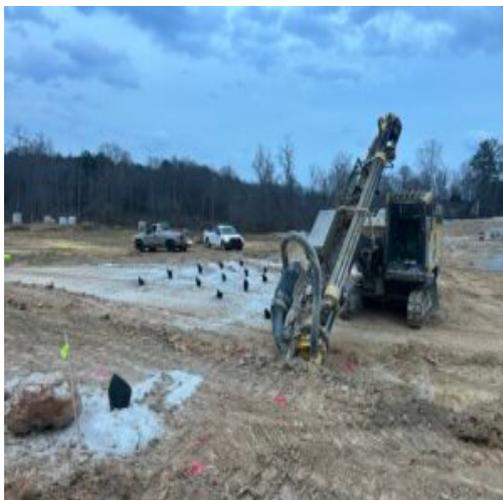
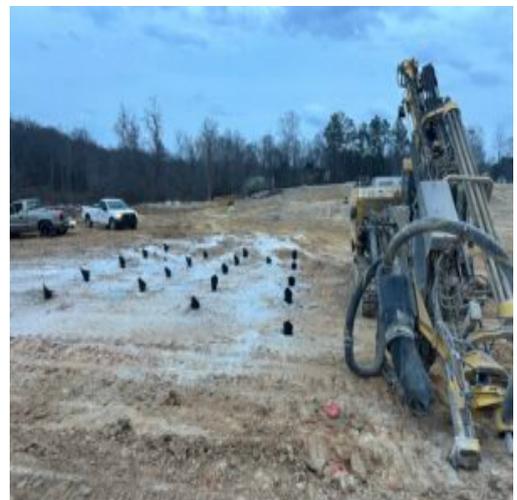
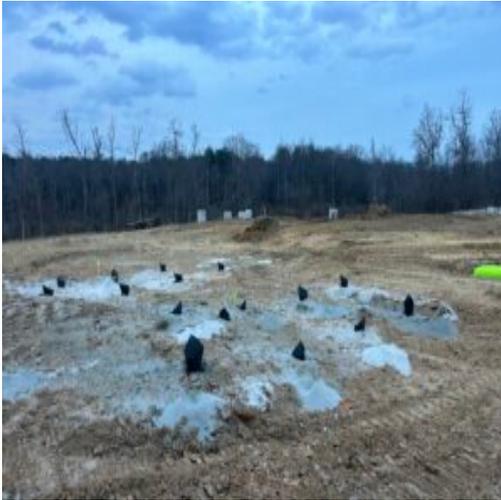
Drilling operations took place today in the northwest corner of the development, south of Manhole A1 along the sewer line. The drilled patterns followed a trench formation with an 8-foot width and 6-foot hole spacing. A total of five laterals in trench pattern were drilled, spanning from Lot #40 down to Lot #37, including the laterals to the lots.

These efforts are part of Precision Blasting's ongoing work to break up the trench rock section in the northwest corner of the development. All drilling appeared to have proceeded according to plan.
