Date : 03/19/2025
Project No : 2024C315
Client Company : J. Chapman Const.
Arrival Time : 03/19/2025 8:00
Onsite Hours : 9:00

ASEC Report ID : 78923
Name of the Project : Cottages at Villa Rica - Rock Blasting
Project Location : Villa Rica
Weather : sunny
Departure Time : 03/19/2025 17:00
ASEC Technician Name : Mahendra Mylabathula

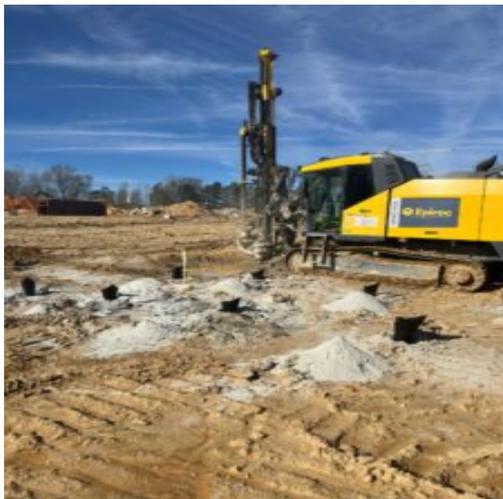
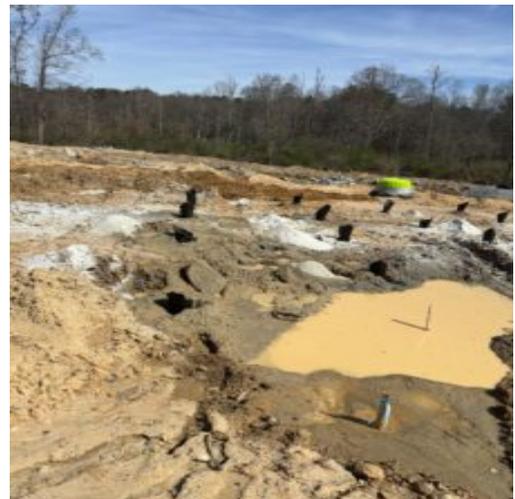
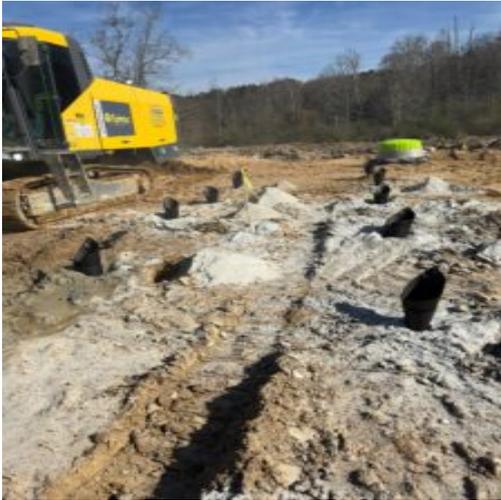
Following yesterday's blasting, the team commenced drilling at laterals #130, #129, #128, and a sewer line located near manhole A2. The drilling operations proceeded without any major issues. However, groundwater was encountered at the starting points of all three laterals, which caused a reduction in the hole depths due to water infiltration. After carefully reassessing the situation and rechecking the measurements, the team took the necessary steps to compensate for the depth loss and continued drilling, ensuring that each hole was maintained at the required depth of 18 feet. Drilling in this area was performed in two rows spaced approximately 8 feet apart, with 5 feet between drilling locations within each row.
