Date : 09/12/2025
Project No : 2025C146
Client Company : Davidson Homes, LLC
Arrival Time : 09/12/2025 09:45
Onsite Hours : 04:45

ASEC Report ID : 85554
Name of the Project : Greene Farms Subdivision
Project Location : 1451 Highway 113, Cartersville, Georgia
Weather : N/A
Departure Time : 09/12/2025 14:30
ASEC Technician Name : Solomon Cherie

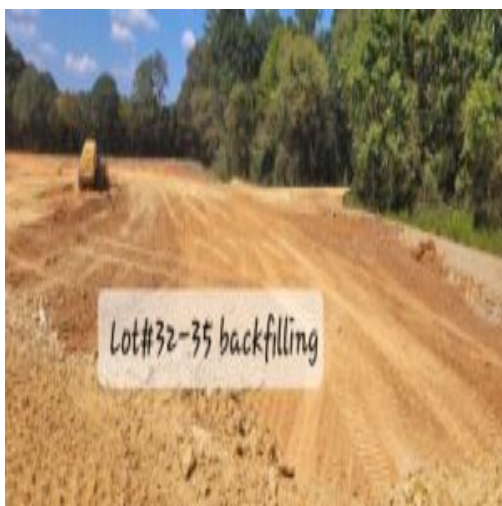
Our ASEC representative was on site as requested and observed the grading contractor continue placing fill for the building pads. Excavation and the hauling of fill material from the cut area was carried out using the heavy duty 349E CAT excavator. Filling of Lots #32 through #35 then continued. Fill materials was spread using a 61Pxi Komatsu bulldozer and was compacted with a sheep-foot roller.

Picture depicting lots 32-35 under backfilling stage Picture showing lots 53-61 proof rolled and passed

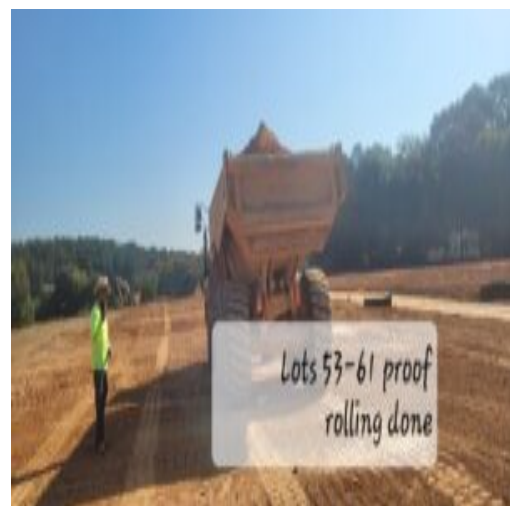
Lots #53 through #61 were filled to grade and then proof-rolled. Proof-rolling displayed no severe pumping/rutting.
