Date : 02/18/2026
Project No : 2025C146
Client Company : Davidson Homes, LLC
Arrival Time : 02/18/2026 12:00
Onsite Hours : 04:00

ASEC Report ID : 90343
Name of the Project : Greene Farms Subdivision
Project Location : 1451 Highway 113, Cartersville, Georgia
Weather : overcast
Departure Time : 02/18/2026 16:00
ASEC Technician Name : Russell Hendrix

1. Purpose

3. Field Evaluation - Proof-Roll

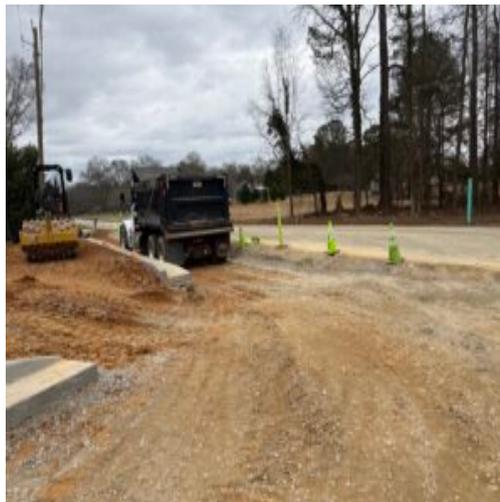
- Visual observation noted excessive pumping and rutting during proof-rolling activities.
-

- Areas exhibiting deflection or pumping indicate insufficient subgrade support with the possibility of water intrusion under the subgrade.

Proof roll of deceleration lane and entrance

Our representatives will return next week to observe additional proof-rolling and test pit explorations to determine the best recommendation for remediation.
