Date : 02/24/2026
Project No : 2025C146
Client Company : Davidson Homes, LLC
Arrival Time : 02/24/2026 08:00
Onsite Hours : 02:00

ASEC Report ID : 90603
Name of the Project : Greene Farms Subdivision
Project Location : 1451 Highway 113, Cartersville, Georgia
Weather : sunny
Departure Time : 02/24/2026 10:00
ASEC Technician Name : Clyde Smith

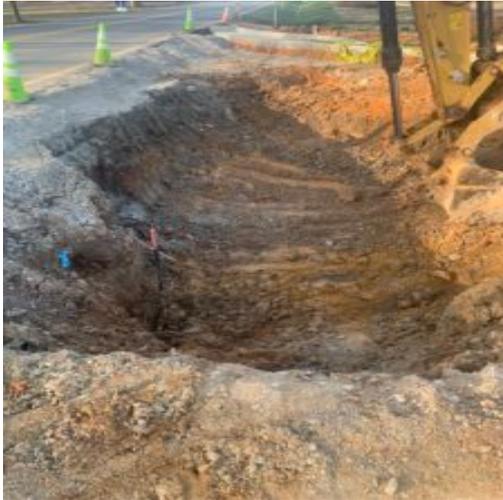
Deep excavation after repair to water line and water pumped out removing additional saturated soils. Also shows approximately two feet of G.A.B. in place at edge of roadway over water line.

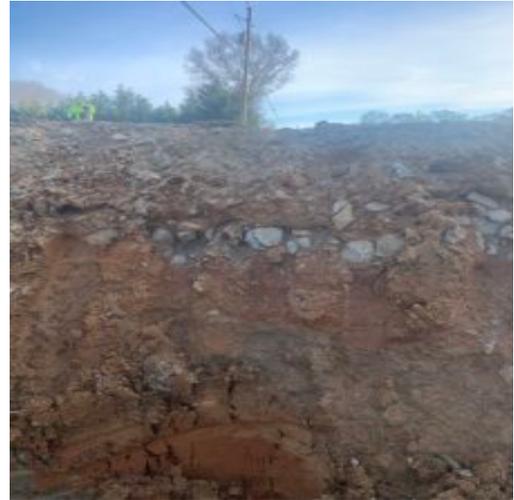
Cross section of cut showing #34 stone in place with trace of fabric with saturated soils beneath. Also minimum amount of G.A.B. stone in place.

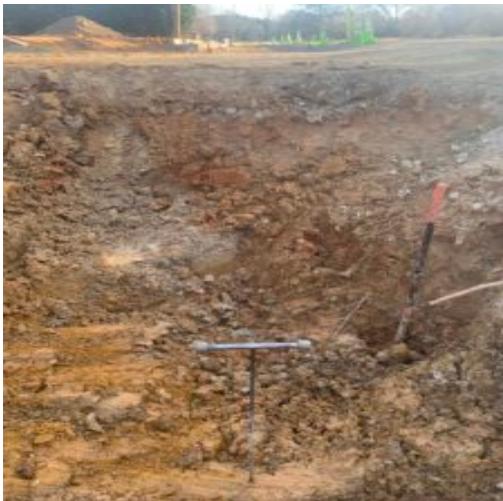
Probing bottom of excavation

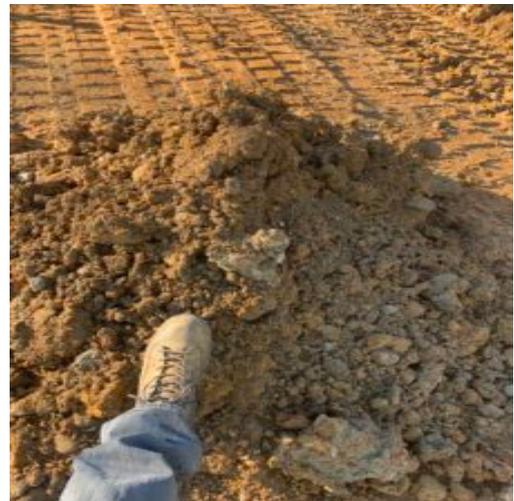
Showing saturated excavated soil materials

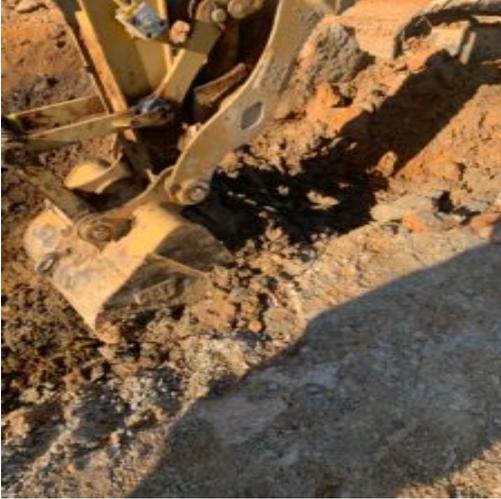
Continuing recommended undercut of -2' to -3'
