Date : 04/21/2026  
Project No : 2025C146  
Client Company : Davidson Homes, LLC  
Arrival Time : 04/21/2026 07:30  
Onsite Hours : 03:30

ASEC Report ID : 93217  
Name of the Project : Greene Farms Subdivision  
Project Location : 1451 Highway 113, Cartersville, Georgia  
Weather : Sunny  
Departure Time : 04/21/2026 11:00  
ASEC Technician Name : Clyde Smith

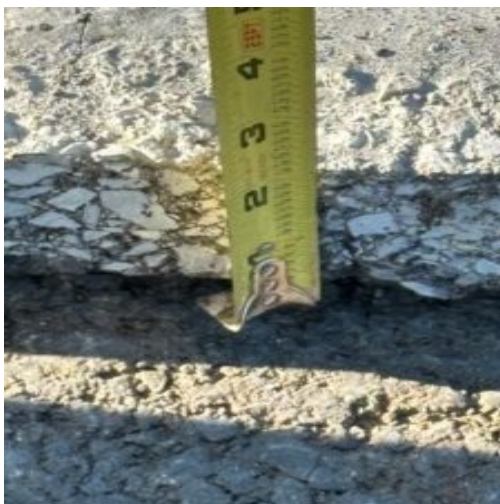
Removed asphalt

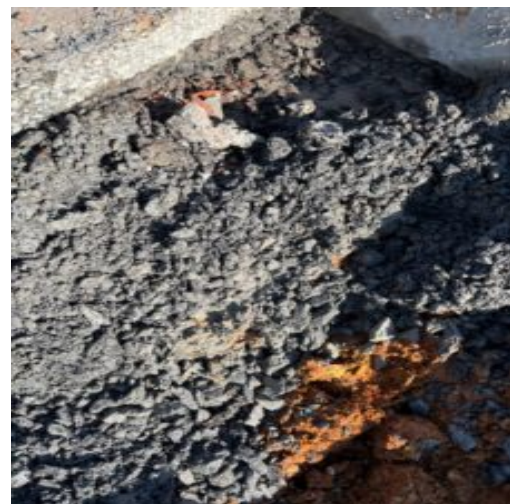
Saturated base stone

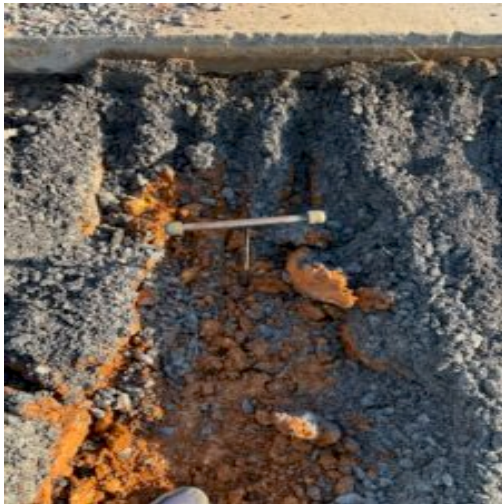
Probing backfill soils

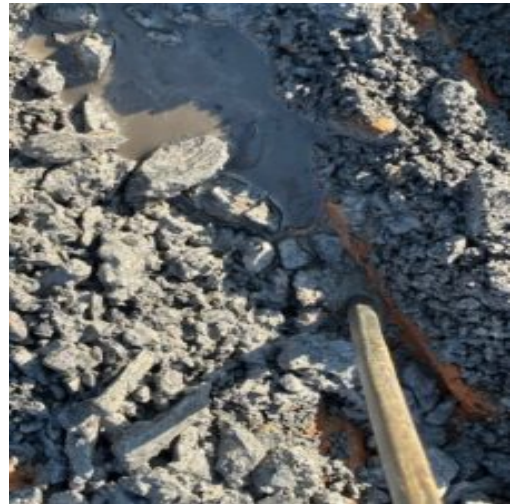
Saturated base stone

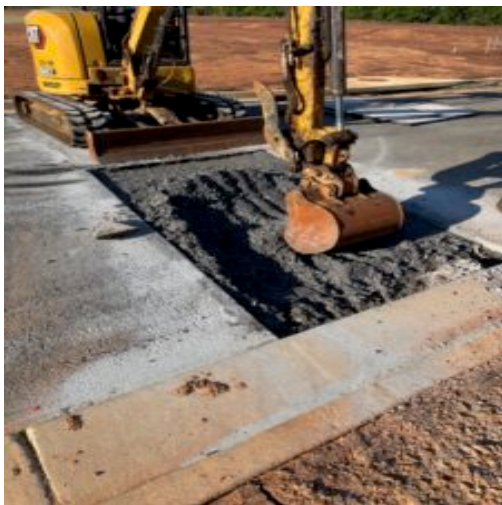
Undercutting in place base stone

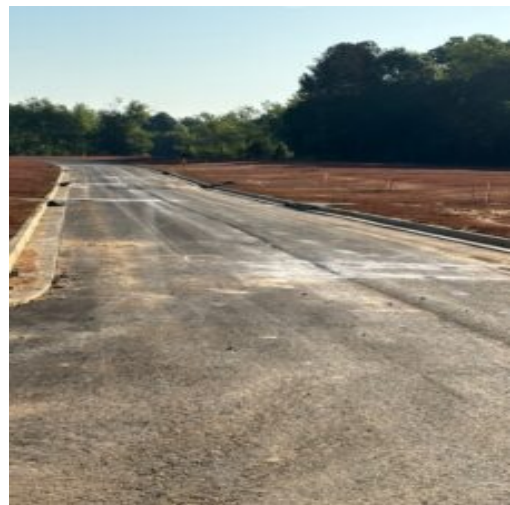
Areas of roadways that was saw cut

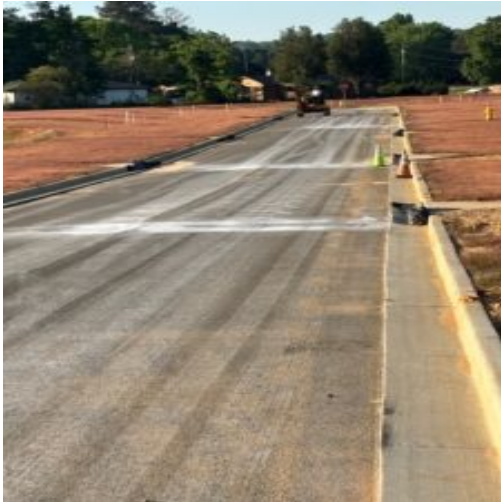
Areas of roadways that was saw cut

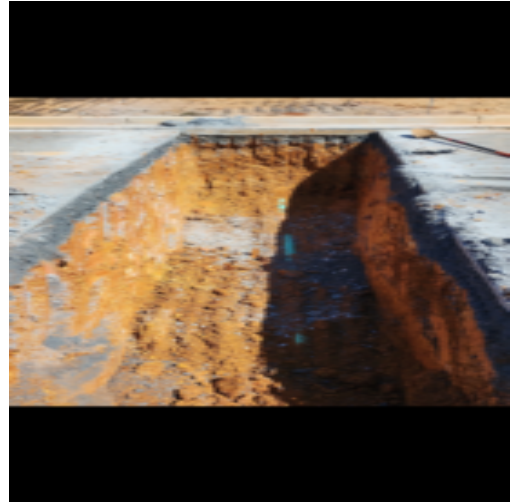
First hole undercut
