Date : 06/07/2025
Project No : 2025C149
Client Company : Davidson Homes
Arrival Time : 06/07/2025 09:00
Onsite Hours : 08:30

ASEC Report ID : 82029
Name of the Project : Grove at E. Thompson Mill Rd
Project Location : Buford
Weather : Sunny
Departure Time : 06/07/2025 17:30
ASEC Technician Name : Sean Willett

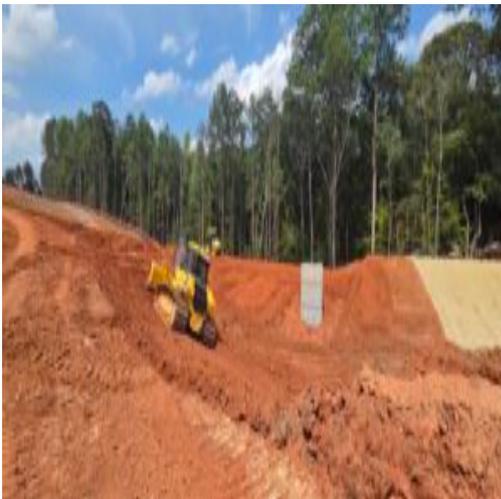
pond 1

The contractor continued placing fill lifts of approximately 8 to 12 inches in thickness across the dam on pond #1 (front right side of site) and pond #2 (back left side of site). The technician density tested each lift and provided all test results to the contractor. Moisture content on pond #1 began to rise above optimum content range, so the technician recommended to aerate these soils prior to recompaction.
