Date : 03/05/2026
Project No : 2025C149
Client Company : Davidson Homes
Arrival Time : 03/05/2026 08:00
Onsite Hours : 9:30

ASEC Report ID : 90978
Name of the Project : Grove at E. Thompson Mill Rd
Project Location : Buford
Weather : sunny
Departure Time : 03/05/2026 17:30
ASEC Technician Name : Samara Simha Reddy Kandi

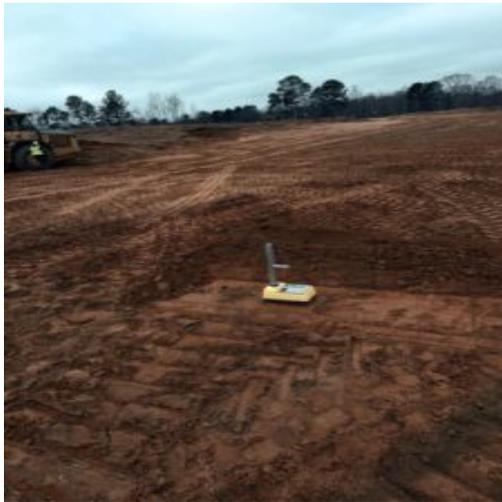
Density tests using Nuclear gauge

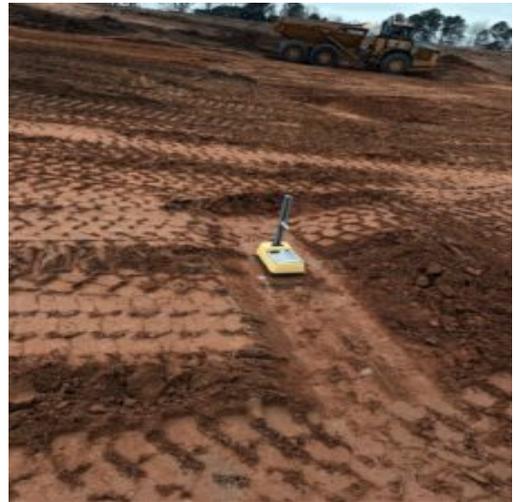
Density tests using Nuclear gauge

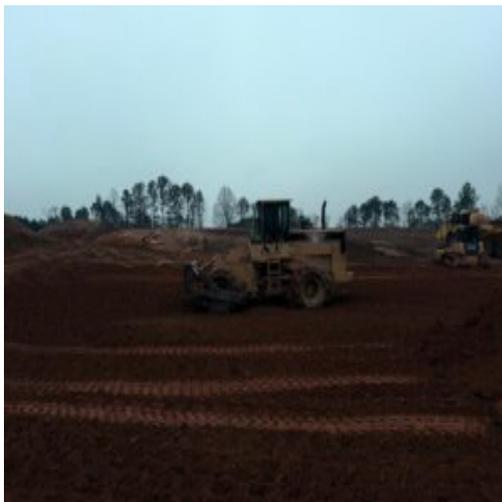
Compacting using 815 equipment

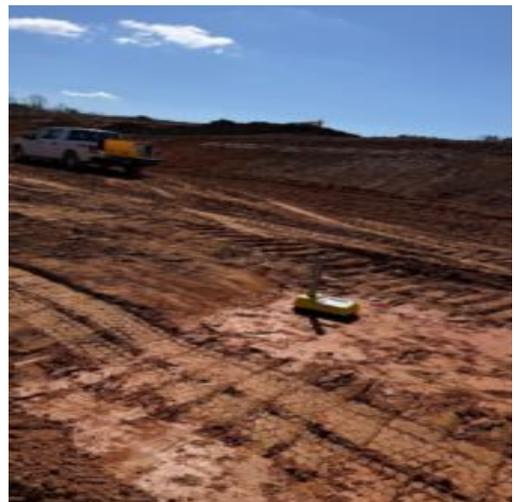
Density tests using Nuclear gauge

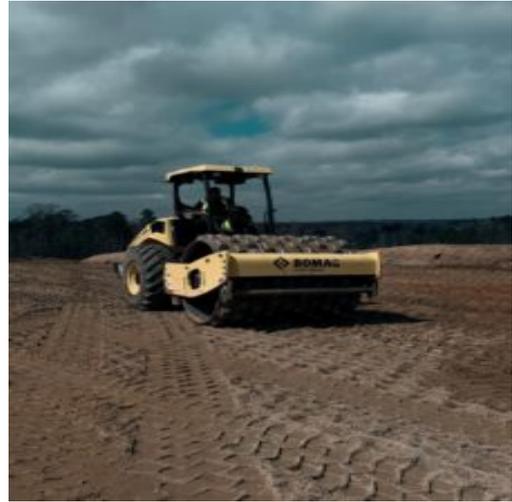
Compacting using Sheep foot roller
