Date : 03/10/2026
Project No : 2025C149
Client Company : Davidson Homes
Arrival Time : 03/10/2026 08:00
Onsite Hours : 9:30

ASEC Report ID : 91286
Name of the Project : Grove at E. Thompson Mill Rd
Project Location : Buford
Weather : sunny
Departure Time : 03/10/2026 17:30
ASEC Technician Name : Samara Simha Reddy Kandi

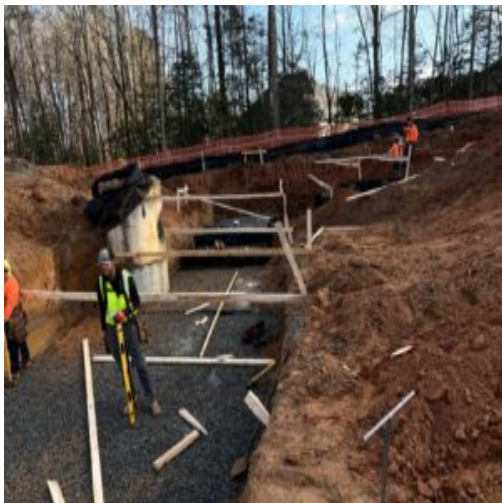
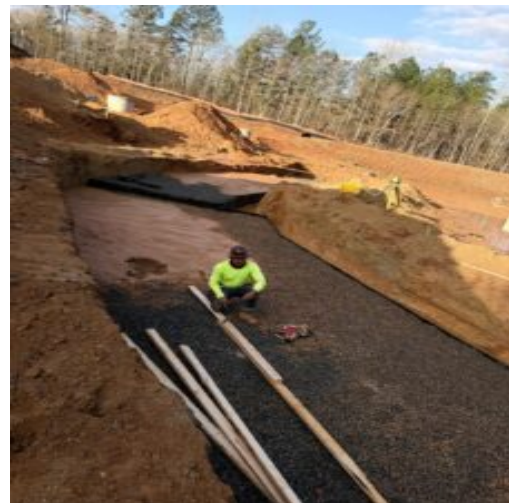
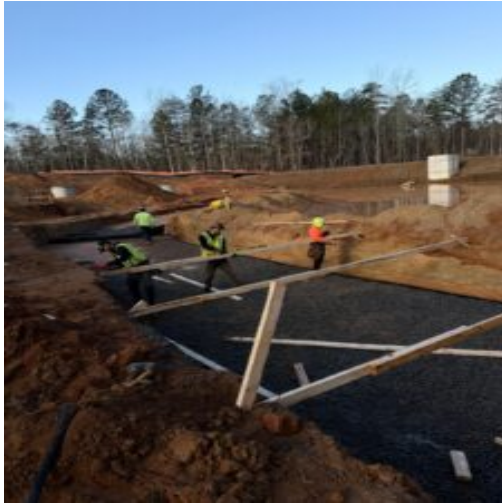
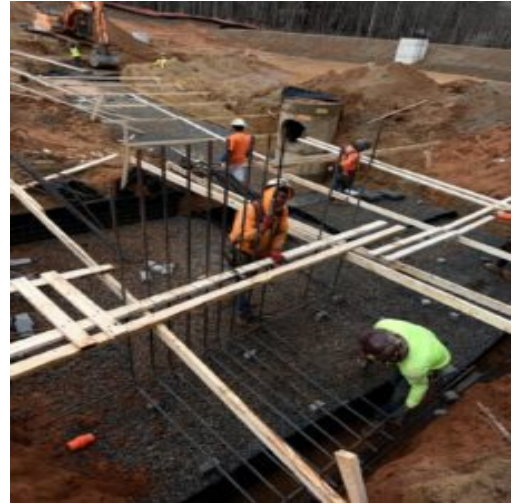
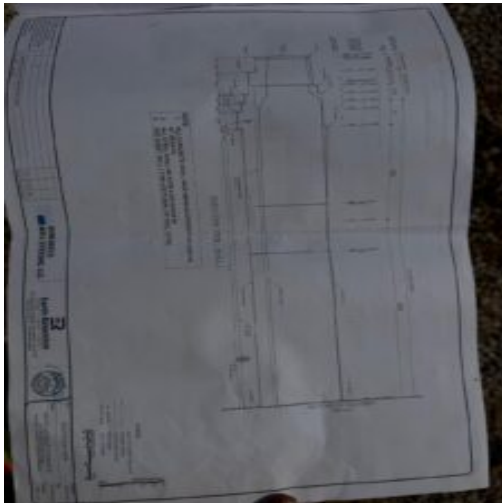
During the site visit, the crew was working at the earth retention wall foundation area where excavation had been completed for 170-180 lineal feet. No.57 stone was placed and leveled as the base layer for the footing. Wooden formwork was installed to mark the footing alignment and dimensions, and the crew started installing reinforcing steel (rebars) for the footing and wall as per the structural drawings up to 50 feet of length. Rebar appeared to be placed as per job specification's for size, spacing and quantity. Dynamic Cone Penetrometer (DCP) tests were performed at multiple locations along the footing alignment to evaluate the in-situ bearing capacity of the footing. At test location 1, the soil encountered was a brown silty sand in a wet condition, where the DCP recorded 12 blows at 1 foot depth, 10 blows at 2 feet, and 15 blows at 3 feet, with rock encountered at approximately a 4-foot depth. At test location 2, the soil was a grey and white micaceous silty sand (wet) with 5 blows at 1 foot, 6 blows at 2 feet, 11 blows at 3 feet, and 13 blows at 4 feet depth. At test location 3, the soil consisted of a grey and yellow micaceous silty sand in wet condition, where the DCP recorded 8 blows at 1 foot depth, 13 blows at 2 feet, 16 blows at 3 feet, and 12 blows at 4 feet depth. At test location 4, the soil was a grey micaceous silty sand in wet condition, where the DCP recorded 7 blows at 1 foot depth and 8 blows at 2 feet depth with rock encountered at approximately 3 feet depth. Based on the observations and DCP results, the subgrade appears suitable for supporting the proposed footing and the placement of the gravel base.
