Date : 04/11/2026
Project No : 2025C149
Client Company : Davidson Homes
Arrival Time : 04/11/2026 08:00
Onsite Hours : 05:00

ASEC Report ID : 92885
Name of the Project : Grove at E. Thompson Mill Rd
Project Location : Buford
Weather : sunny
Departure Time : 04/11/2026 13:00
ASEC Technician Name : Samara Simha Reddy Kandi

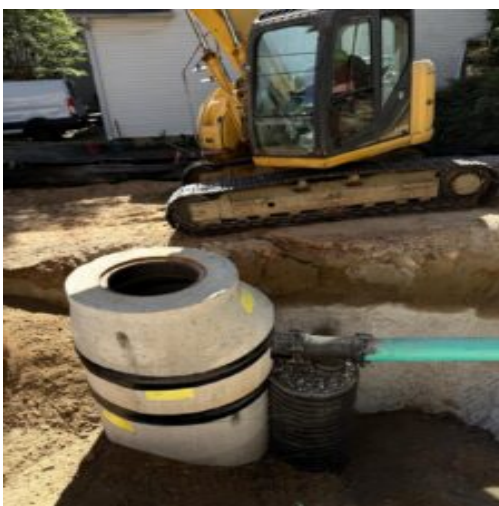
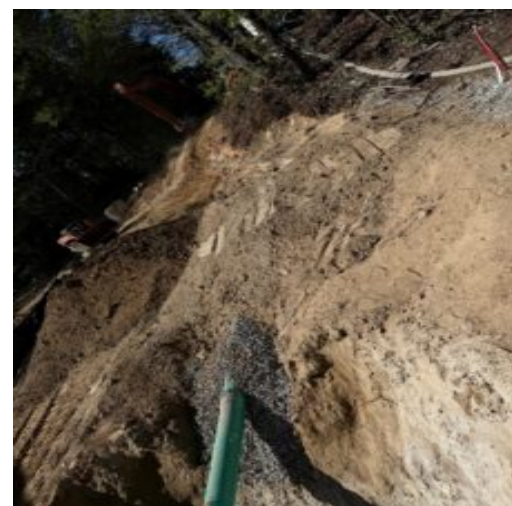
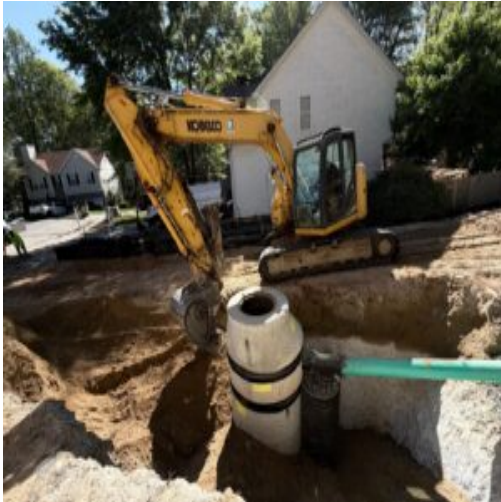
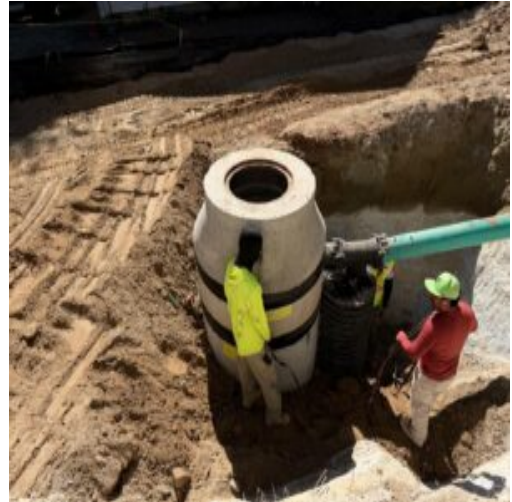
At Retaining Wall 5, Dynamic Cone Penetrometer (DCP) tests were performed to evaluate the sub-grade soil bearing pressures.

At the Buford neighborhood site, the crew began work at the manhole by installing a corrugated HDPE sleeve (encasement) around the vertical DIP pipe. Gravel was placed within the sleeve to. Temporary backfill material was then placed around the pipe and structure to provide initial stability, with further compaction and final backfilling to be completed in subsequent operations.
