Site Visit Report - Retaining Wall Evaluation

ASEC Report ID : 79071
Name of the Project : Riverwood Retaining Wall
Project Location : Dallas
Weather : sunny
Departure Time : 03/25/2025 12:00
ASEC Technician Name : Vamsi Polisetty

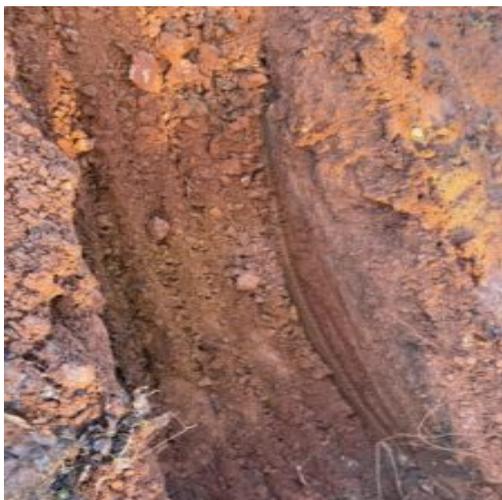
Test pit behind lot 227

- Test pits behind lots 227 through 230 revealed loosely placed fill within the top 2 to 3 feet. While this material is believed to be located above the proposed retaining wall foundation elevation, remediation may be required before proceeding.

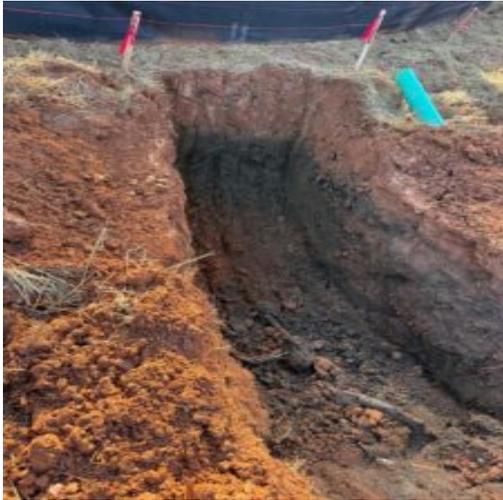
Test pit behind lot 226

- In the section behind lots 225 and 226, organic material mixed in with fill material was encountered to depths of up to 4 feet below the existing grade.
