Date : 03/12/2025  
Project No : 2025C150  
Client Company : Davidson Homes  
Arrival Time : 03/12/2025  
Onsite Hours :

## 1. Introduction

ASEC Report ID : 78654  
Name of the Project : Riverwood Retaining Wall  
Project Location : Dallas  
Weather : sunny  
Departure Time : 03/12/2025  
ASEC Technician Name : Russell Hendrix

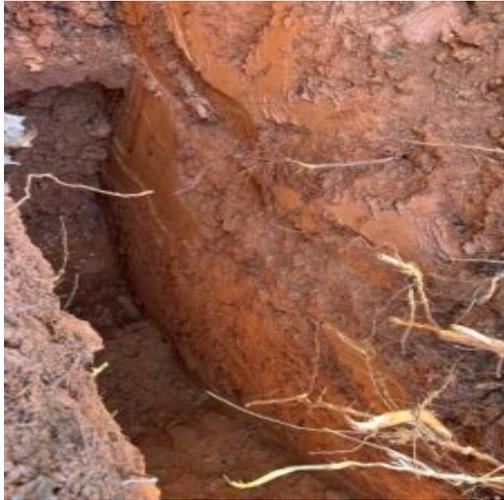
test pit 215

- **Findings:** No resistance at 3-6.5 feet depth. At 6.5 feet, water quickly filled the bottom of the pit.

- The test pits confirm that significant portions of the site contain **uncompacted fill** and organic materials, which are questionable for supporting structural loads without remediation.
- Water intrusion at Location 215 suggests potential **groundwater issues** that could further compromise stability and workability.
- The **bearing capacity of the original soil is inconsistent**, with probe depths varying across locations.
- Given these conditions, it is **unlikely that the existing soil can support 3,000 PSF** without remediation.

1. **Soil Remediation:** The existing fill should be removed and replaced with properly compacted engineered fill.
2. **Compaction Testing:** Any new fill should be compacted in controlled lifts and tested to meet design specifications for compaction and bearing.
3. **Foundation Alternative:** If removing the fill is not feasible, proprietary foundations (e.g., piers or piles) may be required to transfer loads to competent soil.
4. **Drainage Considerations:** Address groundwater concerns, particularly at Location 215, to prevent long-term stability issues.

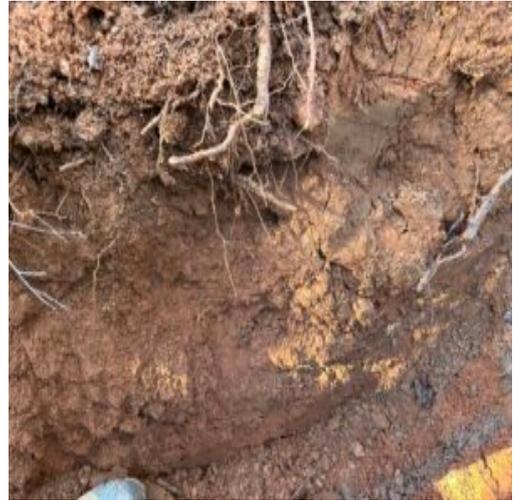
test pit 220

- **Findings:** Suspected original soil present at 3 feet.
- **Probing:** (at 3 feet in depth) 2-3 inches at depth.

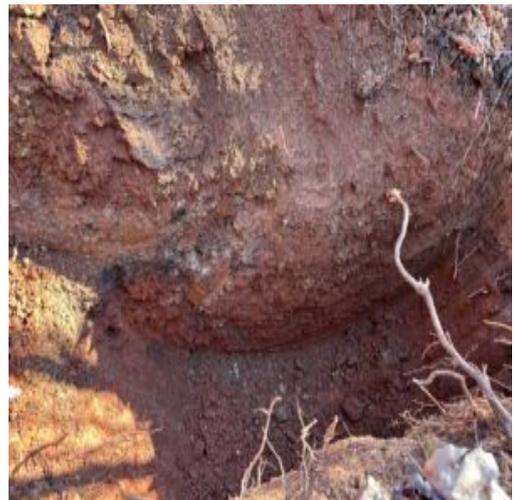
Test pit 205

- **Findings:** Suspected original (residual) soils encountered at a depth of 4 feet.
- **Probing:** (at 4 feet) 3 inches at depth.

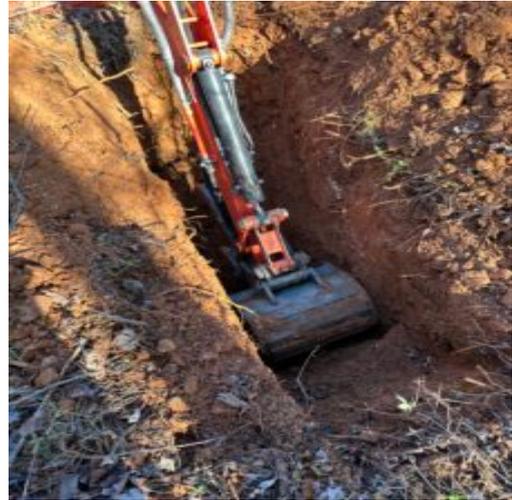
Test pit 207

- **Findings:** 5 feet of suspected uncompacted fill, with original soil at 6 feet.
- **Probing:** Fill layer probed (at 4 feet) 4-6 inches; original soil (at 6 feet) probed 3-4 inches.
