Date : 04/03/2025
Project No : 2025C160
Client Company : Artisan
Arrival Time : 04/03/2025 4:00
Onsite Hours : 02:00

ASEC Report ID : 79431
Name of the Project : Rockmart Township - 115 Felton Drive
Project Location : Rockmart
Weather : Sunny
Departure Time : 04/03/2025 6:00
ASEC Technician Name : Clyde Smith

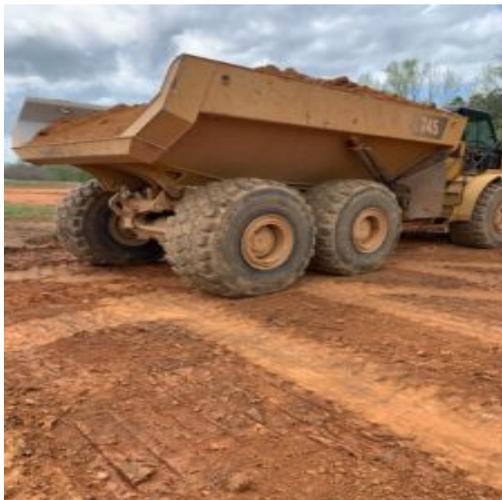
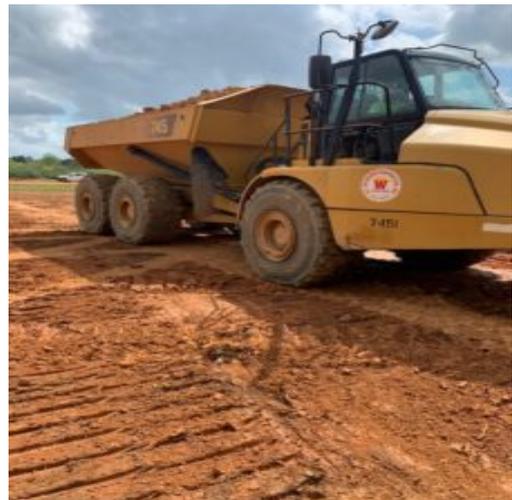
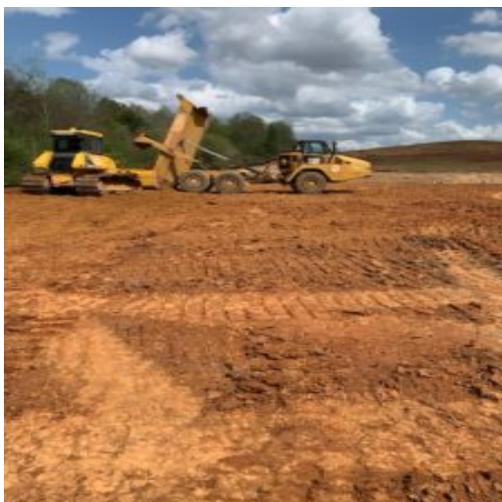
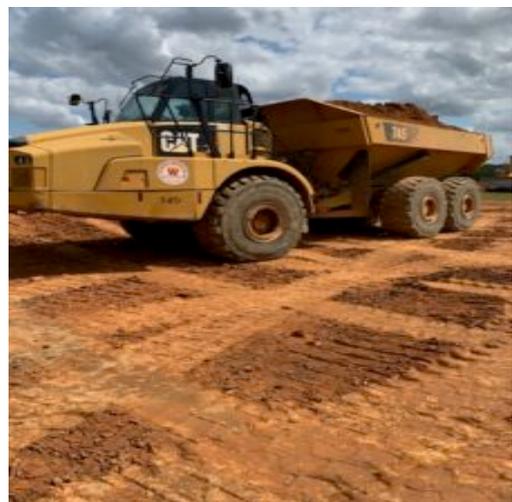
On the above date our representative was on site as requested to observe the grading contractor (Wilbanks) strip existing subgrade soils from Lot #33, removing organic topsoil. The writer visually inspected the subgrade by proof-rolling, using a loaded off-road dump truck making two passes over all areas of concern. Subgrade soils appeared stable under traffic with no apparent pumping or deflection and was suitable for fill placement.
