Date : 04/29/2025
Project No : 2025C160
Client Company : Artisan
Arrival Time : 04/29/2025 09:30
Onsite Hours : 06:00

ASEC Report ID : 80781
Name of the Project : Rockmart Township - 115 Felton Drive
Project Location : Rockmart
Weather : Overcast
Departure Time : 04/29/2025 15:30
ASEC Technician Name : Sean Willett

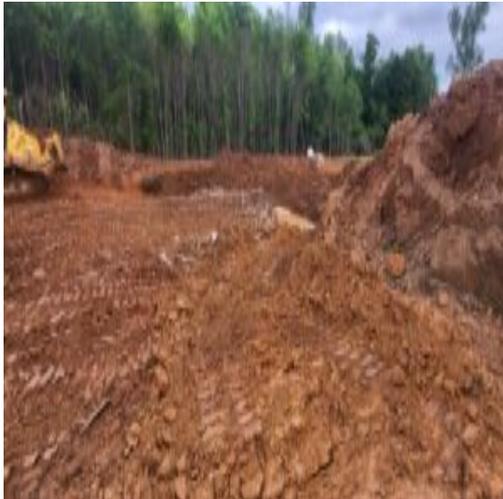
We observed the contractor undercut Lots #16, #17, and partially #18 approximately 5 feet. There was water present in the undercut with some areas probing soft. The lot will be filled with approximately 15 feet of soil. The contractor requested a recommendation for the best solution. Mr. Clyde Smith of ASEC was called for an evaluation and recommendation. Mr. Smith recommended to place approximately 5 feet of riprap and compact to create a solid foundation for the soil lifts. A series of probe rod tests were performed.

lot #16 and #17 being filled with riprap

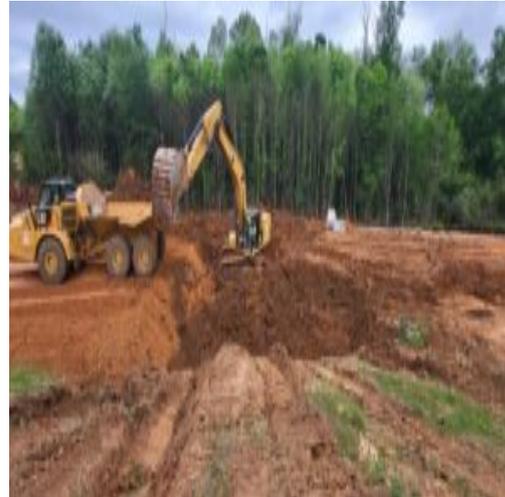
lot #16 and #17 being excavated to approximately a 5ft undercut

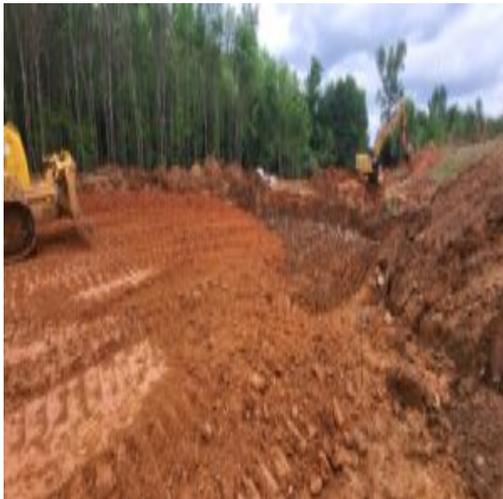
lot #16 and #17 being filled with riprap

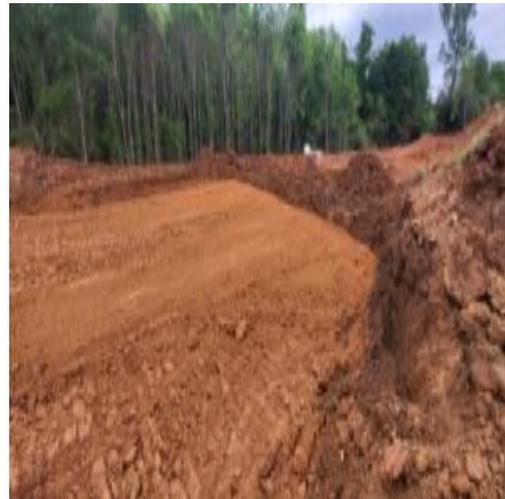
bridge lift of soil over riprap lot #16 and #17

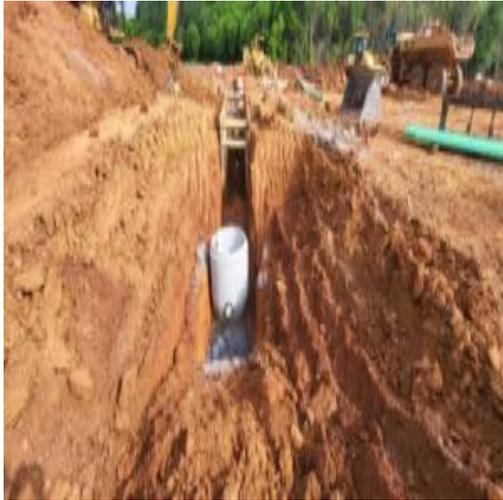
The technician also observed the installation of SSMH1.1 with approximately 1 foot of No. 57 stone bedding to elevation. In the center of the pipeline that runs from SSMH1.1 and SSMH1.0B, there was an approximately 5 feet of undercut spanning approximately 10 feet in length, that was replaced with approximately 4 feet of clean (trucked in) riprap and capped with approximately 1 foot of No. 57 stone to elevation. This is in addition to the same size undercut from SSMH1.0B as mentioned in the previous day's report.

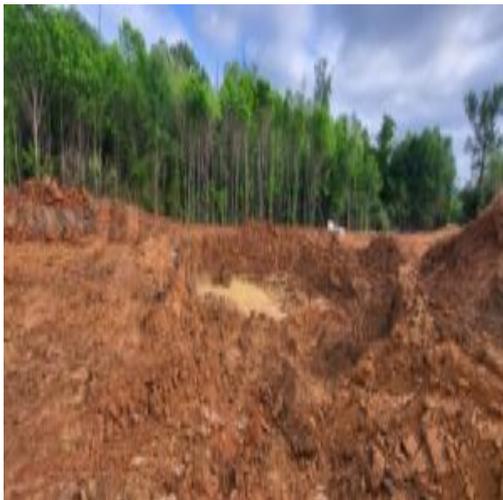
water present in undercut of lot 16 and 17

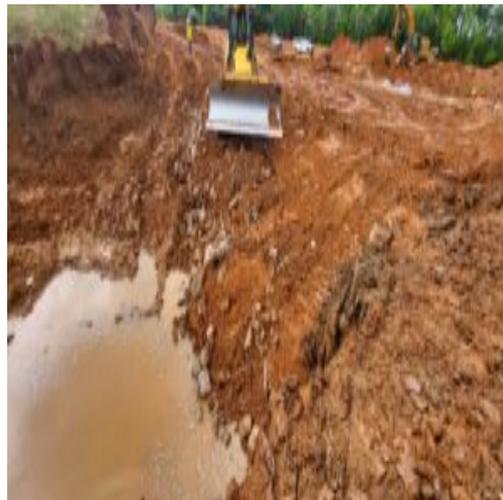
lot #16 and #17 being filled with riprap
