Date : 04/28/2025
Project No : 2025C160
Client Company : Artisan
Arrival Time : 04/28/2025 10:00
Onsite Hours : 03:00

ASEC Report ID : 80635
Name of the Project : Rockmart Township - 115 Felton Drive
Project Location : Rockmart
Weather : Overcast
Departure Time : 04/28/2025 13:00
ASEC Technician Name : Sean Willett

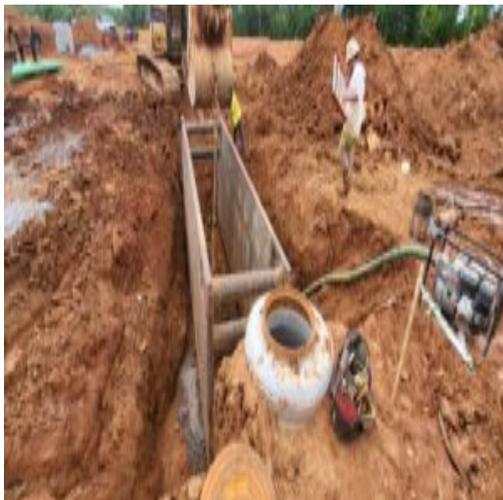
The contractor began excavating SSMH1.0B to SSMH1.1. Approximately 10 feet from SSMH1.0B 5 feet was undercut and replaced with large riprap and capped with approximately 1 foot to 1.5 feet of No. 57 stone to elevation.

trenching SSMH1.0B to SSMH1.1

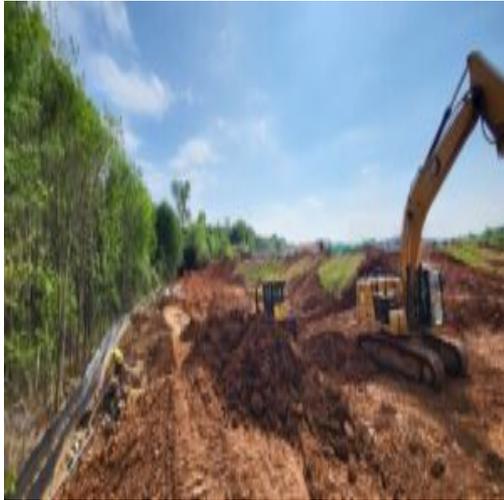
Our ASEC representative was on site as requested by the contractor (Wilbanks) for the observation/testing of the placement of soils. The contractor requested the technician to identify how much topsoil was present in the bank along Lots #15 through #20. The bank was estimated to be 30 feet wide x 300 feet long with the top elevation at 765.5 and bottom elevation at 756.5.

Approximately 300ft long bank by lot #15 to #20

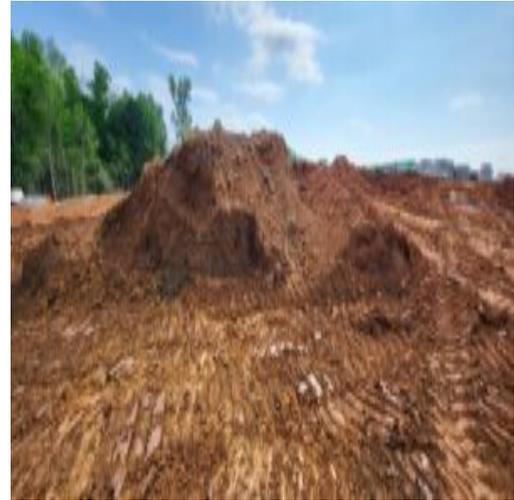
Approximately 30ft wide bank by lot #15 to #20

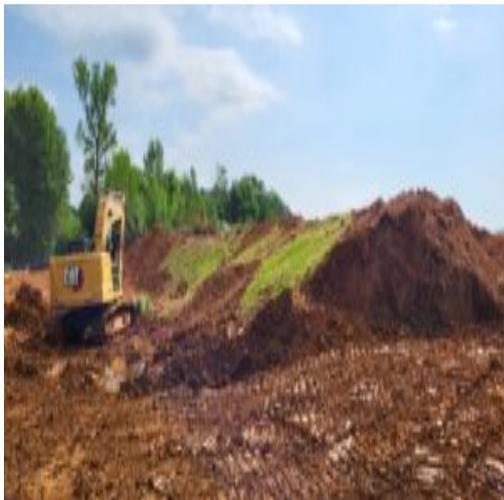
Approximately 300ft long bank by lot #15 to #20
