Date : 05/06/2025
Project No : 2025C160
Client Company : Artisan
Arrival Time : 05/06/2025 07:30
Onsite Hours : 07:00

ASEC Report ID : 81494
Name of the Project : Rockmart Township - 115 Felton Drive
Project Location : Rockmart
Weather : Overcast
Departure Time : 05/06/2025 14:30
ASEC Technician Name : Sean Willett

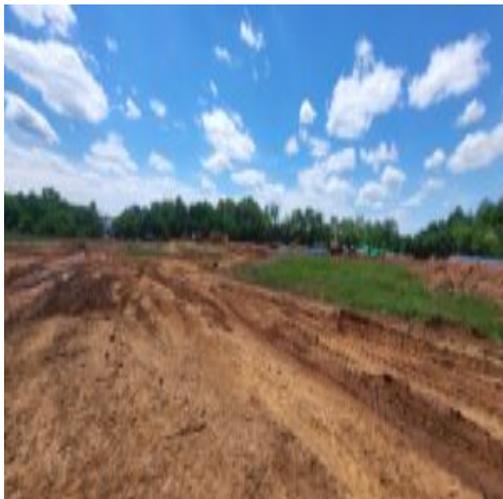
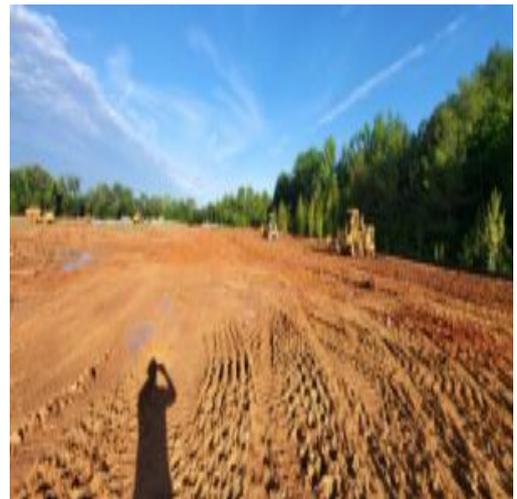
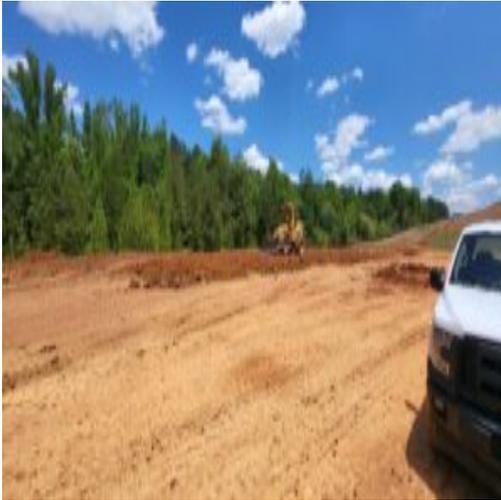
Our ASEC representative was on site as requested by the contractor (Wilbanks) for the observation/testing of the placement of soils. The technician observed the contractor place 1 lift approximately 8 inches in thickness over Lots #30 through #40. Fill materials tested were found to be higher than optimum moisture content and was left to aerate in place to reduce in-situ moistures prior to compaction.

Compaction results were found to be at least 95% and within optimum moisture content range (3 percent above and below optimum). All test results were provided to the contractor.
