Date : 05/20/2025  
Project No : 2025C160  
Client Company : Artisan  
Arrival Time : 05/20/2025 07:45  
Onsite Hours : 06:45

ASEC Report ID : 81813  
Name of the Project : Rockmart Township - 115 Felton Drive  
Project Location : Rockmart  
Weather : Sunny / overcast  
Departure Time : 05/20/2025 14:30  
ASEC Technician Name : Sean Willett

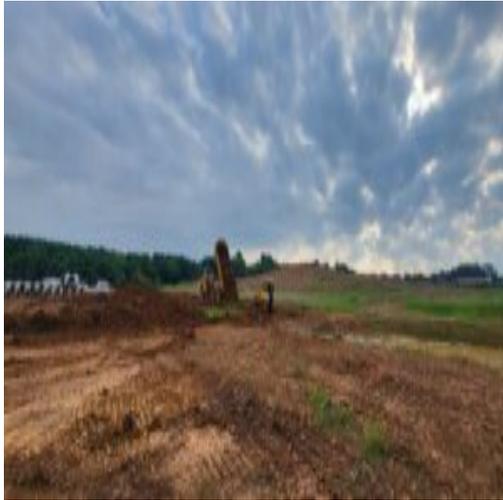
The contractor stripped topsoil from Lot #81 to approximately Lot #89. The topsoil was placed on bank (green space) along Lots #127 through #133.

topsoil placed on bank

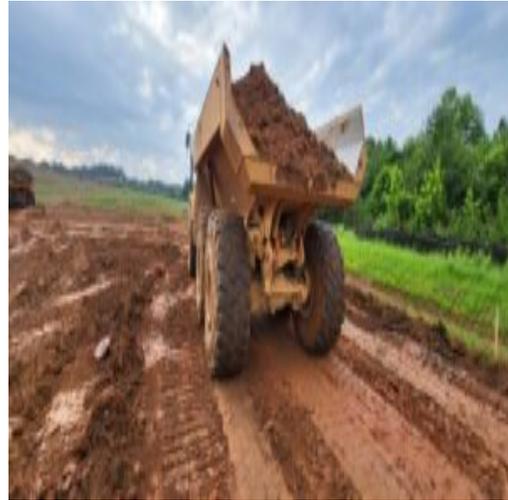
The technician observed a proof-roll of Lots #81 through #86. There were no signs of severe pumping and/or deflection. Another proof-roll will be performed on the next workday for Lots #87 to #89 (temporary detention pond in Lot #90).

proof roll

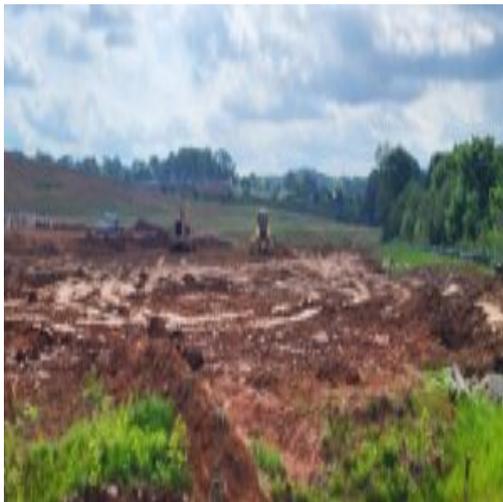
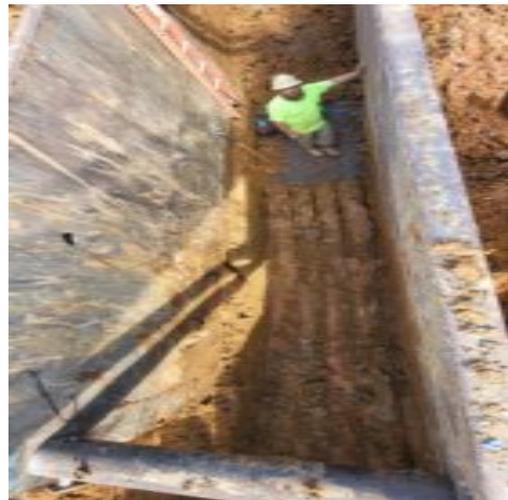
The contractor continued backfilling for the pipeline from SSMH4.1 to SSMH4.2. The pipeline was bedded with No. 57 stone to elevation up to the center of pipeline. The approximate center of the pipeline was reported to be soft during excavation. The technician generally probed this area of the trench using a 3/8" diameter probe rod, which showed approximately 8 inches of embedment. The technician recommended that the contractor undercut another 8 to 12 inches, or until more stable soils were encountered. Then the contractor could bed the trench with No. 57 stone or riprap with a No. 57 stone cap.

center of pipeline SSMH4.1 to SSMH4.2

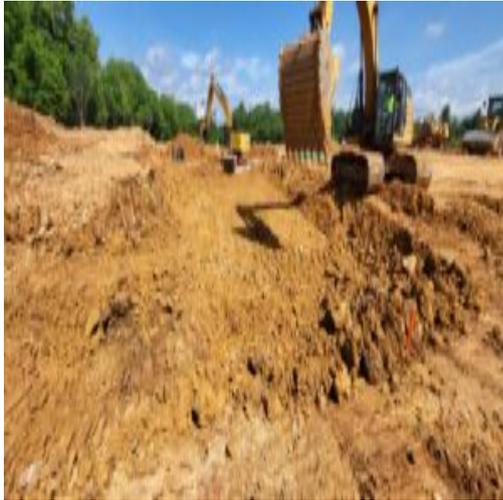
The contractor then began placing fill in lifts of approx. 8in to 12in thick across Lot #81 to approximately Lot #85, and on Lot #106 and #107. Material was excavated from Lot #1, and #90 to be placed for these lifts. Density testing was performed with results provided to the contractor. The technician recommended the contractor allow ample time to aerate wet soils before recompacting.

excavation of lot #1
