Date : 06/05/2025
Project No : 2025C160
Client Company : Artisan
Arrival Time : 06/05/2025 11:30
Onsite Hours : 03:00

ASEC Report ID : 82003
Name of the Project : Rockmart Township - 115 Felton Drive
Project Location : Rockmart
Weather : sunny
Departure Time : 06/05/2025 14:30
ASEC Technician Name : Sean Willett

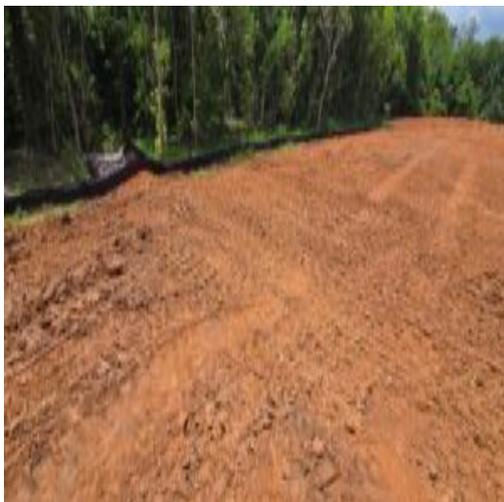
Head wall BE1

The contractor previously backfilled headwall BE1. The contractor did not request density testing on this backfill. The contractor began excavation for headwall BE6 with an invert elevation of 753.2.

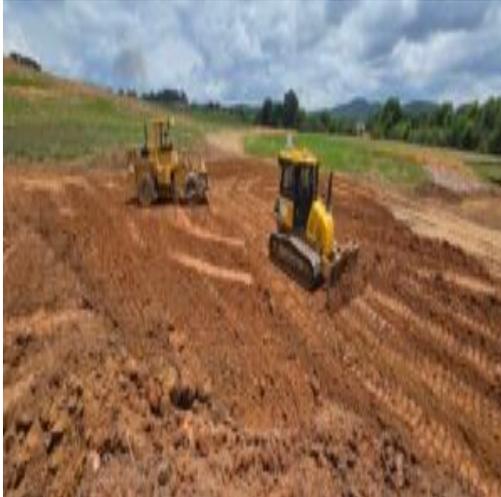
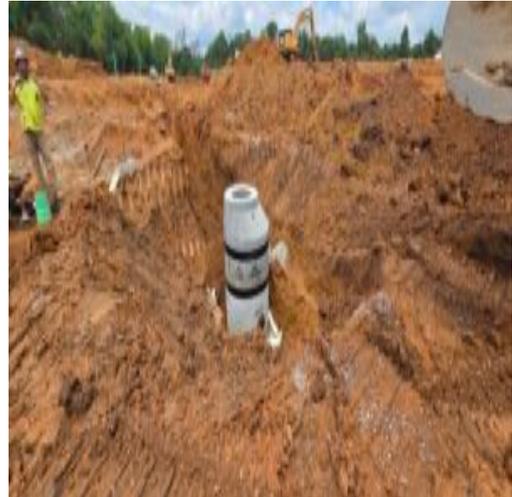
SSMH4.3

The contractor continued working on pipeline to SSMH 4.3. The contractor reported an approximately 2 feet of cut, bedded with No. 57 stone to elevation.
