Date : 06/10/2025  
Project No : 2025C160  
Client Company : Artisan  
Arrival Time : 06/10/2025 09:00  
Onsite Hours : 05:00

ASEC Report ID : 82129  
Name of the Project : Rockmart Township - 115 Felton Drive  
Project Location : Rockmart  
Weather : sunny  
Departure Time : 06/10/2025 14:00  
ASEC Technician Name : Sean Willett

As requested, the site was visited by our AS Engineering and Consulting (ASEC) representative for the purpose of providing quality control inspection and testing services. Visual observation techniques were employed to verify compliance with project drawing/specifications, applicable codes, and materials submittals. The following observations were observed on site this day.

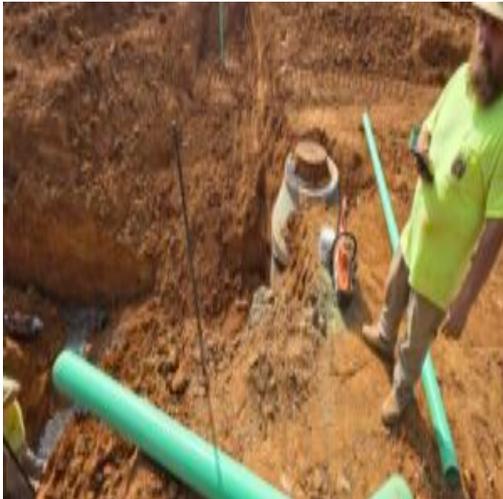
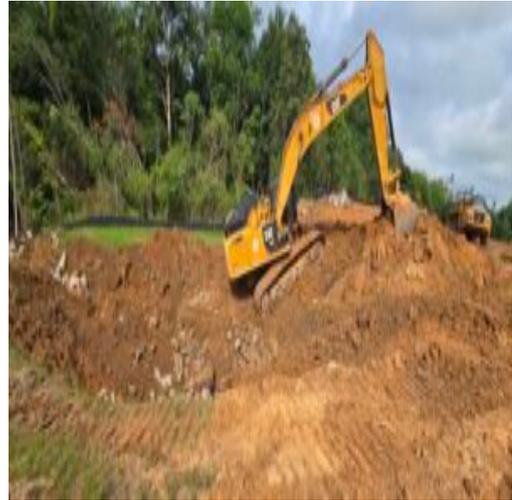
lot #1

Contractor began excavation of topsoil from lot #1. The contractor asked the technician to check the bottom of the excavated area in lot #1. There were signs of low compaction. The contractor reported approx. 10ft of fill will be placed in this area. The technician recommended a bridge lift of approx. 2ft before compaction. There was riprap present in bottom of excavation before bridge lift was placed.

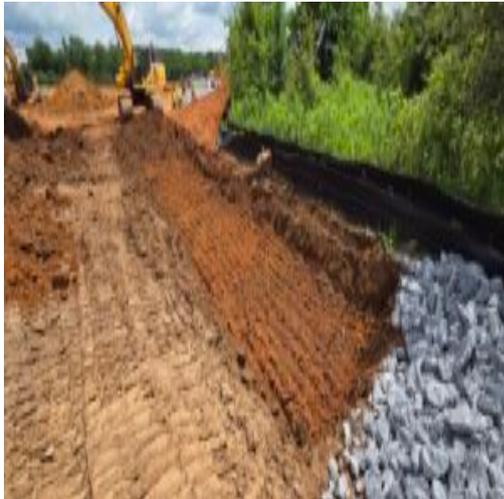
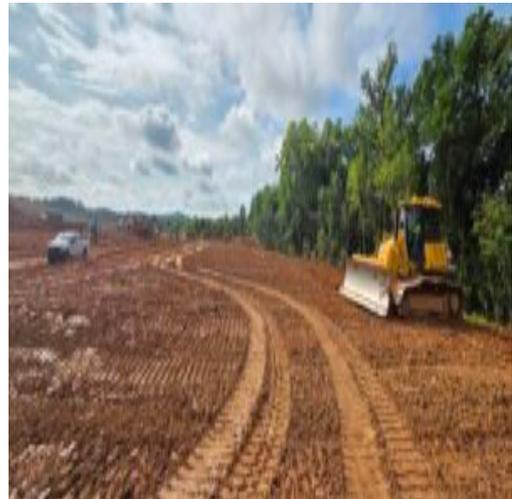
lot #2 - 15

Our ASEC representative was on site as requested by the contractor (Wilbanks) for the observation/testing of the placement of fill/backfill. The technician observed the contractor place 1 lift approximately 8 inches in thickness over Lots #2 through #15 to elevation (approx. 760 -762). The technician will go through with contractor to record final grades of each lot at a future date.
