Date : 06/11/2025  
Project No : 2025C160  
Client Company : Artisan  
Arrival Time : 06/11/2025 08:30  
Onsite Hours : 9:00

ASEC Report ID : 82145  
Name of the Project : Rockmart Township - 115 Felton Drive  
Project Location : Rockmart  
Weather : Sunny  
Departure Time : 06/11/2025 17:30  
ASEC Technician Name : Sean Willett

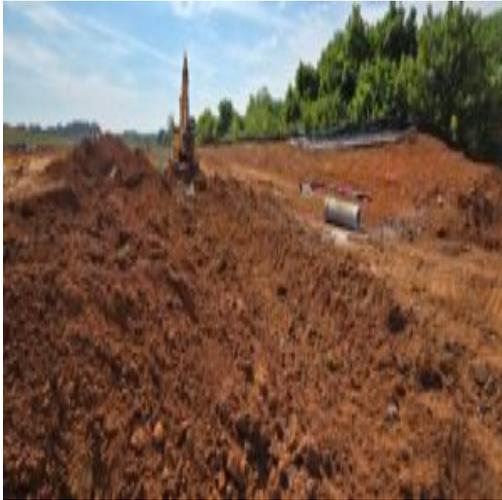
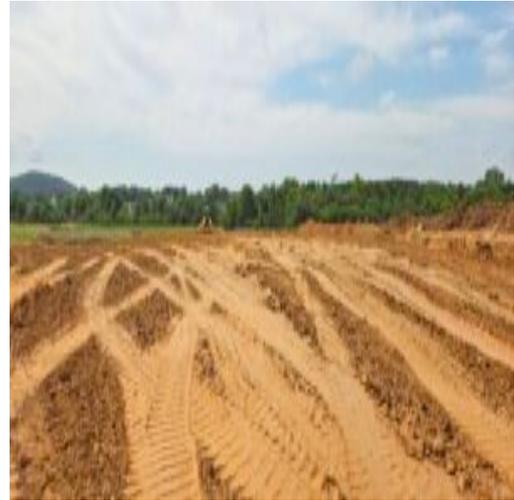
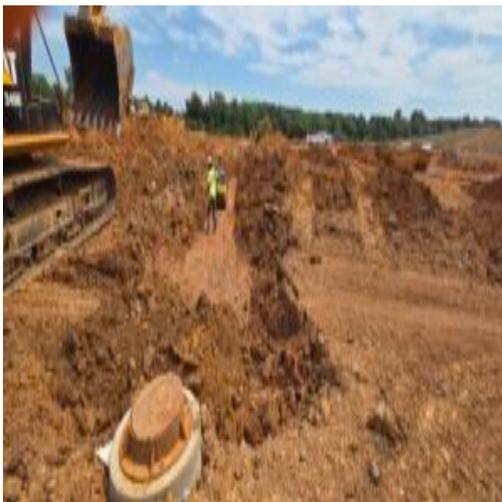
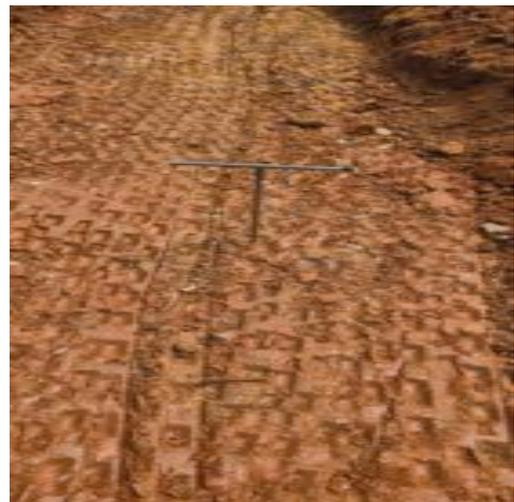
SSMH4.3 to 5.0 pipeline

The contractor began backfilling pipeline from SSMH4.3 to SSMH5.0. The technician density tested this pipeline starting 4 feet over pipeline and provided all test results to the contractor. The technician recommended to allow aeration of wet soils to near optimum moisture content before compacting again. The technician probed this pipeline which were found to be not stable at this time. The technician informed the contractor of these results.

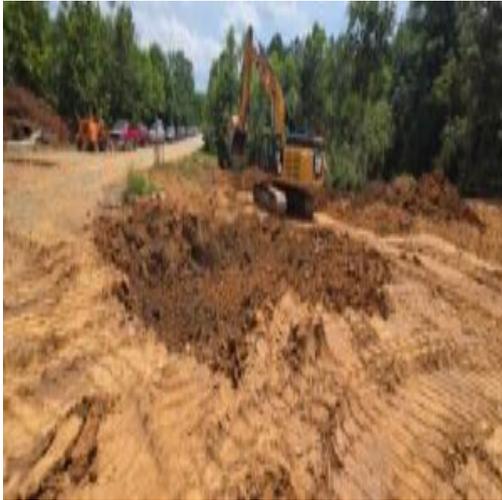
The contractor began placing lifts on lot #1 in approx. 8 to 12 inches in thickness. The technician density tested approx. every 2 feet. All test results were provided to the contractor. The technician recommended to remove soils that were too high in moisture content and allow ample time to dry. The contractor spread lifts of over saturated soil with a lift of optimum moisture levels over top of the over saturated lifts. The contractor then compacted the lifts via sheepsfoot and rolled in the lifts with a loaded off-road dump truck. The technician watched the roll in of these lots to see any signs of pumping. The technician showed the contractor where pumping was present, and the contractor excavated out these areas. There is a watermain present in the pad of lot #1 that the contractor said will be excavated at a future date. The technician recommended to excavate a 10ft x 10ft area around this main due to poor compaction in this area. There were signs of poor compaction in these lifts via density testing. The contractor still has approx. 2 feet of fill to reach elevation. The technician recommended to allow ample time for the lifts to dry to near optimum moisture content and to recompact this area before placing final lifts.
