Date : 06/12/2025
Project No : 2025C160
Client Company : Artisan
Arrival Time : 06/12/2025 08:30
Onsite Hours : 08:00

ASEC Report ID : 82155
Name of the Project : Rockmart Township - 115 Felton Drive
Project Location : Rockmart
Weather : overcast
Departure Time : 06/12/2025 16:30
ASEC Technician Name : Sean Willett

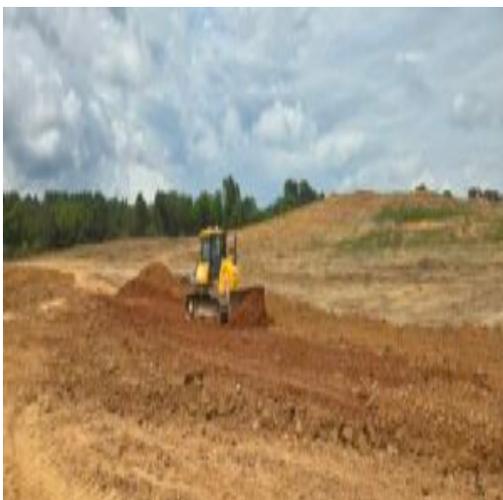
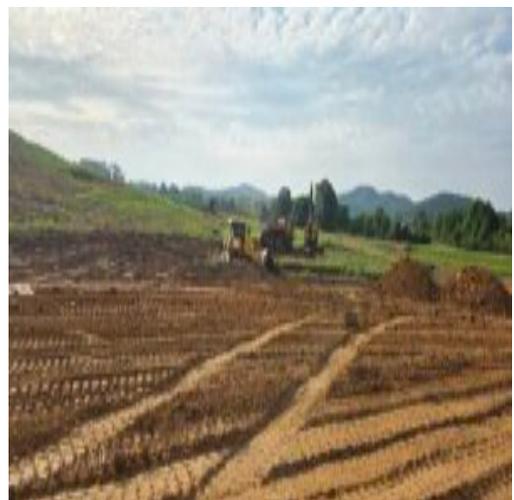
SSMH 1.2 to SSMH1.3

The contractor continued working on pipeline from SSMH1.2 to SSMH1.3 with a reported undercut of approx. 8in to 12in, bedded with 57stone to elevation.
