Date : 06/16/2025  
Project No : 2025C160  
Client Company : Artisan  
Arrival Time : 06/16/2025 08:00  
Onsite Hours : 05:00

ASEC Report ID : 82299  
Name of the Project : Rockmart Township - 115 Felton Drive  
Project Location : Rockmart  
Weather : Sunny  
Departure Time : 06/16/2025 13:00  
ASEC Technician Name : Sean Willett

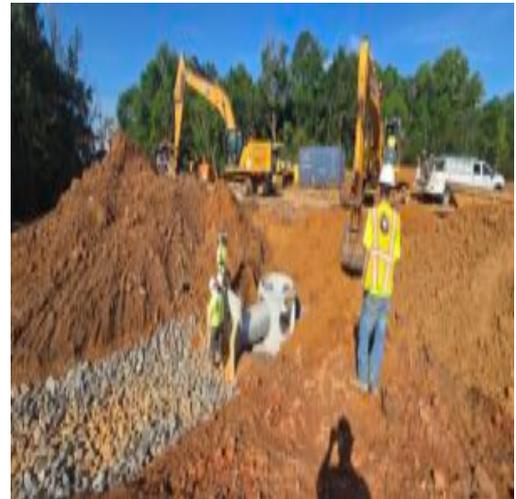
BG1

The contractor (Robbie) and his crew had already excavated a large area by the entrance of the site for structure BG1. The technician told the contractor the dirt was too wet to place back in and properly compact to site specs. With rain in the forecast, the contractor asked if they could place No. 57 stone around the structure to get the excavated area filled in as quickly as possible. The technician recommended not to do this unless they could find drier material to cap the No. 57 stone with, to prevent water from settling around the drainage structure. The contractor then chose to proceed to place backfill around the structure with soils that were too wet for proper compaction. The contractor elected to not follow our recommendations.

Our representative spoke with the superintendent (Hugh @ Wilbanks) over the phone about the site conditions. The superintendent did not want his crew to fill with overly saturated materials, but the contractor proceeded to do so anyways. The superintendent made it very clear that he is not interested in going back to fix these areas. No testing could be performed around this structure or pipeline.

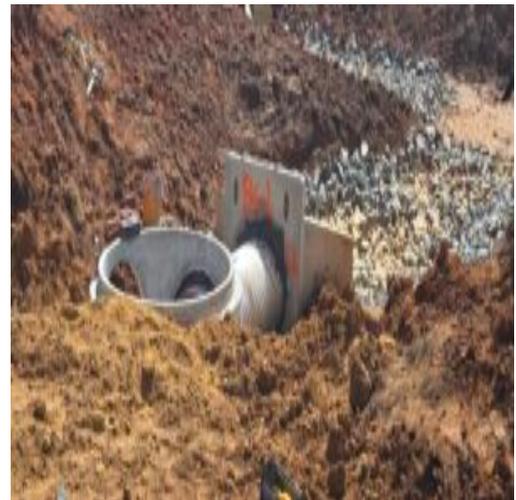
BG1

The contractor (Randy) excavated drier fill from the top of the hill and placed it around the structure for the contractor (Robbie) to finish backfilling with. The contractor (Randy) then excavated more fill from top of the hill to bring Lots #31 -39 to finished grade. The contractor placed 1 lift, approx. 5 to 12 inches in thickness, across these lots and compacted. The technician will density test the final grade of these lots on the next available workday.

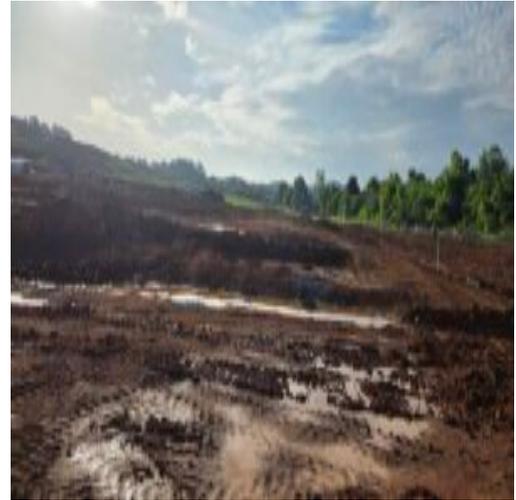
The technician moisture checked multiple points around the site first thing in the morning for the contractor to determine if they could place fill today. Moisture contents were very high (well above optimum range) for proper compaction. The contractor (Randy) searched the site for drier material and excavated fill from the top of the hill (Approx. Lot #192 -194 area).

wet conditions on site

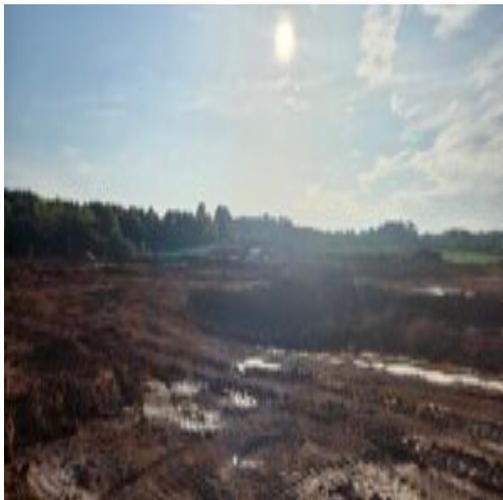
wet conditions on site
