Date : 06/19/2025
Project No : 2025C160
Client Company : Artisan
Arrival Time : 06/19/2025 09:00
Onsite Hours : 02:00

ASEC Report ID : 82366
Name of the Project : Rockmart Township - 115 Felton Drive
Project Location : Rockmart
Weather : overcast/raining
Departure Time : 06/19/2025 11:00
ASEC Technician Name : Sean Willett

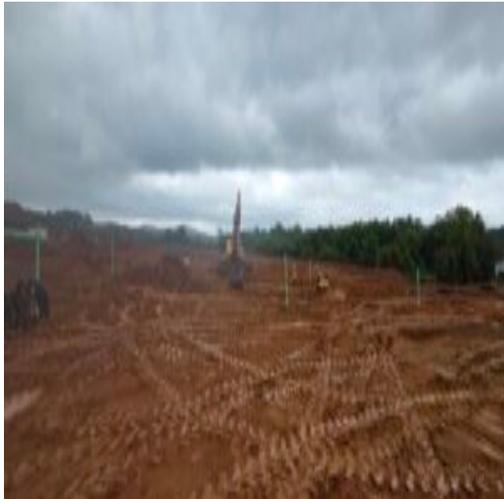
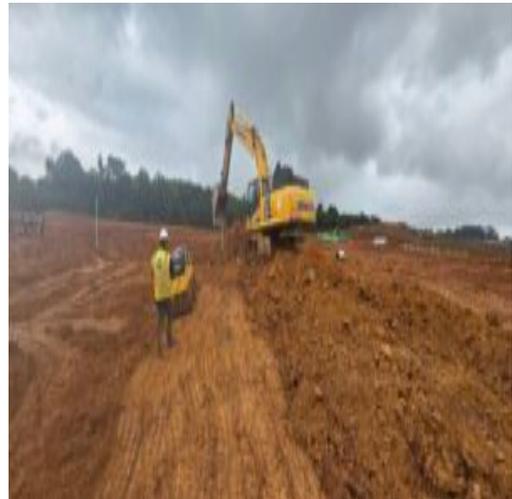
structure BG5 pipeline

The technician observed the contractor (Robbie) excavating/backfilling the BG structures pipeline up to structure BG5. The technician moisture checked soils placed directly over pipeline. Moisture content was approx. 27%, which is well above the optimum moisture content range. The technician recommended not to backfill with this oversaturated material. The contractor proceeded to backfill anyways, against the technician's recommendation.

During this time, it began to rain. The contractors proceeded to place topsoil and backfill the pipeline and structure BG5 in the rain. The contractor continued to backfill the pipeline with oversaturated fill in the rain. The technician took pictures of this activity and left the site.
