Date : 06/28/2025
Project No : 2025C160
Client Company : Artisan
Arrival Time : 06/28/2025 08:00
Onsite Hours : 04:00

ASEC Report ID : 82635
Name of the Project : Rockmart Township - 115 Felton Drive
Project Location : Rockmart
Weather : sunny
Departure Time : 06/28/2025 12:00
ASEC Technician Name : Sean Willett

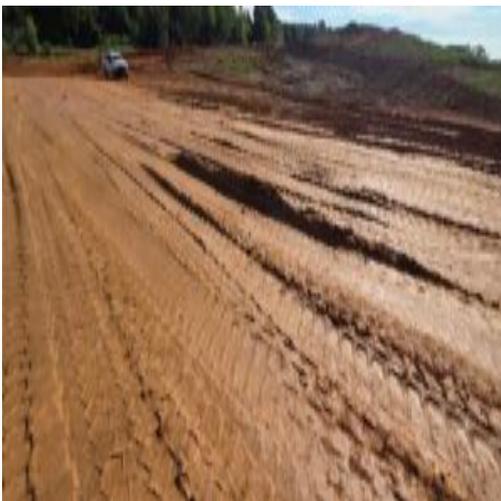
Lot #127 and partially on Lot #128 showed signs of pumping due to wet fill previously placed, this was fill excavated from road cuts on the previous day. The technician recommended for the contractor to scarify the lift and allow ample time to aerate before compaction.

pumping on 127 and part of 128

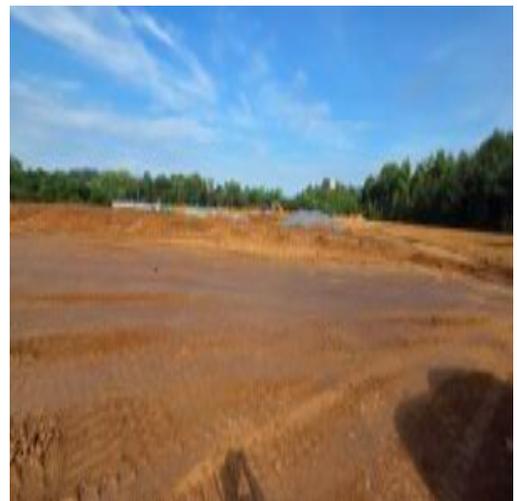
pumping area

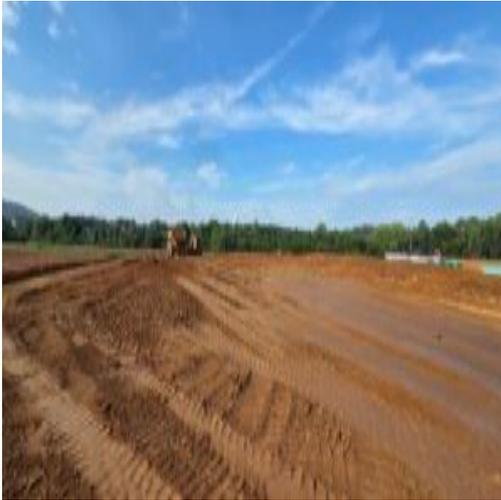
Our ASEC representative was on site as requested by the contractor (Wilbanks) for the observation/testing of the placement of fill/backfill. The technician observed the contractor place 1 lift approximately 8 inches in thickness over Lots #127 through #133 and Lots #80 through #82. The fill was placed in approx. 8 to 12 inches in thickness.

placing fill across 127 - 133
