Date : 07/02/2025
Project No : 2025C160
Client Company : Artisan
Arrival Time : 07/02/2025 07:30
Onsite Hours : 01:30

ASEC Report ID : 82729
Name of the Project : Rockmart Township - 115 Felton Drive
Project Location : Rockmart
Weather : overcast
Departure Time : 07/02/2025 09:00
ASEC Technician Name : Sean Willett

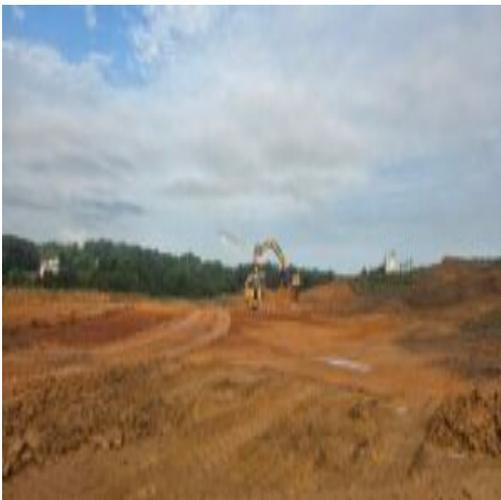
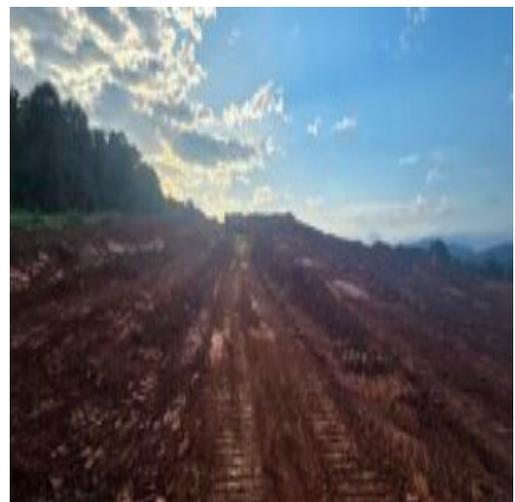
#40 - #50 roadway

The contractor continued placing fill, in approximate 8 to 12 inches in thickness, across Lots #137 through #139 and lots #156 through #158. Our representative performed density testing in these areas and provided all test results to the contractor. The contractor excavated materials from approximate Lots #40 through #50 for these fill areas.
