Date : 07/10/2025
Project No : 2025C160
Client Company : Artisan
Arrival Time : 07/10/2025 08:30
Onsite Hours : 04:30

ASEC Report ID : 82959
Name of the Project : Rockmart Township - 115 Felton Drive
Project Location : Rockmart
Weather : sunny
Departure Time : 07/10/2025 13:00
ASEC Technician Name : Sean Willett

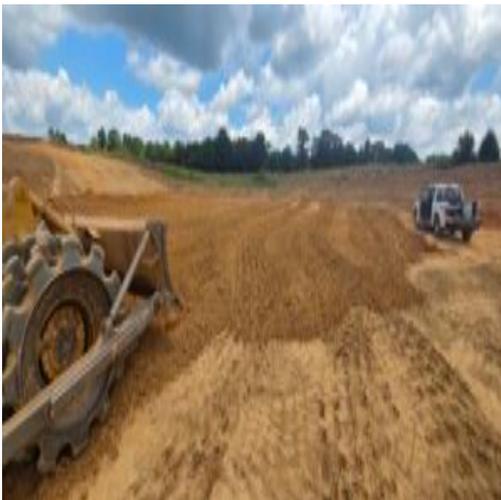
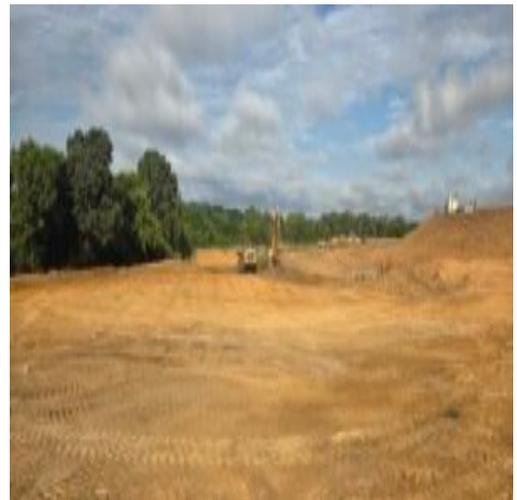
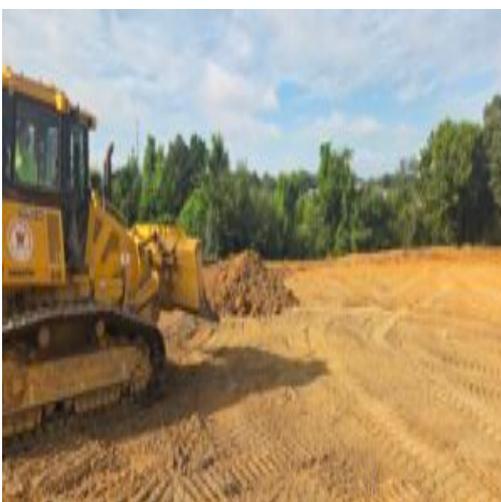
Our ASEC representative was on site as requested by the contractor (Wilbanks) for the observation/testing of the placement of fill/backfill. The contractor continued placing one lift across Lots #155 through #156. Fill was spread in approximate 8 to 12 inches of thickness and compacted via a sheep-foot roller. The representative performed density testing this area and provided test results to the contractor.
