Date : 07/23/2025
Project No : 2025C160
Client Company : Artisan
Arrival Time : 07/23/2025 08:30
Onsite Hours : 07:30

ASEC Report ID : 83279
Name of the Project : Rockmart Township - 115 Felton Drive
Project Location : Rockmart
Weather : sunny
Departure Time : 07/23/2025 16:00
ASEC Technician Name : Sean Willett

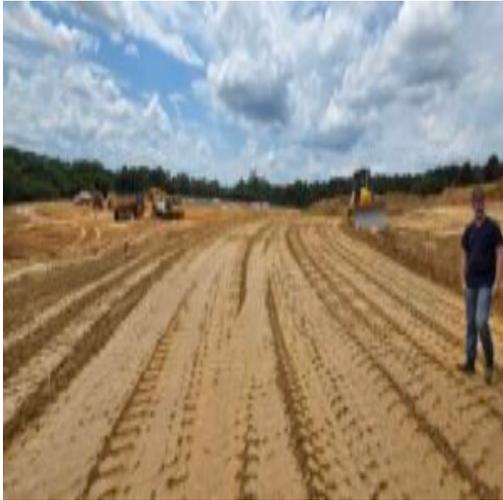
lots 173 - 180

The contractor began placing lifts along the slope of lots #174 - #180 area. The contractor said this slope will be excavated again for the basements of these lots. The technician density tested this area and addressed the contractor about low compaction results. The technician recommended to roll in the lifts with a loaded off-road truck. Density tests showed the soil being used was too dry for proper compaction. The technician observed the contractor mix in topsoil with organics in this location. When the technician spoke to the contractor, they said they didn't realize it was topsoil being used in this area. The technician stopped anymore topsoil from being placed in this area.

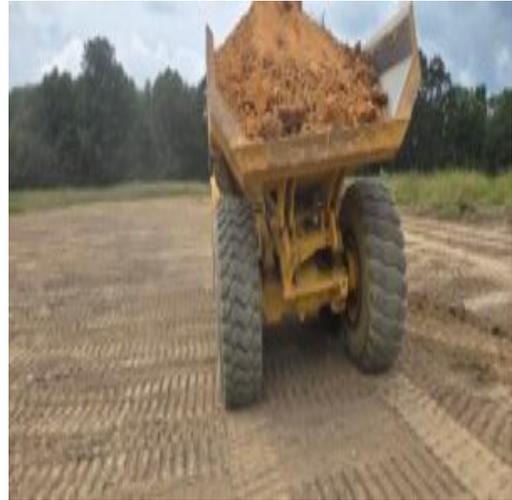
The contractor stripped topsoil from Lots #197 through #208 and #209 through #229. A proof-roll of this area was performed with a loaded offroad dump truck. The technician recommended to remove the soft spots that were marked. General probing of these areas was performed also. In spots where fill exceeded 10 feet, the technician recommended to do a bridge lift of approximately 2 feet. The contractor agreed.

proof roll

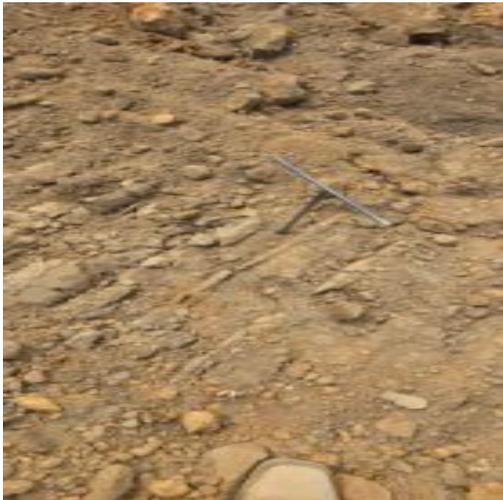
proof roll soft spot

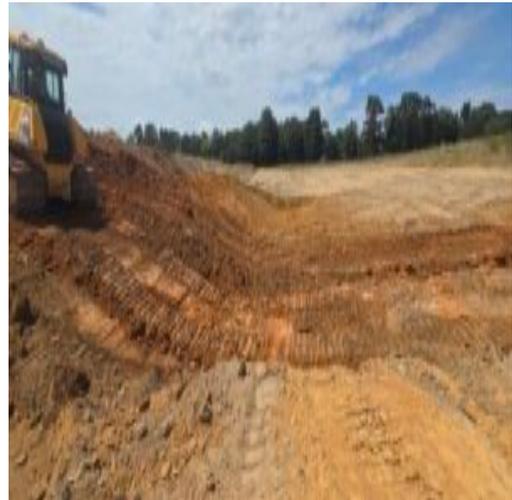
cut out soft spot on proof roll

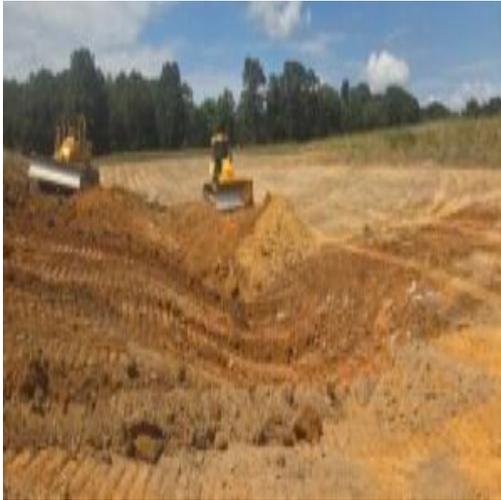
bridge lift in soft spot

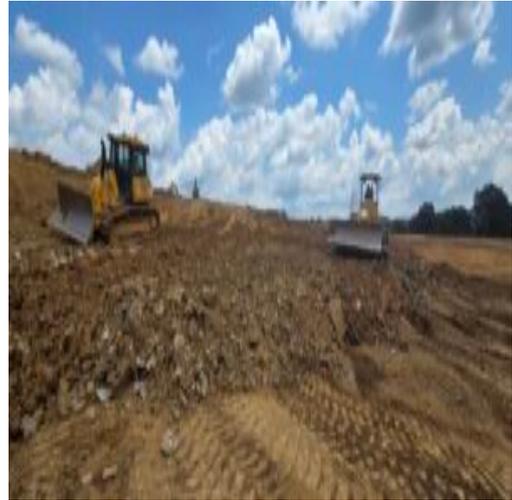
building the bank of 173 - 180
