Date : 07/24/2025
Project No : 2025C160
Client Company : Artisan
Arrival Time : 07/24/2025 08:45
Onsite Hours : 07:45

ASEC Report ID : 83308
Name of the Project : Rockmart Township - 115 Felton Drive
Project Location : Rockmart
Weather : sunny
Departure Time : 07/24/2025 16:30
ASEC Technician Name : Sean Willett

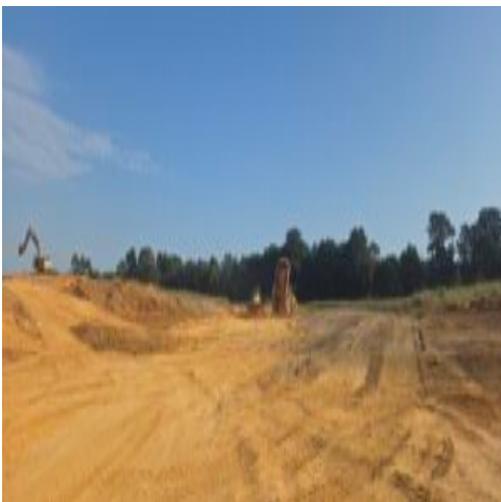
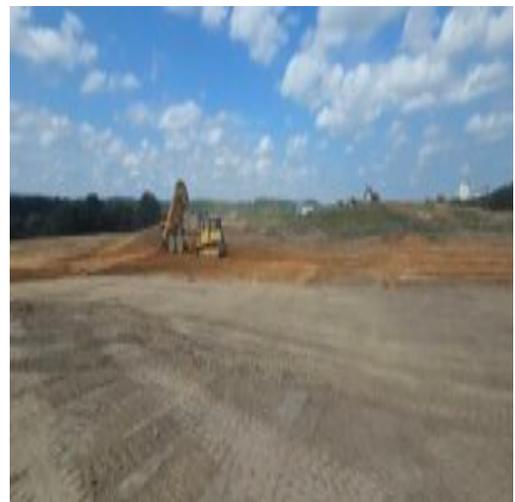
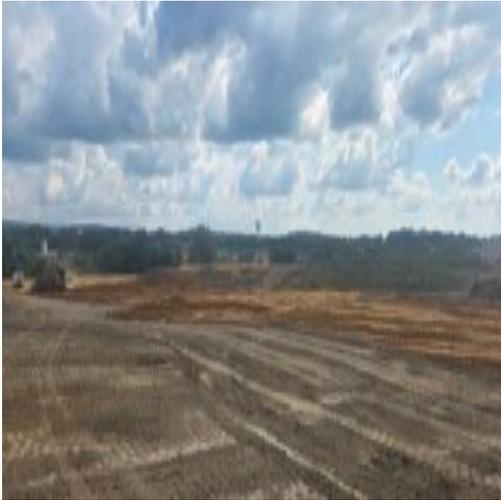
Our ASEC representative was on site to observe the contractor (Wilbanks) continue the placement of fill across the site.

The contractor placed lifts of approx. 8in to 12in in thickness across Lots #197 - 208 and #215 - #224. The technician performed density testing and provided test results to the contractor.

The contractor stripped topsoil from approximate areas of Lots #50 - #60 and requested our representative to observe a proof-roll of this area first thing in the morning.
